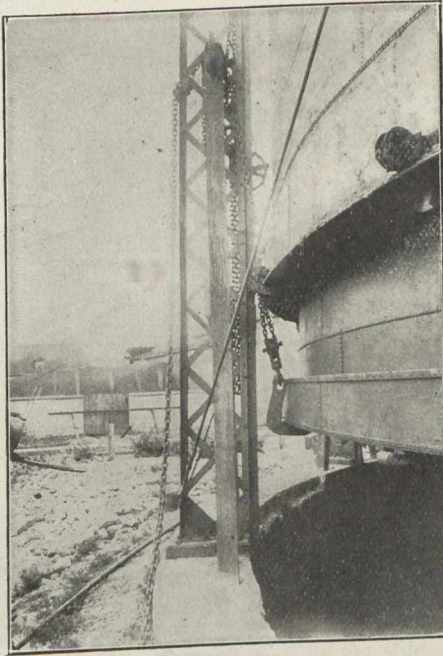
**Suspension of Tanks, showing One of the Ten Columns.**

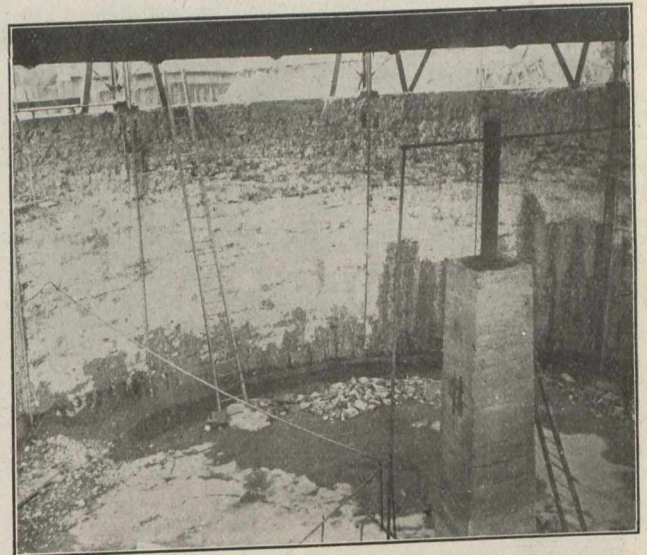
**A View of the Interior showing the Crumbled Condition of the Original Wall.**

wooden forms, so that three inches of concrete might be placed against the present main concrete wall. (3) Leave paper on and line with brick, (four inches) embedded in cement. (4) Put in steel lining, with a 3-inch flange at bottom, this flange to be covered with a good, strong mixture of concrete. (5) Raise both lifts and blow up present concrete wall and build a new one.

In regard to No. 4, it was considered too expensive, as was also No. 5. Nos. 2 and 3 were thrown out as the space between the holder and concrete was small. It would be necessary to cut off about two inches of the flange or cut away the masonry to allow the laying of brick on the concrete. In the meantime several methods were used to stop the leaks. The driving of a small wrought iron pipe, about  $\frac{1}{8}$ -inch, into wall where leaks were the worst and fill up the other leaking places. Also, the leaks were plugged with clay and mortar. Over this was trowelled on a strong mortar of cement, alum and sand, but this was forced or eaten away. Several loads of manure were scattered upon the surface of the water, and a mixture of three parts of bran and one of cement was put on the water close to the concrete wall to draw it into the openings.
