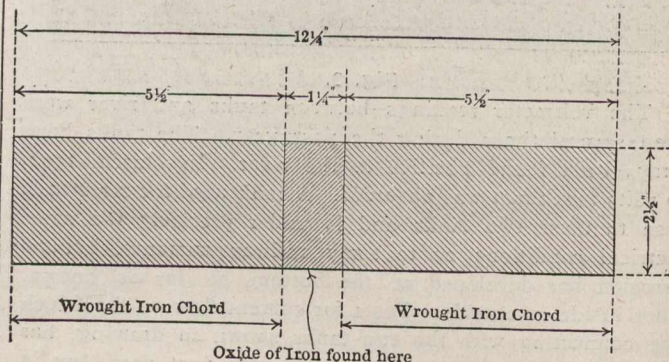
Cross section with dimensions of two wrought iron bridge chords, before being damaged by electrolysis. Point St. Bridge, Providence, R.I.

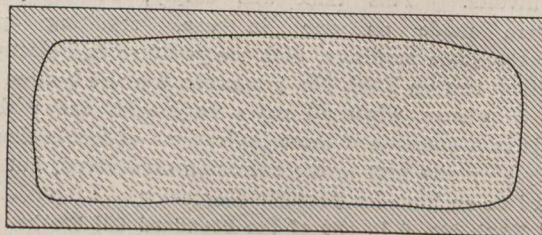
SECTION OF ONE OF THE WRO'T IRON CHORD MEMBERS OF POINT STREET BRIDGE

Original section of Chord before being affected with electrolysis.

Section of Chord after being affected with electrolysis.

Area of original section 12.375 Sq'r. Inches. Area of present section 8.41 Sq'r. Inches. Percent of loss of section 32 Per cent. Area worked out with planimeter.
