### RAIL FAILURES DUE TO BURNS AND CRYSTALLIZATION, CAUSED BY SLIPPING OF ENGINE DRIVERS, BALTIMORE AND OHIO RAILROAD.\*

By A. W. Thompson, Chief Engineer Maintenance of Way.

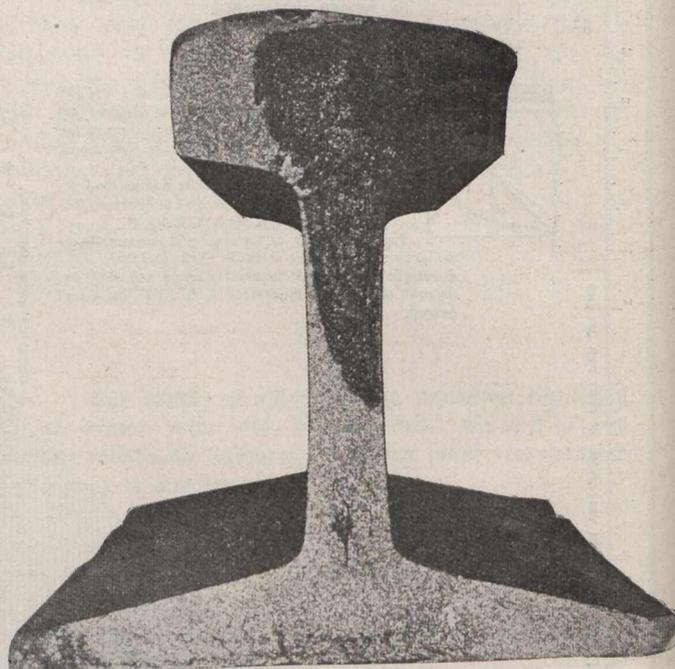
Failed Rail (Carnegie) Rolled 7-96. From Wreck at Shenandoah Junction.

The rail was in the low side of the curve, being jointed with a four-hole splice, and it broke into twelve pieces. The lengths of the pieces varied from 3 in to 24 ft., most of which were over  $1\frac{1}{2}$  ft. long. The attached photographs show a view of these pieces with the exception of the end pieces, which remained in the splice. At two points the breaks were square, as if sawed, but in the other cases the breaks were slanting, each in different directions. This was the only rail damaged in the accident. Gauge at point of accident was found to be 4 ft.  $8\frac{1}{2}$  in.; elevation of curve,  $6\frac{1}{4}$  in.; both line and surface were good.

Microscopical tests of the rail later developed the fact that slight cracks existed in the base of the rail before the accident occurred, but these cracks were entirely too small to have been detected by even close examination with the eye before the rail became separated. The rail was inspected by track walker only a short time before the derailment took place.

The rail showed very little wear and the only marks which could be detected were those made by the slipping of the drivers of the engine. The frequency with which these marks occurred on this one rail was due to the fact that westbound freight engines stop nearly always in about this spot to back
