The following summary states concisely the conditions existing in the city.

#### District Affected by Stray Currents.

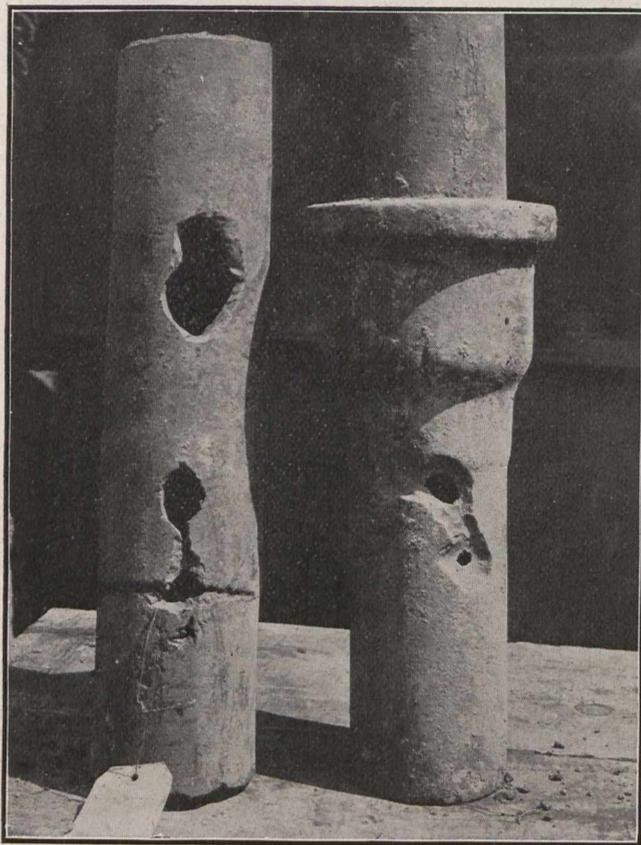
The tracks are bonded at the corner of Main Street and Portage Avenue to the return feeders of a total sectional area equal to 6,848,000 circular mills. The drop of potential between this point and the negative bus bars, if these carried the whole railway current would reach 12 volts at

times. The distance is approximately 1,200 feet, that is, the drop of potential from these tracks to the station is one volt per 100 feet. This is altogether excessive, a voltage drop of one-half volt per 300 feet is usually considered large enough. The above condition is responsible for the trouble reported in district No. 4.
