INVESTIGATION OF EFFECT OF FIRE IN A LARGE REINFORCED CONCRETE PAPER MILL.

At 11 p.m., May 25th, 1912, fire broke out at the pulp-board mill of the Androscoggin Pulp Company, South Windham, Maine. The Aberthaw Construction Co. built this structure in 1906, L. W. Jones, of Milton, New Hampshire, being the engineer. The building is of reinforced concrete

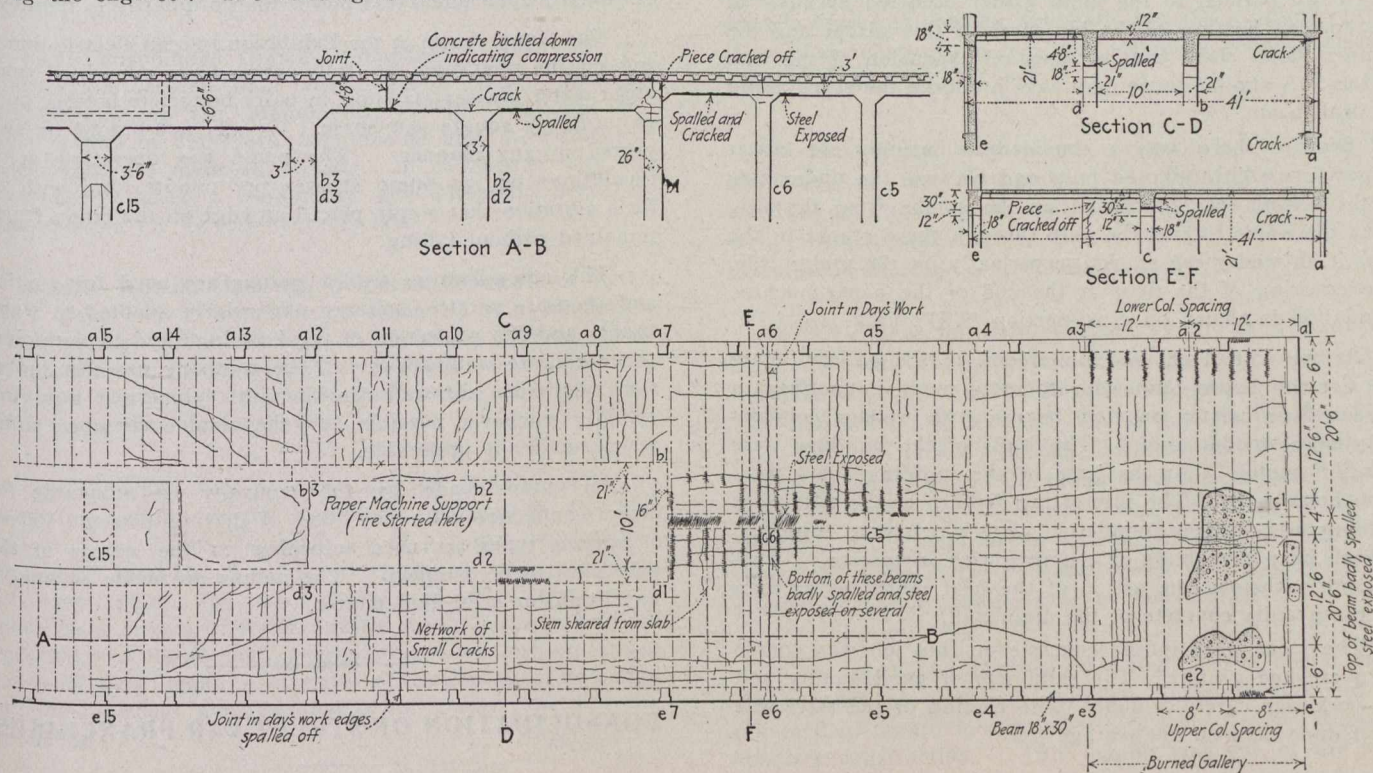
Fig. 1.—Androscoggin Pulp Co. Fire.

The fire started under the first floor in the middle of the building (Fig. 1). As far as could be observed, the principal effect of the heat was to expand the floor, causing a movement of the column. It was reported that on the morning of the 26th the end wall of the mill was observably out of plumb. At that time the concrete was generally so hot that one could not stand putting his hand on it outside of the building. Later on, this particular wall drew back again to the perpendicular. The crack at the pier, crack "A-7" (Fig. 2) shows the effect of this movement on the outside wall, where the size of the wall beam changes due to different spacing of the columns. The cracks above and below the bracket of the column also seemed to indicate the longitudinal movement of the floor.

It will be noticed (Fig. 1) that in the section of the floor at the wall end of the building (right end) the main

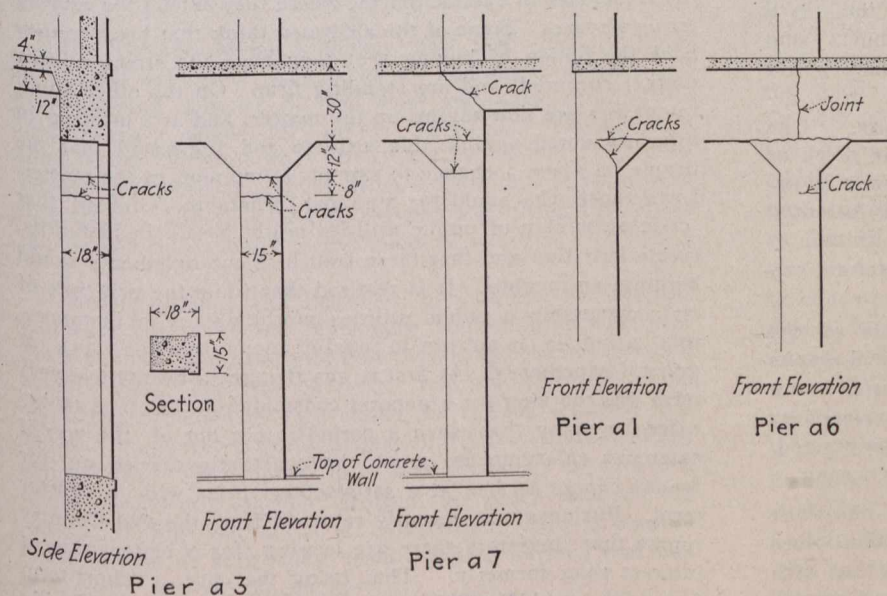
The cracking of the columns at the side of the building seemed to indicate the same sort of expansion. These cracks occurred at

both top and bottom of some of the columns. The top cracks are shown in Fig. 2.
