#### Damage to Buildings.

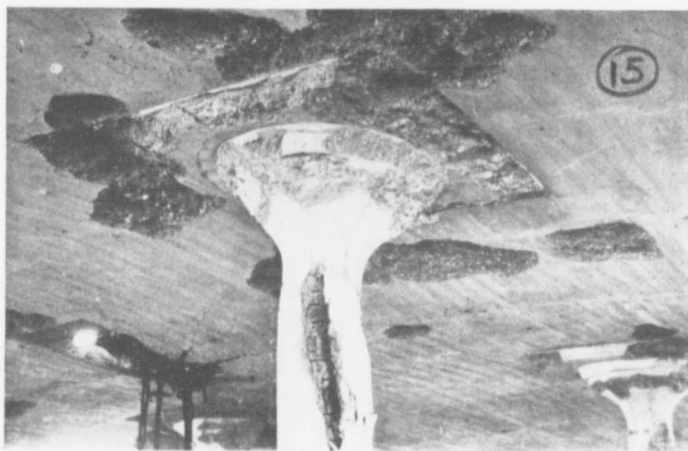
Fig. 12. A column failure.
