Appendix 1.

Detailed description of accident.

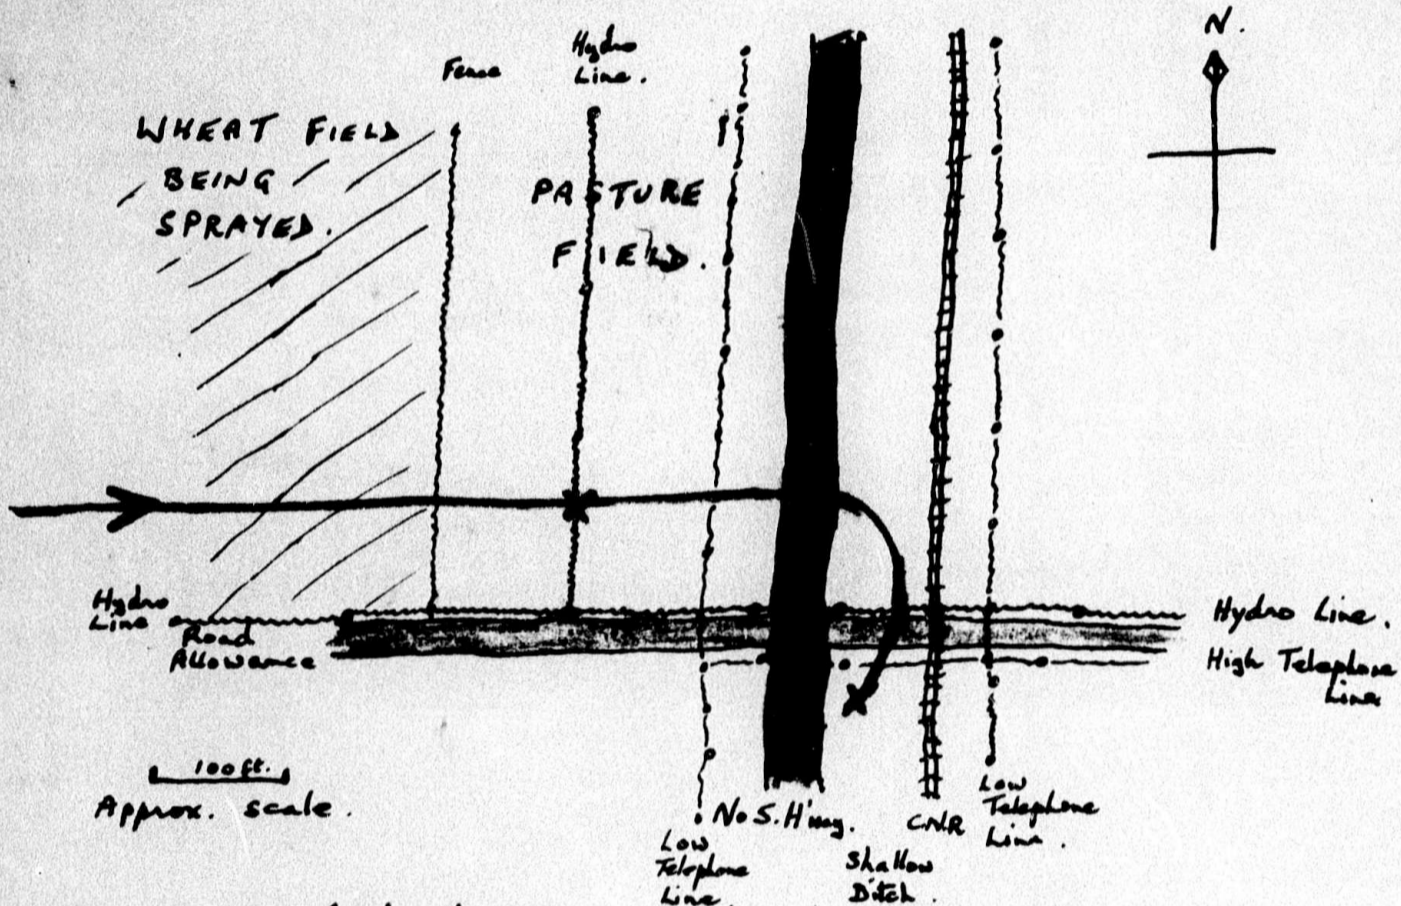
The field had been sprayed 2 days before in a N-S direction. Due to the hydro line on the S. boundary, a headland was not sprayed in this direction, normal procedure being to do this E-W, or parallel to the hydro line. As I had used up the chemical on completing the N-S run, the headland was left for another time, and it was while doing this that the accident occurred.

Before going in to spray, I always "case" a field for hazards. I had done so on this occasion. My first run was E-W along the S. boundary, coming in over the railway, road & hydro line. It was on the second run, W-E, that the accident occurred.
