The purpose of this article is to describe briefly how the repairs were carried out, the broken 12-foot length of pipe being removed and a sound one substituted. Fortunately it was possible to undertake the repairs before the end of winter, while the water level in the river remained at its minimum, and the ice was in good condition.

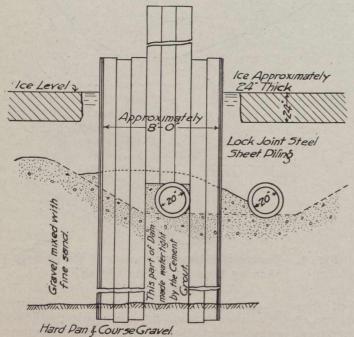
bed of the river with the two lines of 20-inch diameter cast iron pipes in position. Fig. 3 shows a cross-section of the cofferdam constructed around the broken pipe. Lock Joint steel sheet piling was used, the length of the dam being about 24 feet.

It would have been a comparatively simple matter to have secured a watertight cofferdam had it been possible to use this piling across the full width of both ends of the dam, but the position of the pipe prevented so simple a solution of the matter.

Fig. 3.—Sketch of Cofferdam Constructed Around the Section of Broken Pipe.

large proportion of fine sand, which overlies for a depth of several feet a firm stratum of coarse gravel and hardpan firmly cemented together, into which the sheet piling was driven.

Several attempts were made to complete the ends of the cofferdam above and below the pipe, but without success, and much delay and expense might have been entailed had not the superintendent in charge of the work conceived the idea of forcing cement grout into the gravel and sand at these points by means of a hand pump—an idea which was put into operation with immediate and complete success. The cement was mixed in deep steel wheelbarrows, and reduced to the consistency of cream with water in which had been dissolved soda crystals, the latter being used to hasten the setting of the cement. The pump was operated by four laborers, and was found capable of exerting a pressure of 40 lbs. when previously tested with water against a pressure gauge.

The work of pumping the grout had to be carried out with the utmost despatch in order to prevent the pump from becoming choked, each batch of grout being handled quickly, and the pump thoroughly washed out after dealing with each batch. In all, twenty-two bags of cement were used, and within a period of 60 hours the cofferdam had been pumped dry.

The subsequent work of removing the broken pipe, and replacing it with a sound one was successfully and expeditiously performed.
