**COLLAPSED COAL TRESTLE.**

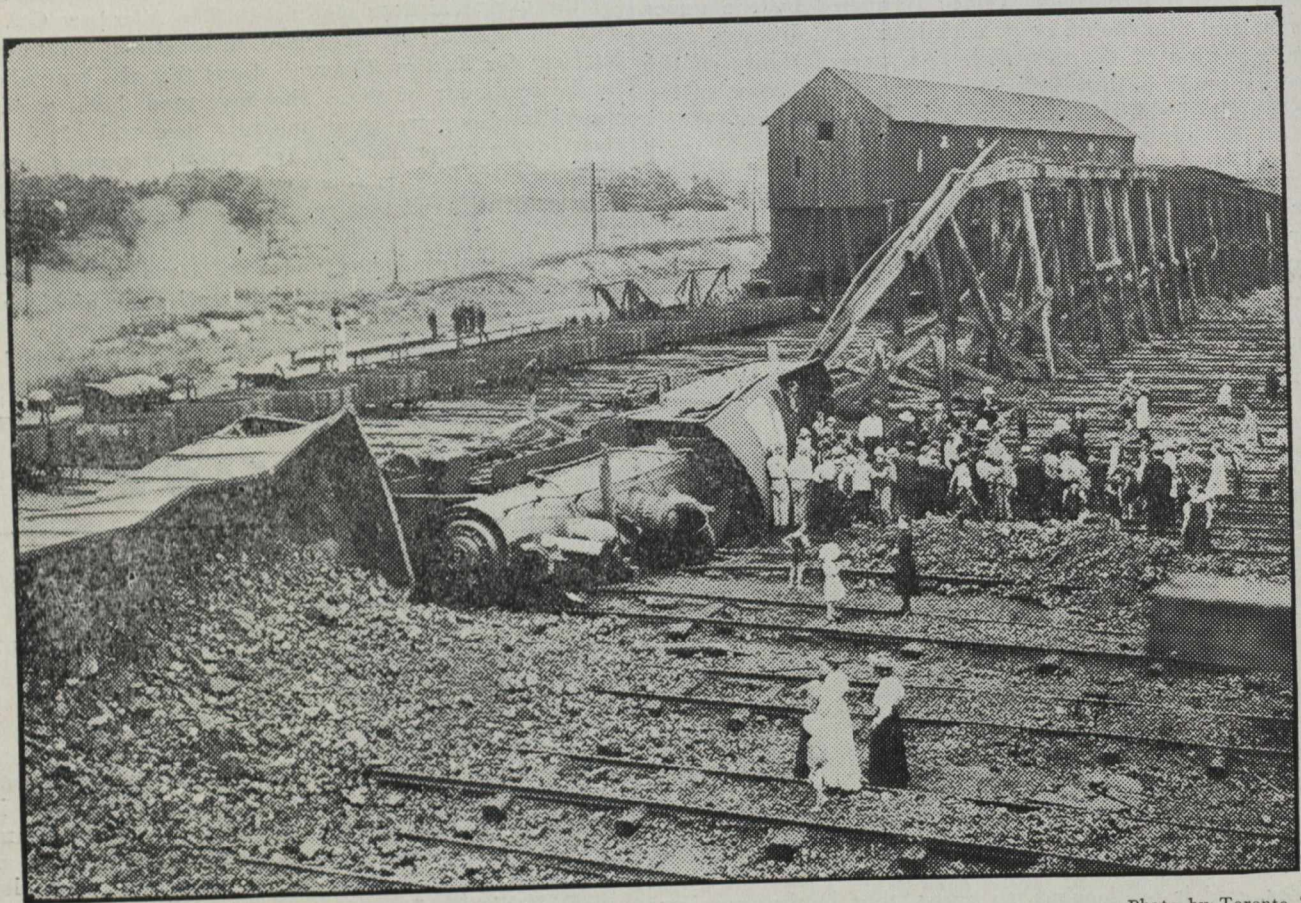
One man was killed and two others seriously injured as the result of the collapse of a timber trestle at the East Toronto Yards of the G. T. R.

The trestle was made of cedar posts. For a number of years its whole length was supported by coal piled underneath it, which reached almost to the level of the elevated track. Recently the yards were removed to Mimico, and the coal was carted away. Recently the Grand Trunk decided to put some more coal there, and the crew and engine were doing the work.

In addition to being weakened by the removal of the coal it was found that the posts had rotted at the bottom.

engine, cars and men to the ground, a distance of 25 feet. Some 300 feet of the trestle fell. The trestle was made of cedar posts varying in size from 18 to 24 inches. The bents were put up at 20 foot centers.
