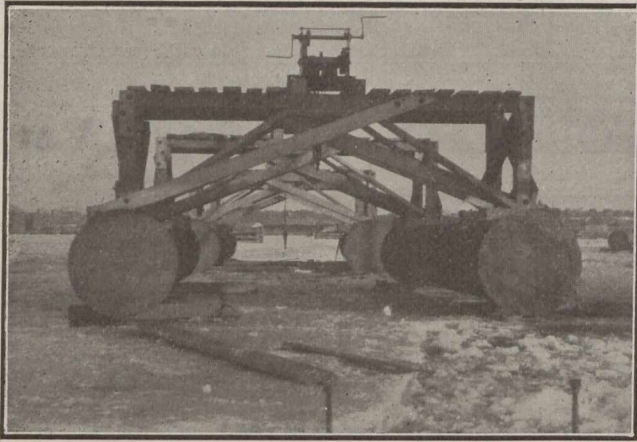
Fig. 5.—The Form of Pipe Float Used.

and taking the pipe ashore. The device used to overcome this difficulty was that of putting bulkheads on two lengths of pipe and erecting a gantry frame at either end, fitted with windlasses. This formed the pontoon

illustrated in Fig. 5, 40 ft. in length, 15 ft. wide, with an open space between the pipes of 6 ft. It had a lifting capacity of approximately 13 tons.
