DAM OF "HOME-MADE" DESIGN FAILS IN NOVA SCOTIA

By K. H. Smith, A.M.Can.Soc.C.E.

Resident Engineer, Dominion Water Power Branch,
Halifax, N.S.

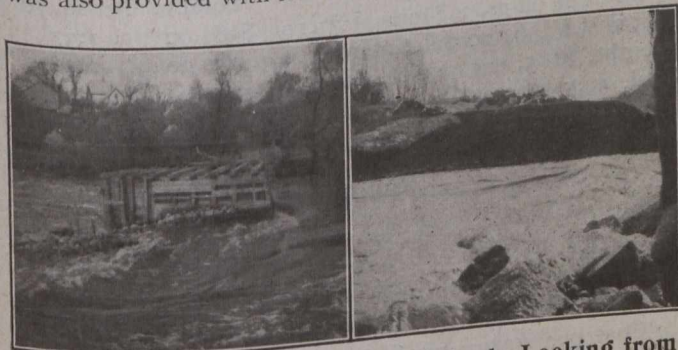
View from Top of Eroded Bank to Flume and Dam

Eroded Bank, Looking from Existing Timber Flume

At the period of highest water, the whole structure was submerged at least two feet, so that the water going over that section of the dam just mentioned washed out the bank, probably beginning where it had already been disturbed and continued to cut into the bank until a channel from 60 to 75 feet had been formed which carried almost the entire flow of the river. The bank at the other end seems to have been saved by the mass of willow roots which it contained. The present condition of the dam is

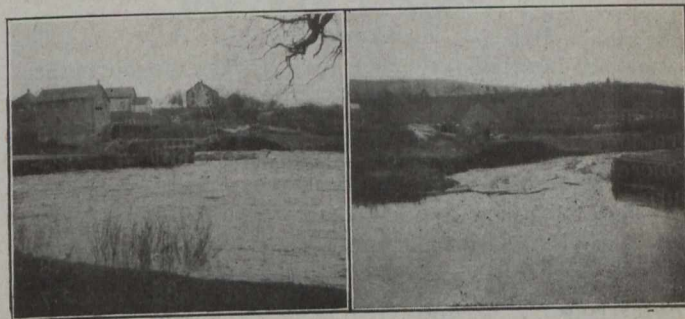
Looking Upstream, Showing Existing Condition of Dam and Break in Bank

View Looking Downstream, Showing Break in Bank

shown in the accompanying illustrations. The greater portion of it remains intact and in good condition, while the stream is flowing in a new channel cut around the end of the dam. In brief, the dam failed due to water going over the top of a bulkhead section caused by the fact that sufficient discharging capacity was not provided by the existing rollway and sluice gate.
