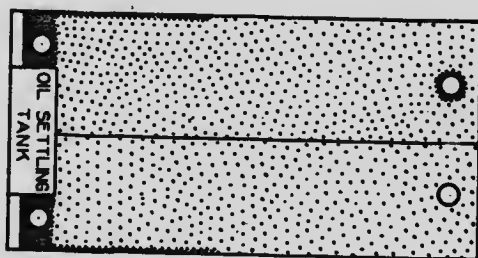
Fig. 18. Diagram showing damaged grain in layer E.

*Layer E.*—It was in this parcel that the damage was most extensive. A body of grain occupying the space between the sides of the ship and the oil settling tank was found to be heating and musty. In some places the wheat was warm five feet away from the bulkhead, and to the full depth of the layer. Probably 700-800 bushels were affected altogether, some of it being very warm, covered with fungi growth, and caked so badly that it was difficult to break down, while in other places it was only just warm and held together very loosely. All the heating wheat which has been described up to the present was mixed up and worked in with the sound wheat during the unloading. The cargo superintendent apparently considered that the damage was not sufficient to make the separate treatment of this grain necessary, and it is for this reason that more accurate information cannot be reported with regard to the weight of grain which arrived out of condition.

Underneath the port ventilator at the forward end of the hold, a quantity of grain weighing about four bushels was found to be badly heating in this parcel. There seems to be little doubt that the cause of this damage was the drainage of water down the ventilator. This wheat was not mixed up with the sound grain.

Along the sides of the ship in the after half of the hold there was a thin layer of very wet, sour and discoloured grain which near the surface had sprouted badly. The bad condition of this wheat was attributed to "sweat" damage. All the grain so affected was kept separate from the main bulk of the parcel.
