ELECTROLYTIC CORROSION OF THE BOTTOM OF OIL TANKS AND OF OTHER STRUCTURES.*

Adolphus A. Knudson, Electrical Engineer.

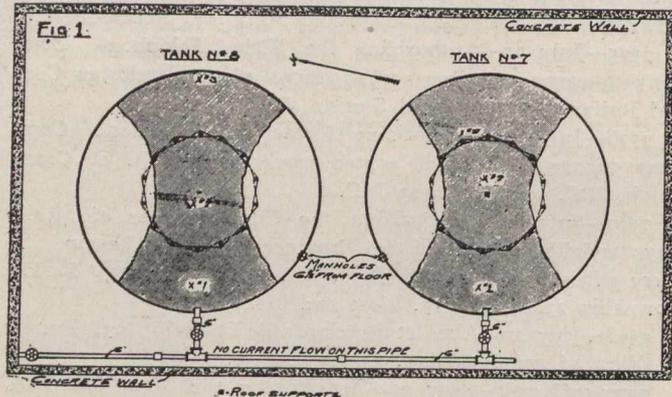
Fig. 1 shows the top view in section of both tanks. These were found numbered 7 and 8 (the same numbers used in the drawing), and will be herein so referred to. These tanks are 35 feet in diameter and 16 feet high, slightly higher at the peak of the roofs. The roofs are supported in this case by perpendicular wooden joists from the floor, as shown by the circle of square dots in the drawing. An intake pipe is located about 6 inches from the bottom of each tank, which is also used as an outlet. These intakes connect to the outside pipe line shown in the drawing.

through the works. When the writer was called to examine, the first discovery made was the pittings originated at the interior of both tanks, the larger part of such pittings on the inside floor, and tapering downward, many of them terminating in holes through the iron. These holes ranged in size from $\frac{1}{4}$ -inch in diameter to more than 1-inch in several cases.

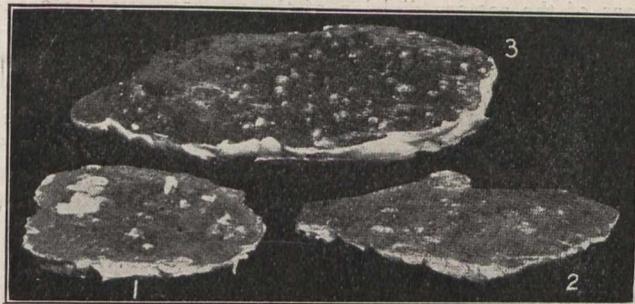
The first three are from Tank No. 7, Fig. 2.

Cast No. 1.—A pitting with a projection near the centre, representing a hole through the metal $\frac{1}{4}$ -inch in diameter. This is the only projection on the casts representing holes

which remained intact; the other broke off when the casts were removed. At the left of this pitting are two white spots which represent holes, where the plaster broke off.

Cast No. 2.—A pitting at the far side nearly through the iron. This was taken about the centre of the tank.

Cast No. 3.—A cluster of pittings representing a fair average of those discovered at the opposite side of the tank from the intake.

Plaster Casts from Tank No. 8. Cast No. 1.—A group near the intake, which represents a fair average at this point, excepting some holes not far away.

Cast No. 2.—Shows a ridge representing a furrow or channel in the iron bottom 4 inches long, $2\frac{1}{2}$ inches wide, and $\frac{1}{32}$ -inch at the deepest point, or within $\frac{1}{32}$ -inch of being through the iron. In the immediate vicinity of this cast were found several holes.

Cast No. 3.—The top broken off, representing a pitting with a hole at the centre. This hole was 1-inch long and $\frac{1}{2}$ -inch wide, measuring from the longest and widest parts.

These two tanks have been in service seven years. As they were much needed for storing oil, temporary repairs have been made by filling the pittings and holes with litharge and red lead, but it is probable that new bottoms will soon be placed in them.
