## FAILURE OF THE ORILLIA DAM.

Orillia Power Dam.

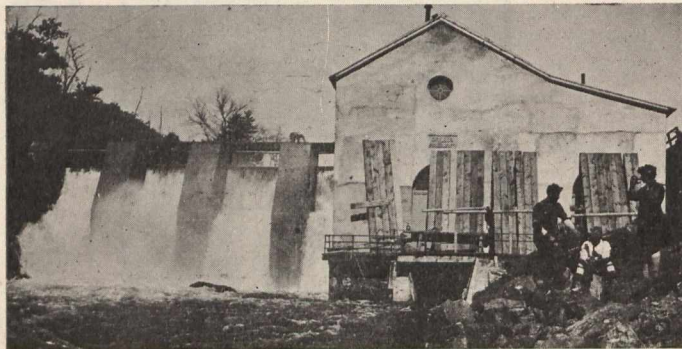
tract and completed the dam, but a considerable and essential portion of the work was carried out in the winter time and in running water, which, it is claimed, washed out the cement. The contractor denies this, and alleges that the break was caused by the washing out of the disintegrated rock at the bottom of one of the sections shown in the accompanying plans. The dam broke away on the 7th April last, during a period of high water, the break having commenced at the bottom, the concrete portion being first carried away and then two sections of the upper works, one after the other.

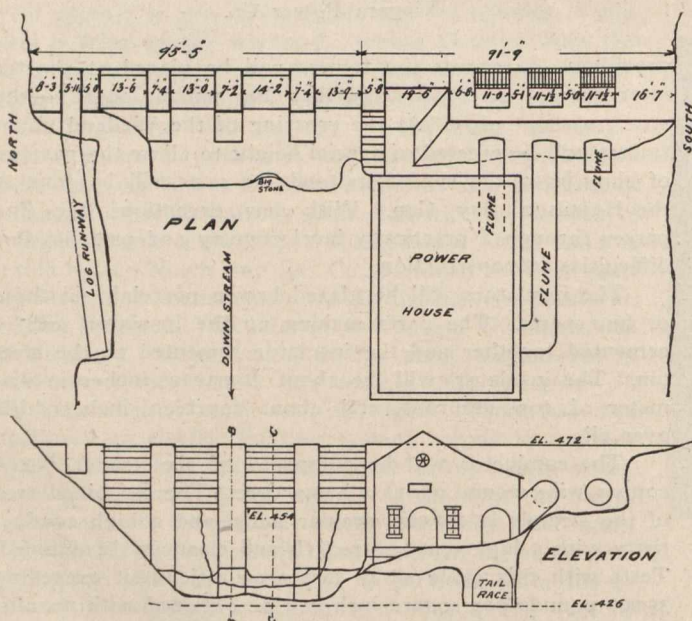
Plan and Elevation, Orillia Power Dam.

ing of two types of section, one of which we will call section B-B, running up to the top level of the dam, as a continuous concrete wall, or pier, the other as per section C-C, only to an elevation of 18 feet below the top of dam, and being supplemented by stop logs to bring it to high water level, sections C-C alternating in between sections B-B, as shown.

The area of the section B-B, at the position where it attains the greatest height of wall, viz., 46 feet is 970 sq. feet, which at 140 lbs. per cubic foot, will weigh 135,800 lbs.

The area of adjoining section C-C will equal 590 sq. feet, which at 140 lbs., will weigh 82,600 lbs.

Multiplying B-B by its length of 7 feet 2 inches, and C-C by its length of 14 feet 2 inches, we have 966,600 lbs. + 1,169,610 = 2,136,210 lbs.

Now the total pressure upon such surface, 21 feet 4 in., in length of a dam 46 feet in height, will equal 1,411,107 lbs., giving a co-efficient of friction of .660.

The overturning moment of the water pressure will, upon the length of 21 feet 4 inches, equal  $1,411,107 \times \frac{46}{3} = 21,636,974$  ft. lbs. The stability of the section will equal  $966,600 \times 12 = 11,599,200$   
 $1,169,610 \times 14 = 16,374,540$

27,973,740 ft. lbs.

As the co-efficient of friction existing in the structure may possibly have been equal to .660, I will not say positively that the trouble lies here. As the stability moment of 28 millions exceeds the overturning moment of 22 millions, I cannot say that the trouble lies here. But one can quite readily see that the estimated pressure in each case is uncomfortably near to the estimated strength. The dotted line, shown on the elevation, represents the line of breakage, all of the wall above this line having been carried away.

It will be noticed that the break occurred at the part where the greatest height and greatest pressure existed. It may also be pointed out that where the break occurred is also where the greatest difficulty was encountered in depositing the material, a portion of it having been deposited, I am informed, in still water, about six feet in depth, recourse having been had to the open cylinder method of depositing concrete. It is well known that this is not the most desirable method, one great drawback being that small chance is afforded for inspection of the bed of the stream. The bed of the stream at this point is known to have contained a deposit of sand, and loose stones, and it is inconceivable that material should have been put in place without every vestige of such deposit having been removed. It was noticed that when the river was in flood, the water "boiled" at the foot of the dam, but later on this point of boiling occurred some distance down stream, and it is asserted that an opening had occurred through the foot of the dam, underneath one of the sections C-C. As this opening, and the pressure of the stream through it, increased, the point of "boiling" occurred farther down stream, until suddenly one of the piers, B-B, fell outward, and northward, and the whole section, as shown, followed."
