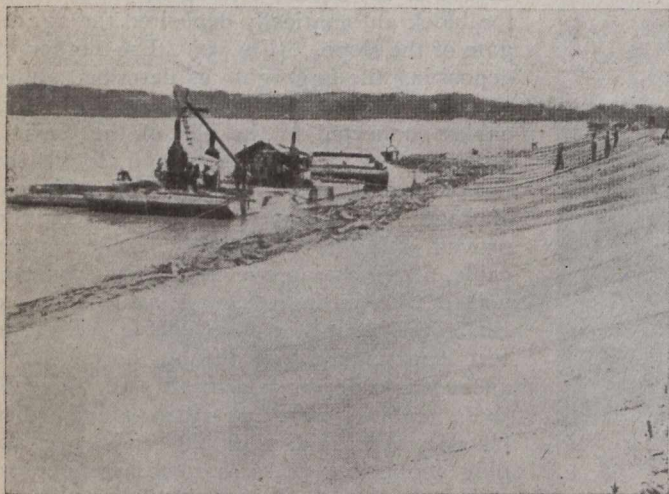
Fig. 5—Concrete Mixer and Delivery Plant; Also Completed Section of Paving
