REPAIR OF INTAKE PIPE FOR CITY OF OTTAWA

RECLAIMING 40-INCH STEEL PIPE LINE LAID A QUARTER OF A CENTURY AGO IN THE OTTAWA RIVER—DESCRIPTION OF REMOVAL, REPAIR AND RELAYING.

By L. McLAREN HUNTER, A.M.I.C.E., City Engineer's Office, Ottawa.

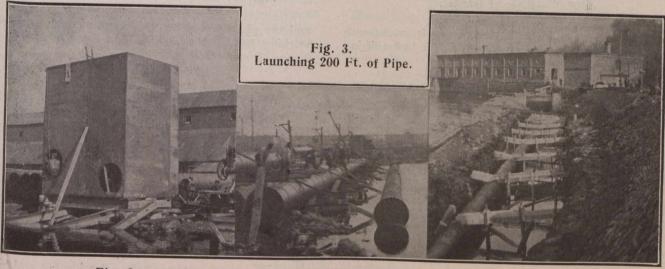
Fig. 1.—A Length of Pipe Ready for Relaying
