Fig. 4.—Plan Showing Timiskaming Regulation Works.

Cofferdam, Quebec Channel.—After the middle of September, 1910, practically all the work was in connection with the cofferdam across the Quebec channel.

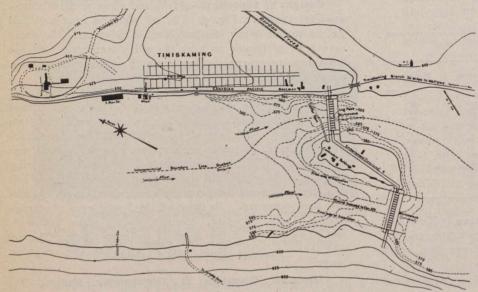
The Ontario bed is boulder strewn with hard material beneath, but the work done in the Quebec channel, before the cofferdam failed (May, 1911), indicates a sand, hard, but easily saturated. Through this material, the seepage

was all that four large pumps could conveniently manage. The foundation for the Quebec side will consequently be modified and include sheet piling beneath the cut-off wall. In fact, it proved impracticable to excavate the cut-off trench to feet deep in the sand, although the boring pipes were broken in piercing the undisturbed bed.
