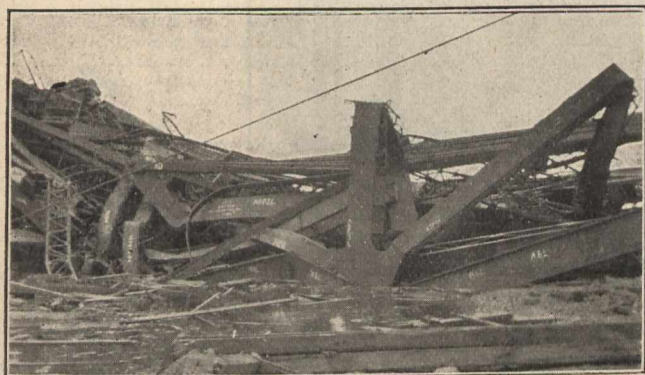
Anchor Arm, Third Panel Point from Main Pier.

It is interesting to note that the bridge sank with a grinding sound, rather than dropped with a succession of reports. This tends to indicate that failure of compression rather than tension members was the initial cause.
