CONCRETE BRIDGE FAILURE

During the summer of 1909, there was erected on Concession B, Township Etobicoke, York County, Ontario, a concrete bridge. The reproduced photo gives some idea of the style of the structure.

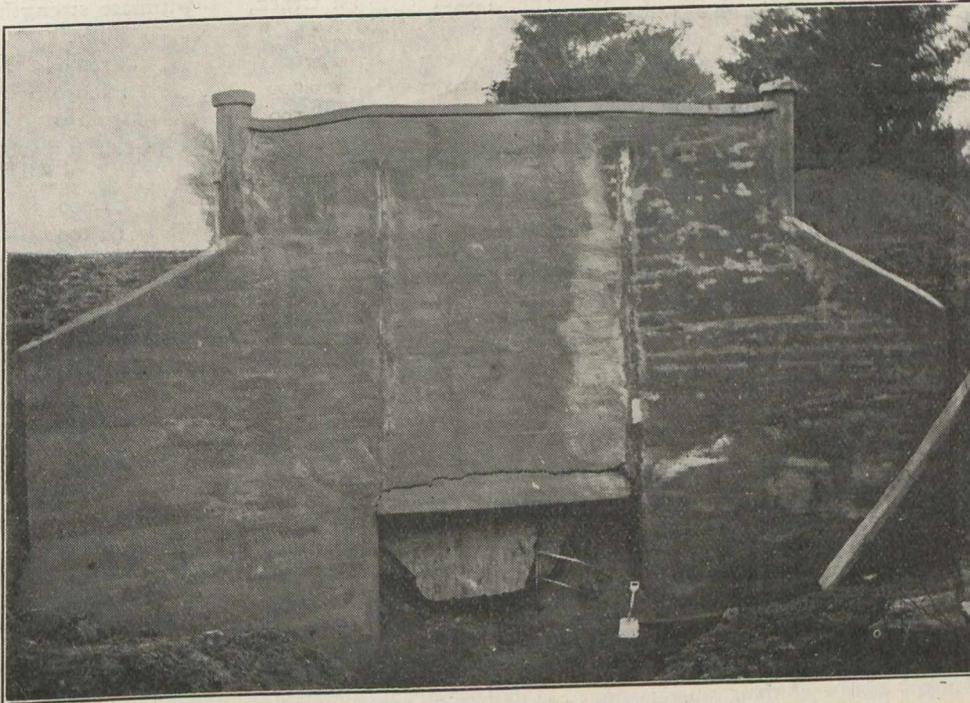
The accompanying photo gives a good idea of the break. The floor fell in, the horizontal crack in the face of the wall shows the depth of floor.

On examination the concrete appeared good being of correct proportion and had set well. The weakness appeared to be in the design.

A calculation made from measurements taken after the failure shows a stress of at least 41,500 pounds per sq. in.

Cheeney Creek Bridge after failure

on the steel in the floor slab and a stress of 1,100 pounds per sq. in. in the concrete.

This certainly looks like a case where the design has been at fault.
