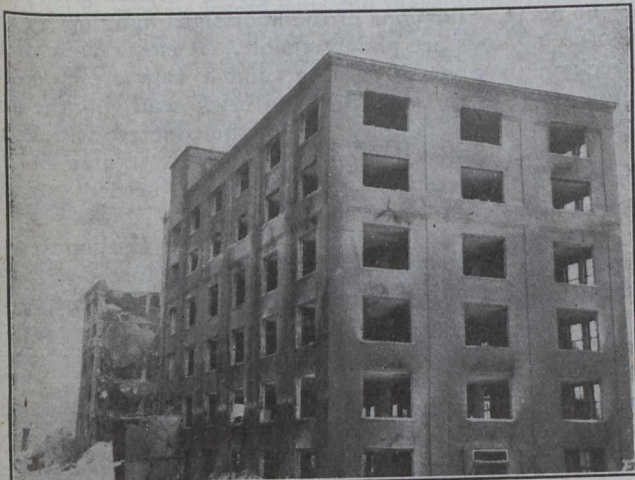
Fig. 5—The Warehouse After the Fire.

The eighteen storage bins were practically uninjured by fire, and represent the only portion of the plant which is not an absolute wreck. Fig. 2 is a general block plan of the plant. The portion of the concrete warehouse which collapsed is indicated, but the remainder of the warehouse is gradually breaking up and is so badly injured that it will be torn down, says Mr. Mylrea.

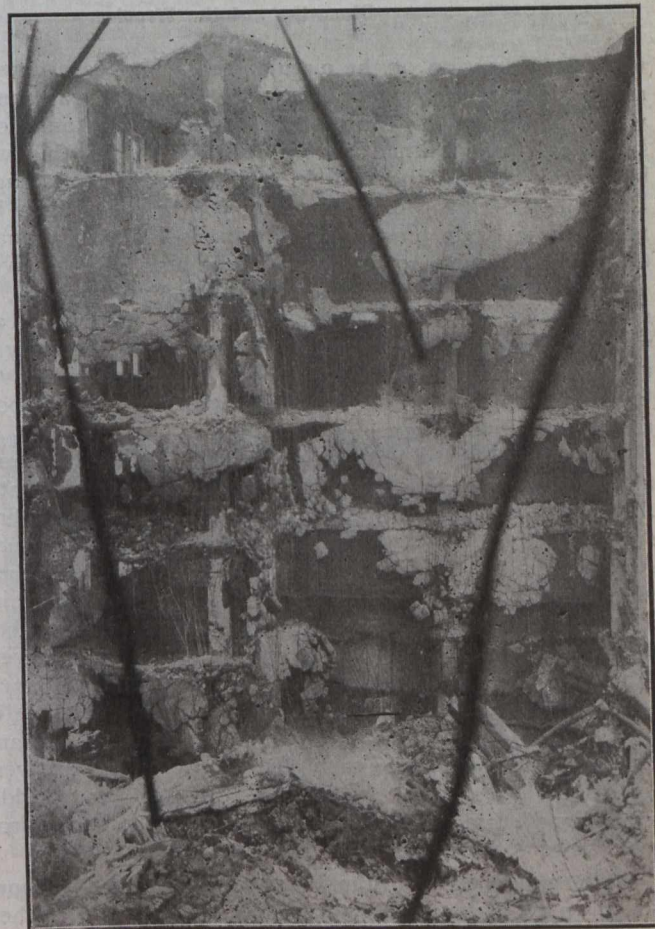
Fig. 6—Looking Directly Toward Standing 1½ Bays to the north. View taken from Standing Bays at the south end.
