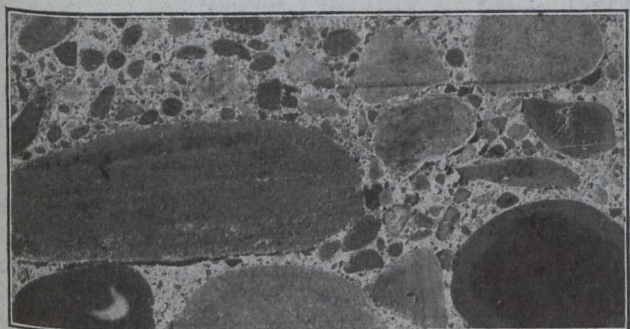
Fig. 4.—Sectional View of Sawed Block. Note Cavities Under Large Stones Due to Excess of Water

ness, there was a space without any mortar between the stones. It is impossible to go over the pavement and pick out such places, as they are hidden from view. The cause of this trouble is evidently lack of rigid inspection during the laying of the concrete. To illustrate the effect of segregating the large stones a photo (Fig. 3) was taken of the fractured surface of one of the six-inch cubes. This shows the lack of adhesion of the mortar to the stone and also why this cube withstood a lesser stress than the others tested.

3. Only enough water should be added to give a concrete which is clammy and on no account should concrete be used which will flow in the spout when the spout is inclined at less than 60 degrees to the horizontal.

4. It is necessary that all concrete should be thoroughly tamped, as the tamping helps to work out any excess water and improves the density and strength of the concrete. Tamping will also help to eliminate the bridging.
