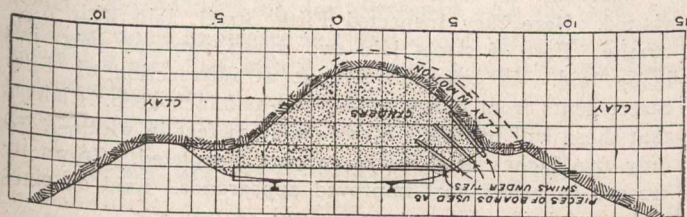
Hiram, Ohio. The wet cut is 2,000 feet long and contains numerous soft spots which required surfacing from two to three times a week. During the winter, when the roadbed was frozen, it was necessary to restrict the speed of trains on this curve. This point is at the extreme outlying end of a five-mile section, and was expensive to keep up, and there was the constant fear that the section foreman might neglect to keep the track in good surface, or that some engineer

Fig. 3—Section of Track at East End of Summit Hill Cut, Norwich, O.

might disregard a slow order and cause an accident. A heavy increase in traffic also increased the difficulty of keeping a safe track, and it was decided to make a third attempt at tile drainage. Cross-section trenches were cut at the softest spots, which revealed the fact that the ballast under the original main tracks, built in 1853 (now west-bound) had been depressed until there was from 44 to 48 inches under the base of rail, and that under the eastbound main built in 1887, had been depressed to a depth of from 48 to 52 inches below the base of rail. The plastic or fluid clay underlying the ballast varied in depth from 10 to 12 inches, below which it was apparently firm enough to resist lateral movement.

The track being on a 4 per cent. grade, the main tile, 8 inches in diameter, was laid at a uniform depth of 74 inches below base of rail. The cross trenches were dug every fifty feet, as narrow as possible, extreme care being taken to have the bottom of the trenches on a uniform grade line. A layer of locomotive cinders about four inches thick was carefully placed in the bottom of the trench and the drain tile laid on this, care being taken to see that the tile was at no point less than four inches from the clay sides of the trench; the entire trench on both main tile and cross drains were then filled with locomotive cinders and the ballast restored over the cross trenches. The main tile was laid from the outlet, up to the point of the first cross trench, then the cross drain was put in. When the excavation for the cross drain reached the pocket or trough under the track, it tapped a body of water, which filled the eight-inch tile two-thirds full, and required half an hour or more to drain it. This was repeated at each cross drain, the quantity of water being almost the same in every case.

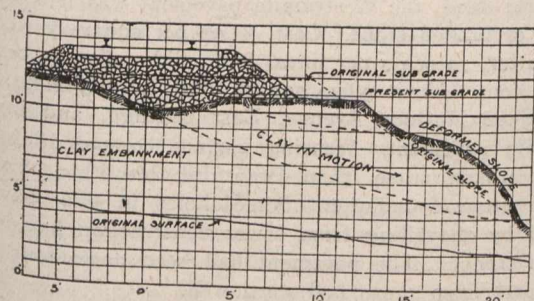
After surfacing the track several times over the cross trenches, no further attention was required for thirty days, when two soft spots developed, one at a point where a cross

Fig. 3A—Soft Spot in Clay Embankment.

drain had been put in and another between two cross drains. The first was dug up, and it was found that the layer of cinders under the tile had been omitted, and that the tile had been laid on top of the plastic clay. This clay had been forced into the tile and completely filled it for a length of five feet, there also being sufficient horizontal movement to separate the tile 12 inches at a point under the low rail. The cross trench was deepened by removing the layer of

plastic clay, the four-inch bed of cinders put in and the trench refilled. In the other case an intermediate cross trench was dug, tapping a pocket of water, which the first cross section had failed to drain; a cross drain was laid, and for the past two years no further trouble has been experienced with this cut. Since the drain tile is laid below the clay, which is saturated with water and in constant motion, and the trench of cinders intercepts all seepage water from the

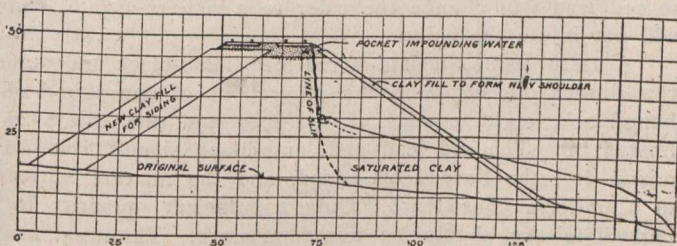
Fig. 4A—Section of Track near Bethesda, O., Showing Slip Occurring at Bottom of Sag.

ported the lighter wheel-loads and traffic. These new spots, as well as the old ones, should be thoroughly drained as promptly as possible, since each inch of settlement adds to the depth of the trench necessary to secure permanent drainage and materially increases the cost of the work. In cuts where there is seepage water on both sides, tile should be laid on both sides of the track with the necessary cross drains.
