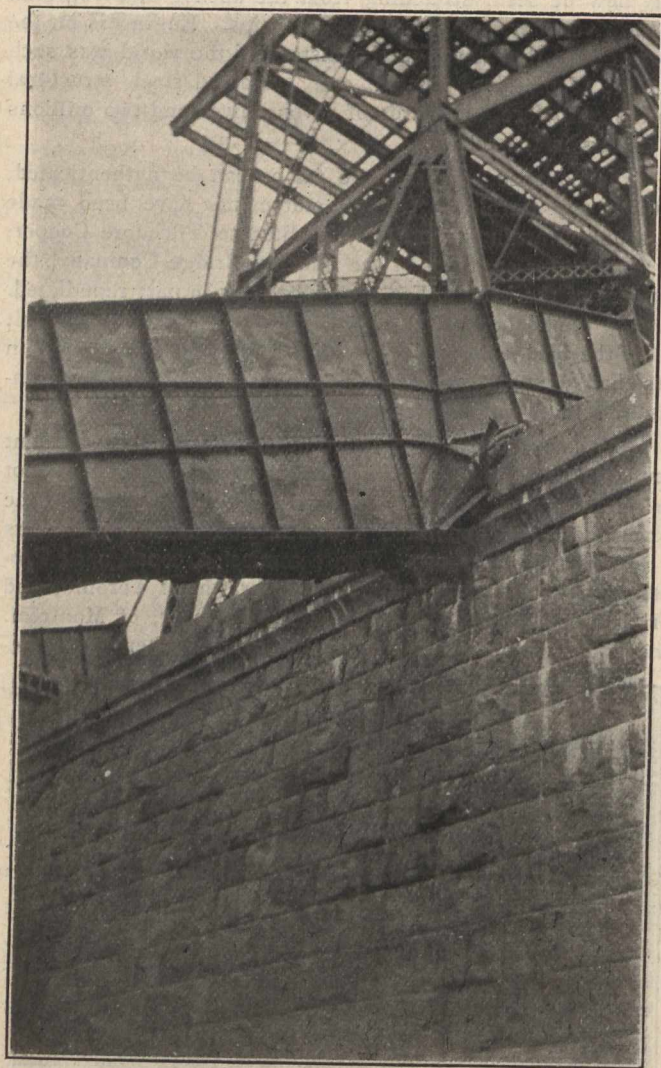
Anchor Casing and Outer End of Approach Span.
