Mr. Mylrea's conclusions are as follows:—

Mr. Mylrea's Conclusions.—"The first lesson to be drawn from this conflagration is that absolutely 'fire-proof' construction is a chimera, for if heat is sufficiently intense and long-enduring, no material can withstand it. This fact has been demonstrated in fires upon practically all the materials of 'fireproof' construction, and now the latest type of building succumbs to it.

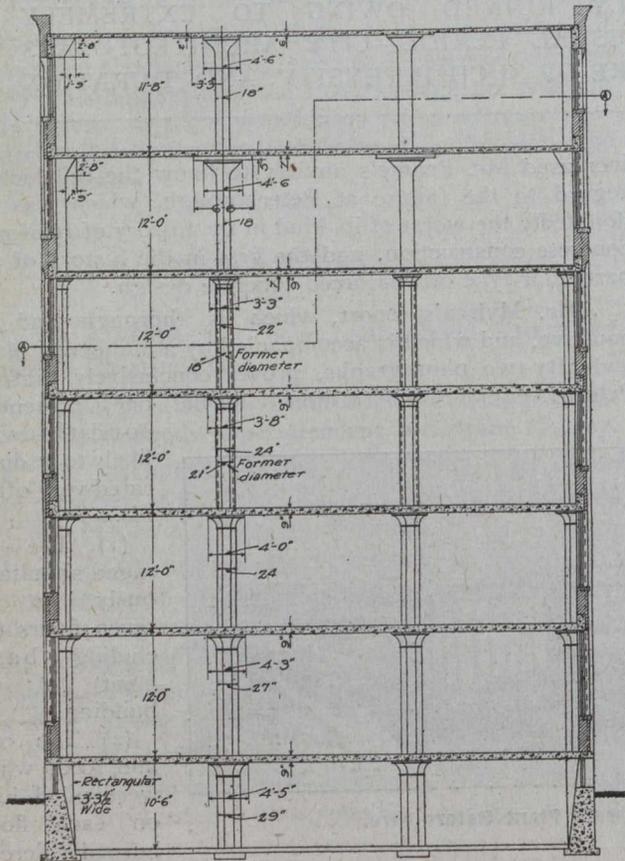
Fig. 3—Typical Cross-Section of Concrete Warehouse.

"But in the reinforced concrete warehouse at the Quaker Oats plant a fire occurred upon all the floors at the same time, of an intensity at least equal to that developed in the Edison fire, and it was seven hours after the fire started before collapse occurred. Even after two months there is considerable heat in the debris, and in some places there is fire still.

"It is not to be considered to the discredit of flat-slab construction that a building of this type failed under such extraordinary circumstances. There was no fusion of the concrete, but the fusion evident at the Edison fire may have been due to the nature of the combustible materials at the points where this occurred.

"The building apparently was constructed in what is known as the 4-way reinforced concrete type of construction. It will be noted that on the first four floors there were no drop panels at the columns, and also that there was more steel put in the diagonal than there was in the straight or direct strip. This is not in accordance with

the more recent by-laws which usually put more steel in the direct and less in the diagonal strip. Judging from the report, however, the building apparently had stood up under quite severe loading, and due to the fact that the different by-laws covering this type of construction
