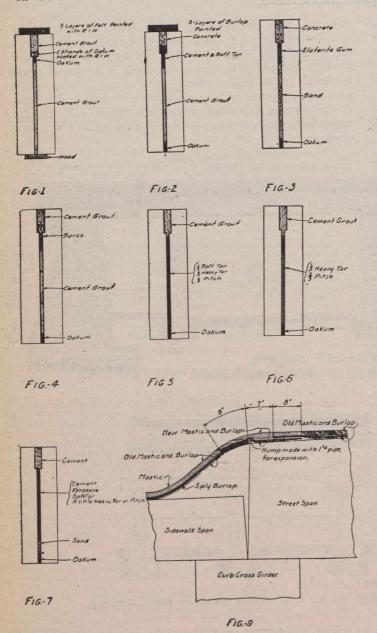
This one failed when the tar leaked out through the oakum, but this was prevented to a great extent by the use of sand above the oakum. At first the joints were water tight, but the jar and slight working about of the slabs loosened the oakum, letting the sand and tar escape. The joint at the abutment also leaked very badly. In addition to this the water found its way through two of the slabs themselves.

It was not long, however, before the boards and tiling crushed down into the newly made fill, giving no means of escape for the water which ran off the bridge, causing it to back up above the level of the bridge seat and find its down the face of the abutment. This was prevented building the concrete so as to overhang the back of abutment about 1 ft. and letting it run down the back about the same distance. The top of the abutment was painted with a heavy coat of tar paint before setting the slabs. This effectually sealed the joint. In all abutments built after this hand side of Fig. 8, in which to place the tile and prevent its crushing down.

The method shown on the right-hand side of Fig. 8 was the one adopted. The slabs were built with a $\frac{1}{2}$ -in. batter on the sides instead of with an offset so that they could be

calked from above. After calking the cracks with oakum they were filled with cement grout. The vertical offset of $12\frac{1}{2}$ in, over the curb cross girder was rounded off by a fillet of concrete. The abutment back of the bridge seat was built up to the level of the top of the sidewalk slab. The lifting stirrups or hook bolts by means of which the slabs were placed were cut off at the top of the concrete and the surface of the bridge swept clean. As a rule only one track or a width of 14 ft. could be waterproofed at one time because of operating conditions and the fact that the force used was of such size that this was one day's work. A strip about 4 ft. wide was mopped with a coat of asphalt which had been heated to the melting point. Four kinds of asphalt were used at different times, Sarco No. 6 and No. 651, melting point 160 deg., Barber Asphalt Company's positive deal "A," melting points 140 deg. Texaco and Warren Chemical Company's asphalt cement. On this was put a strip of 8-42 in. wide. oz. open-mesh, first quality burlap, This came in 2,000-yd. bundles and was made into rolls coiled on a 11/2-in. gas pipe 7 ft. long. It was applied by starting at one end of the bridge and rolling it across. A man followed the roll and swept out any wrinkles so as to give a smooth surface and bond it to the asphalt below. ' The top of this burlap and a strip of concrete about 15 in. wide on one side of it was then painted with hot asphalt and another layer of burlap laid, covering two-thirds of the first layer, the rest lapping over on the concrete. This burlap and the adjacent concrete were then painted and another strip laid covering one-third of the first and two-thirds of the second strip. In this way the burlap was made three-ply. had been taken that the temperature of the asphalt was not high enough to burn the burlap. A melting point of 160 deg. Fahrenheit gave the best results, as asphalt with a higher melting point burns the burlap and it becomes more brittle at low temperatures. After three-ply of burlap had been laid the whole surface was again mopped with asphalt and a protecting layer of mastic put on. This layer consisted of one part of asphalt and four parts of dry engine sand. The asphalt was heated to the melting point in one kettle and the engine sand heated over an iron plate. They were mixed and stirred in another kettle until of the right consistency, a s'ow fire under the kettle keeping the mix ture plastic. This mastic was dipped into iron wheelbarrows, wheeled on broad runways laid on the burlap, dumped, and finished with wooden trowels to a thickness of I in. This 1-in. top of this mastic was mopped with asphalt. layer was not intended to aid in waterproofing, but was put on to protect the burlap from the ballast and the track tools.

The drainage system consisted of inverted 8-in. halftiles laid between each track leading from the hump over the curb cross girder to the back of the abutment. Back of the abutment and about 1 ft. below the bridge seat a board was placed on which rested another 8-in. half-tile. The end of the burlap rested in this and another 4-in. tile was laid it. The tiling was given a slope of about 1 per cent. for ward down-pipes. These down-pipes were 50 ft. apart and ran down the back of the abutment to the sidewalk level, then through it and under the sidewalk to the gutter. The sharp edges of the crushed stone ballast from cutting into it. The crushed stone ranged from ½ in. to 2½ in. and was used to allow free movement of the water through it.
