## Steel-Plate Drip Floor for Niagara Railway Arch Bridge.

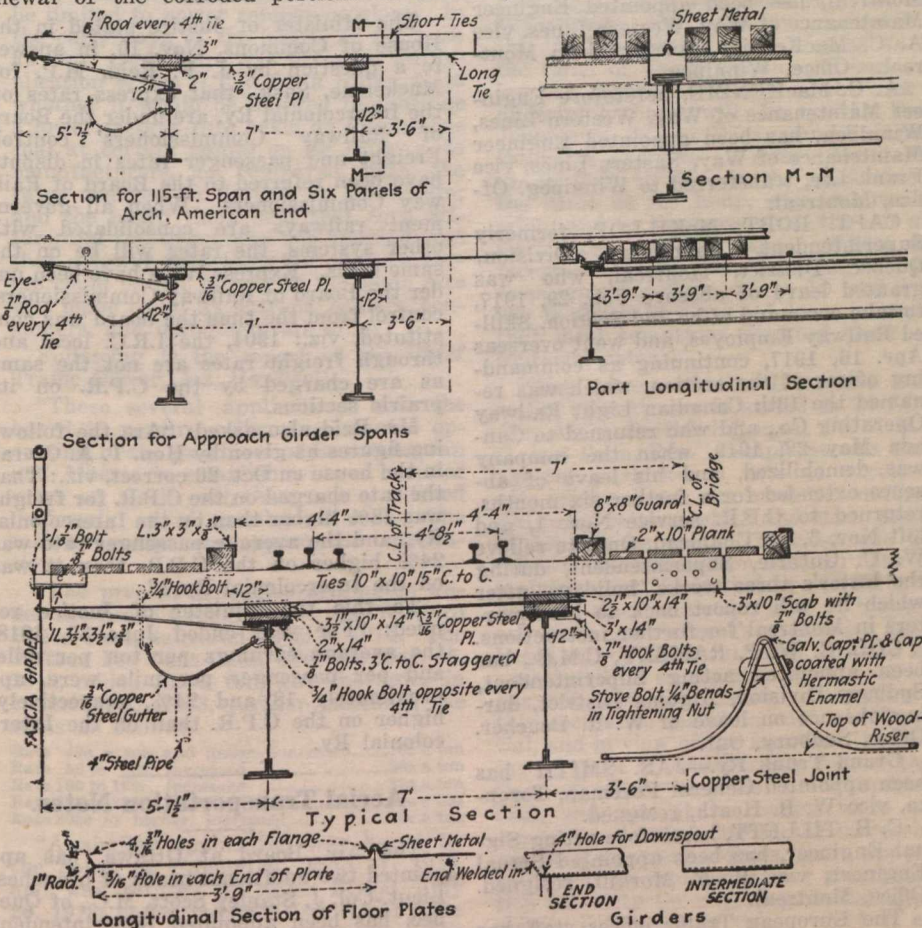
pleted the drainage floor was set in place. This, as fully shown by the accompanying drawing, consists of plates of copper-steel 3-16 in. thick, resting on maple raising strips bolted to the top flanges every 3 ft. by countersunk bolts. By making the strips on the inner stringer thicker than those on the outer stringer a drainage slope outward was given to the plate; a longitudinal gutter of copper steel under its outer edge takes the drainage to downspouts. The plate floor under each track is 9 ft. wide.

The track ties, 10 x 10 in., are dapped to 9½ in. depth for a length of 14 in., to receive 10 x 14 in. raiser blocks of hardwood, in order to raise the ties clear of the drip plate. The thicknesses of the blocks over the inner and outer stringers differ by 1 in., as shown, so as to make up for the difference in thickness of the raising strips under the drip plate and thus bring the ties level. The blocks are spiked to the ties. All the timber is treated with hot carbolineum. The copper steel floor plates are flanged sections 3¾ ft. wide, their length of 9 ft. extending crosswise of the track. The ends of the sheets are left plain. The side flanges, which form the joint between abutting sections, are 2 in. high, flaring, with fillet of 1-in. radius at the junction of flange and plate. Each flanged edge is punched with four 5-16 in. holes; the two joining flanges are covered for protection by a channel of no. 16 galvanized sheet steel fastened by stove bolts, which also hold the adjoining sections together.

New Floor of Niagara Railway Arch Bridge With Drip Plate and Gutter.

At the examination of the bridge the main structure was found to be in splendid condition, but the top flanges of floor beams and stringers and the stringer laterals showed losses of 25% to over 50% in thickness from corrosion. Reinforcement of the weakened members was imperative, and as it was desired also to bring all parts of the bridge up to E 60 capacity the two pieces of work were taken in hand at the same time. The bridge was originally designed for about

floor system it was desired to provide protection against further corrosion. To this end C. E. Fowler, consulting engineer for the work, designed a special drip-protective floor which is being installed by the Terry & Tench Co., New York, contractors for the repair and reinforcement work, under direction of Mr. Fowler and H. B. Dickinson, Superintendent of the bridge for the owners.

In carrying out the floor system repairs and reinforcement, the cover plates and in some cases the flange angles of the stringers were cut off, traffic being restricted to one track while work was going on in the width of the other track. About 65,000 rivets had to be cut out. Where injury to the metal from heating was not to be feared, rivet heads were cut off by oxyacetylene torches fitted with special tips; such a torch cut off 500 to 700 heads of ¾ in. rivets a day, or four times as many as one hand crew could do. New and heavier flange material was then riveted in place with countersunk rivets, so as to leave a flat surface as a seat for the drainage floor. All old metal was cleaned with sandblast and then painted with tockolith, with a view to counteracting the influence of any remaining rust.
