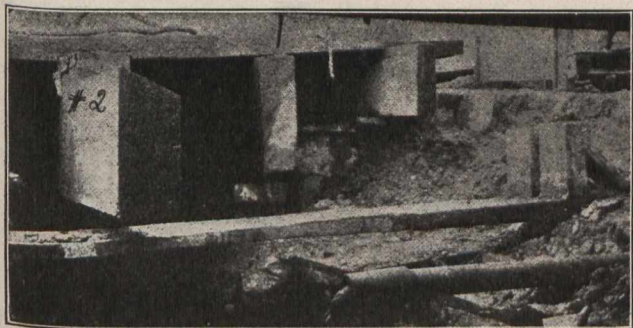
Fig. 5.

tained later. This sample is a mass of oxide of iron 5 inches long by 2 inches deep, and is $1\frac{1}{2}$ inches to $1\frac{1}{4}$ inches thick. It was taken from between two bridge chords which lay $1\frac{1}{4}$ inches apart, from a bridge that was taken down and replaced by a new bridge, in the city of Providence, R.I. These bridge chords where they lay in soil were badly corroded, and when found were surrounded by a mass of oxide, the same as this sample. Figs. 4 and 5 are photographic reproductions of same; Fig. 6, corrosion at ends of spans. The dimensions of these chords, which were of wrought iron, are given in drawing "A." The comparison of damage

with the original size is given in drawing "B." Electrical measurements have been taken upon this bridge for some years past by the writer, who has often predicted damage. The bridge has always been found positive to the soil at the eastern end where this corrosion was discovered. In 1902 corrosion and holes were found upon one of the sheet iron trusses where it entered the soil. The railway power-house was a short distance from this bridge on the west bank of the river. Submarine cables from the power-house were attached to a cable box close to the eastern end of the bridge.

Stray currents have been found on this bridge from July, 1900, up to September, 1903, when they were checked by a change in the railway return conductors, which were placed on poles and the cables abandoned.
