Rail Causing Derailment at Salisbury Junction.

Rail Causing Derailment at Shenandoah Junction.

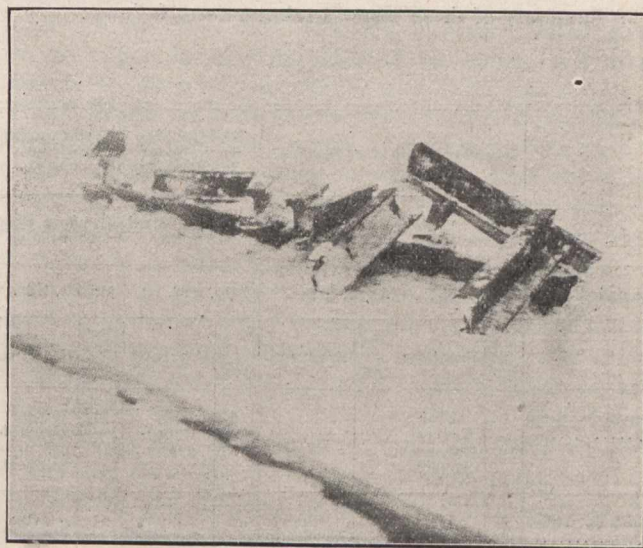
The pieces were not carried any distance, with the exception of the longer ones, and this condition would naturally lead to the conclusion that the breaks were caused by the downward pressure of the engine passing over the rail ends.

This analysis shows the composition to be rather high in phosphorus, with manganese closely approaching the upper allowable limit. While either one in itself would not be a serious matter, the combination would tend to make a somewhat brittle rail, even though the phosphorus is no higher than is found in many good rails.

The rail placed with head up broke with fine crystalline fracture, near supports. Rail with head down broke near center, on first blow, with a fine crystalline fracture.

This rail also broke near center with fine crystalline fracture. A common and noticeable feature of all these breaks is that with head up they break near supports, while with head down they break near the center, but the burnt rail broke under a much less number of blows whichever way it was placed, and with a very much less final deflection.

Views Showing Pieces of Rail which Broke at Salisbury Junction.
