ELECTROLYSIS FROM STRAY ELECTRIC CURRENTS.

By A. F. Ganz, M.E.

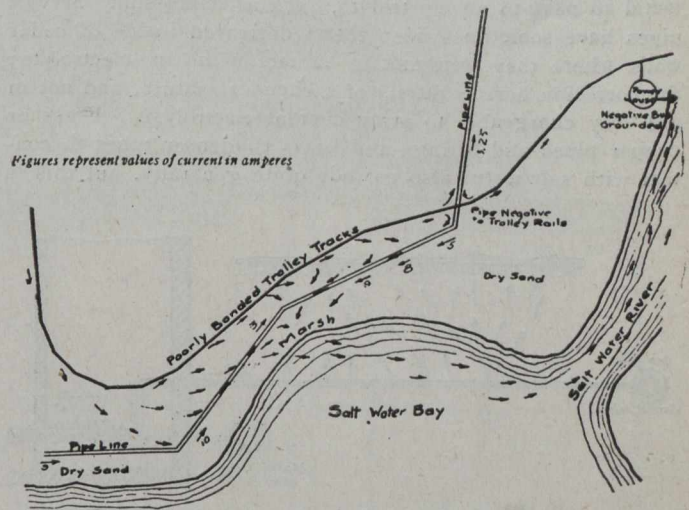
Damage and Danger Produced by Stray Electric Currents on Underground Piping.—It has already been pointed out that damage from electrolysis to underground piping usually results in the neighborhood of the power station from current leaving the pipe to flow to the rails and to other return conductors, and that service pipes in the same locality are most frequently damaged where they cross under and are positive to trolley rails. The destruction of underground piping by electrolysis is, however, by no means confined to the so-called positive districts in the neighborhood of the railway power station, but will occur at any point in the pipe where current leaves the pipe to flow to the surrounding soil. In Fig. 10 is shown a water pipe and trolley line near a salt water bay, about 8 miles distant from the railway power station supplying this trolley road. The trolley rails at this point are about 25 volts positive to the water pipe; that is, the water pipe is in a highly negative district. The railway power station is located on the shore of a salt water bay, and its negative bus-bar is grounded through low resistance ground connections, so that large currents leak from the trolley rails at points shown in Fig. 10, and flow through the ground and the salt water of the bay to return to the negative bus-bar at the railway power station. These stray currents in their path encounter the water pipe and flow part of the way thereon. The values of current indicated on the pipe to flow to the surrounding soil and from there to the salt water. An examination of the pipe at this point also indicated that it had been badly corroded by electrolysis. This, therefore, affords an excellent example of destruction by electrolysis of a water pipe in a highly negative district.

Fig. 10.—Diagram Showing Stray Current Leaving Water Main in Negative District.

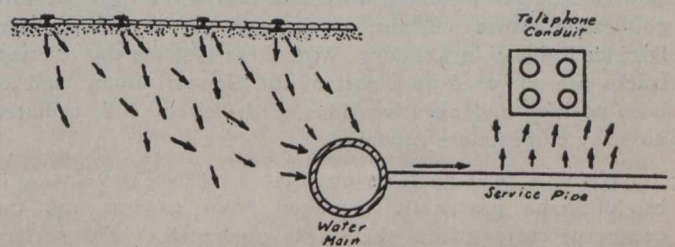
In Fig. 11 is also shown a water main and service pipe crossing under trolley rails and under telephone ducts. At this point the pipe is also negative to the trolley rails, but positive to the lead sheaths of the telephone cable, the potential condition with reference to the cables being caused by the fact that the telephone cable sheaths are bonded to the railway return conductor at the power station. As shown in the diagram, current flows from the rails to the water pipe,

and leaves the water service pipe where it crosses under the telephone ducts to flow to the cable sheaths, resulting in the destruction of the service pipe. An examination showed pits extending entirely through the service pipe, directly under the telephone ducts and facing the ducts. This, therefore, affords another illustration of destruction of a service pipe in a negative district.

Fig. 11.—Example of Service Pipe Negative to Trolley Rails and Destroyed by Electrolysis Due to Currents Flowing from Rails to Pipe and from Pipe to Telephone Cable Sheaths.
