#### PUTTING A CONCRETE JACKET ON A CRACKED CHIMNEY.

Two points of considerable engineering interest stand out from the facts of the work recently done by the Aberthaw Construction Company, of Boston, in putting a reinforced concrete jacket around a cracked and leaky chimney in the plant of the Winchester Repeating Arms Company, at New Haven, Conn. The job was of rather peculiar character, but the method by which it was done offers practical suggestions for handling work of different details.

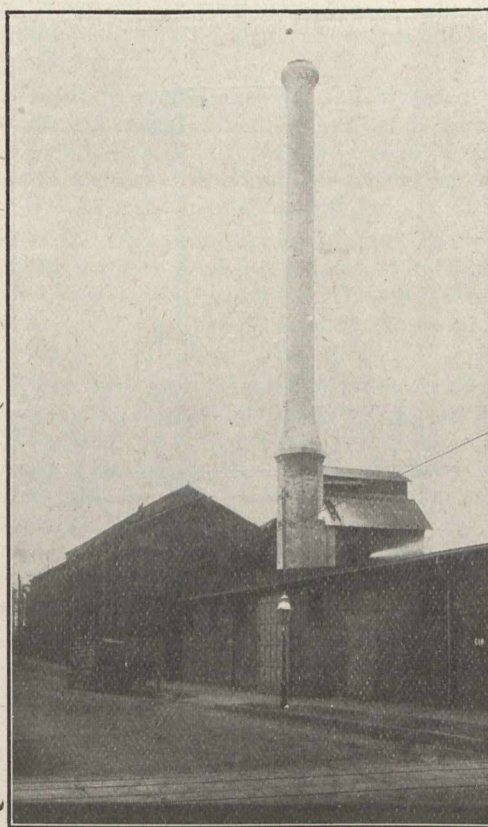
The original chimney was of reinforced concrete, but it had developed large vertical cracks which allowed the escape of smoke and at times the inflow of air—both of these actions being harmful to the efficiency of the draft. This chimney rested on a brick foundation which was part of the power house building. Above this foundation it was about 80 feet, spread to an outside diameter of 8 feet at the bottom, and 6 feet at the top; it was four feet in diameter, inside, and was unlined. The old concrete, forming a wall about four inches thick in the cylindrical part of the chimney, had proved seriously defective aside from developing cracks.

It had been laid as a stiff, dry mortar, without stone, and by the time the Aberthaw Company took hold of the job, the mortar had become so soft and "punky" that it crumbled easily under a blow and came away from the reinforcing metal with dangerous readiness.

The new concrete jacket put about the old chimney by the Aberthaw Company was five inches thick over the whole surface of the old structure. The vertical reinforcement consisted of four sets of square twisted steel bars with 32 in each set, equally spaced, and with the ends of the successive sets lapped. The lowest set of bars,  $\frac{5}{8}$  inch thick and 20 feet long, were upset at their lower ends to  $\frac{3}{4}$  inch diameter, and were screwed into an anchor ring 4 inches wide by  $\frac{1}{2}$  inch thick sunk in the brick work at the base of the chimney. The other three sets of vertical bars were  $\frac{1}{2}$  inch

Before the first section of the concrete jacket was applied the old chimney was carefully wrapped with asbestos felt. This served a double purpose, acting first as an expansion joint between the old and new structures, and serving also to protect the green jacket against too rapid drying by the heat of the inner shell, and against the drawing of moisture from the green concrete into the old chimney.

The other aspect of the work, which is of especial practical value, was the ingenious construction and operation of the form used by the Aberthaw Construction Company on the cylindrical portion of the chimney. The form proper consisted of a cylinder of 16 gauge iron 5 feet high, with an inside diameter of 5 feet 8 inches. This was made in three
