Report on the
Quaker Oats Company Fire

At Peterboro, Ontario

December 11th, 1916

CANADIAN FIRE UNDERWRITERS' ASSOCIATION
SPRINKLERED RISK DEPARTMENT
TORONTO, ONTARIO

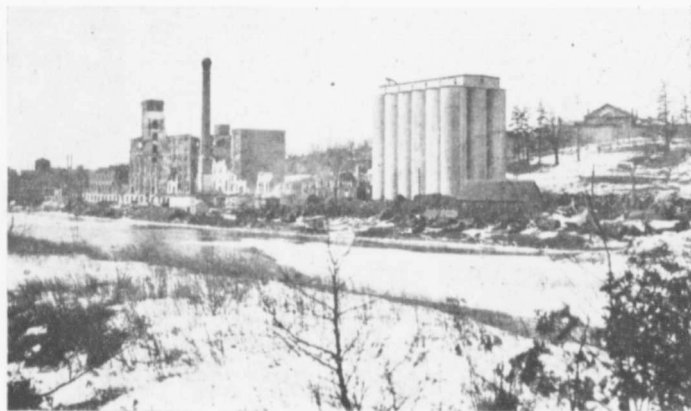
Fig. 2. View of the plant after the fire.

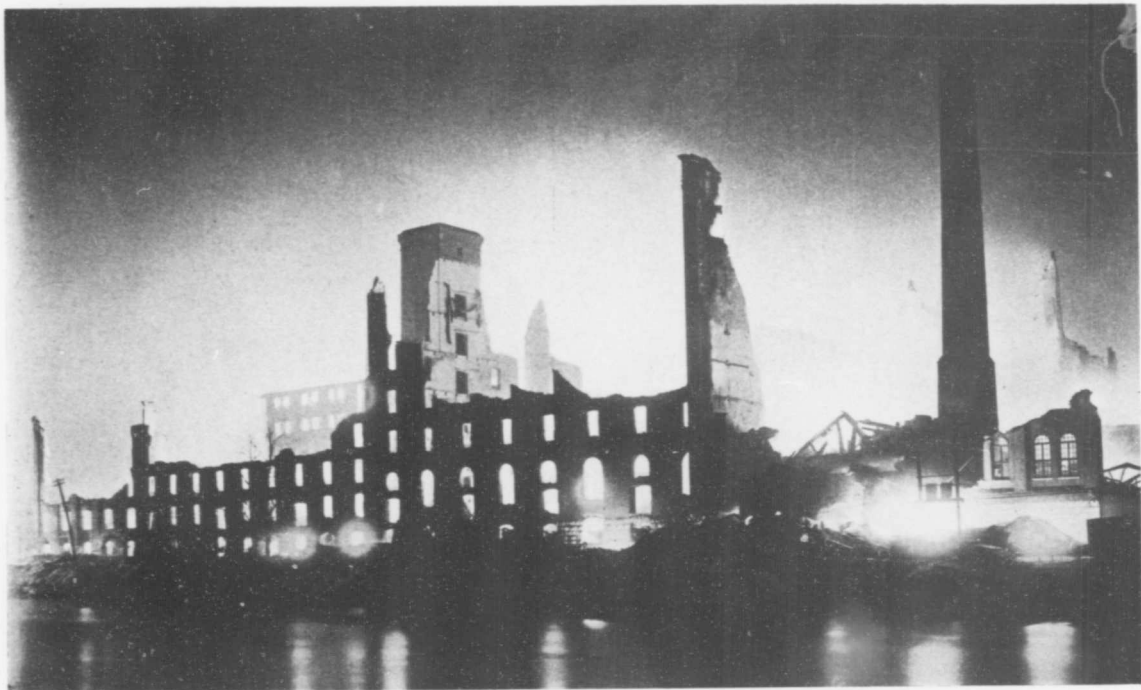
View of the ruins of the Quaker Oats Plant at Peterboro, Ont., taken at 10 3 p.m. on the night after the disaster.

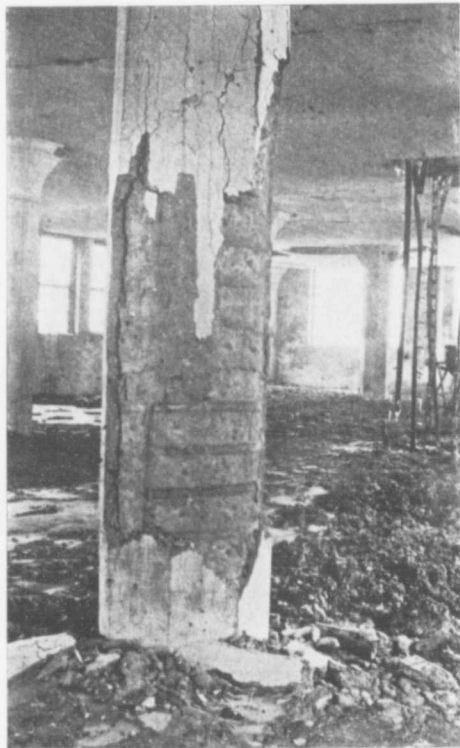
Fig. 3. Spalled column and unprotected bag hoist on right.

The complete failure of the Concrete Building shows the necessity of providing automatic sprinkler protection wherever the contents of a building are combustible, irrespective of the construction of the building; and the folly of constructing an otherwise fire-resistive building and then leaving large unprotected openings, such as the bag hoist openings in the Concrete Warehouse, is demonstrated.

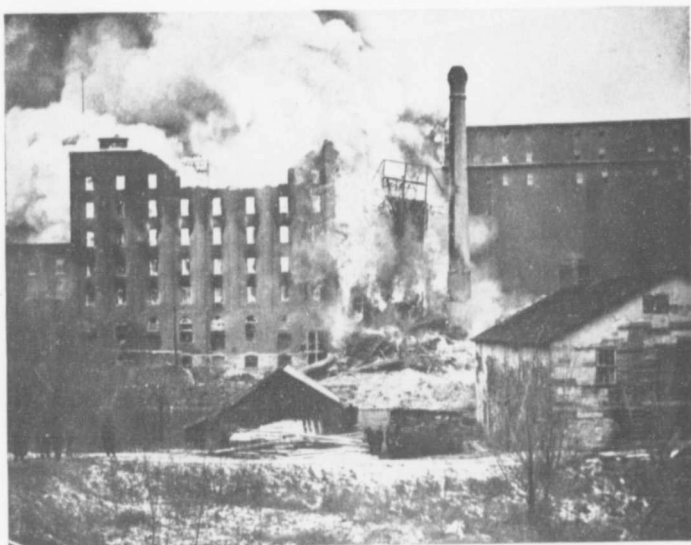
Fig. 4. Shows collapse of grain tank and dry house; also fire gaining headway in frame metal clad grain elevator.

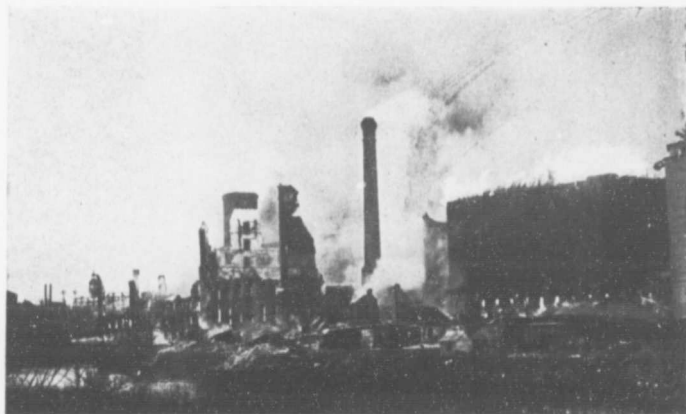
Fig. 6. Photograph taken at noon. Illustrates rapidity of fire.

Figure 6 taken at noon shows how rapidly the plant was reduced to ruins, although Elevator "A", because of its wooden crib construction, continued to stand and burn for some time until it finally collapsed. The burning grain was heaped against the south end of Elevator "B" and the concrete was considerably spalled; but beyond this the Elevator suffered no material damage at this time. Some six weeks afterwards, however, as a result of the corn in the

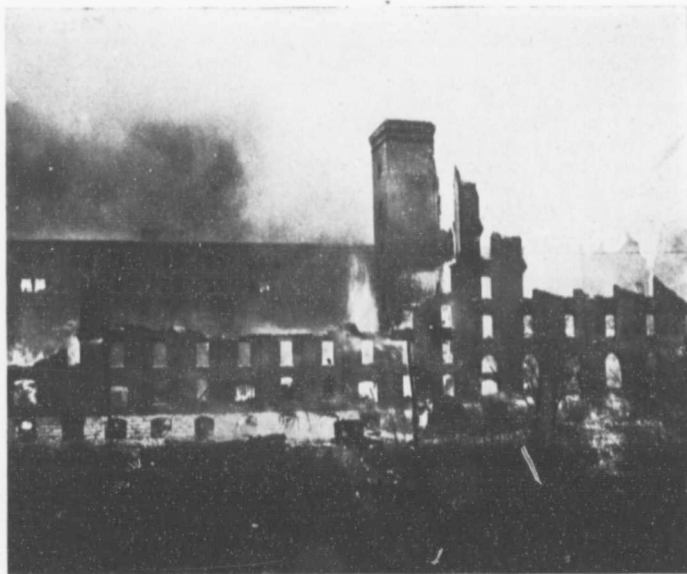
Fig. 7. Shows how concrete warehouse, equipped with wired glass windows, withstood exposure until other buildings collapsed.

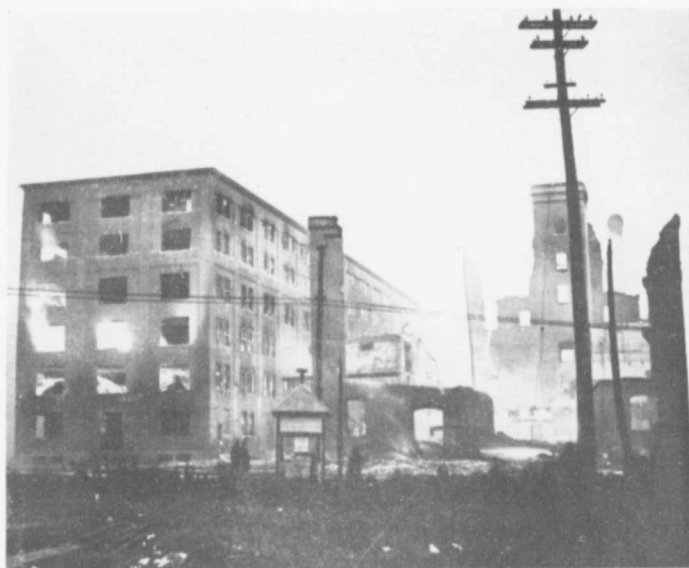
Fig. 8. View looking North from Hunter Street. Note stock piled high in concrete warehouse. Ruins of mill buildings on right.

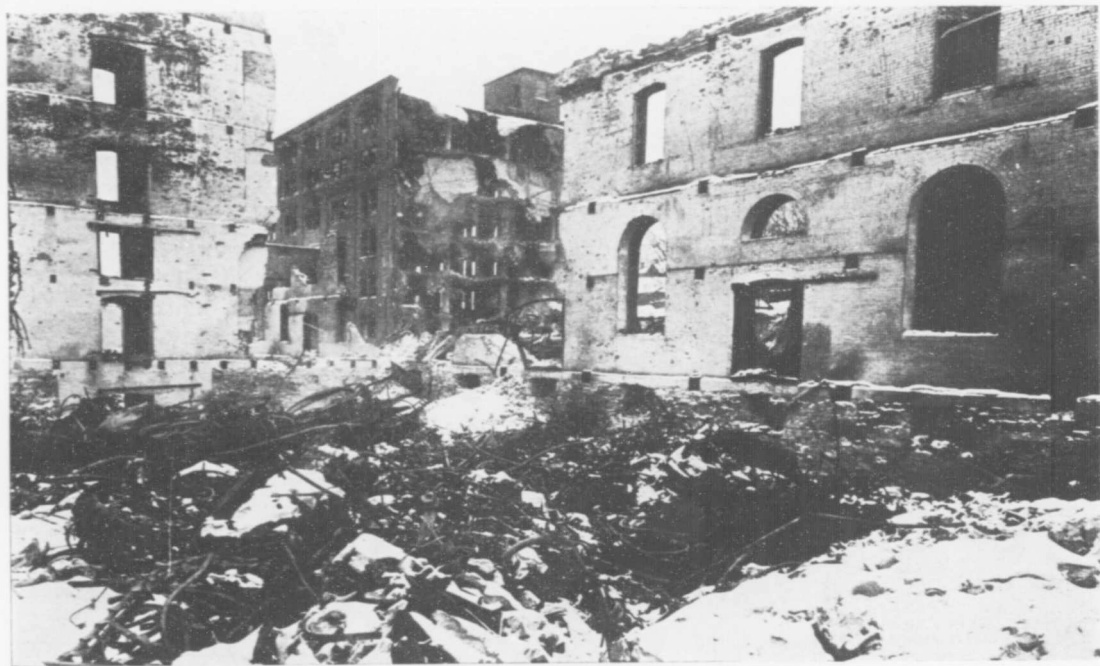
Fig. 9. Shows ruins of Dry House and other buildings.

maining buildings in this row the ruin was complete. As is graphically shown in Figure 9 nothing but hopelessly tangled masses of machinery and a few stumps of walls are left. Beyond the spalling of the lower 15 feet of the three south bins of Concrete Elevator "B," this was scarcely damaged, which may be largely attributed to the direction of the wind. Elevator "A" and the Cleaning Mill were as completely ruined as the Mill, the only things of a combustible nature that were left being a large quantity of grain which was partly salvaged during the next couple of months, before burning completely through, and the bottoms of some wooden columns that were buried in this grain.

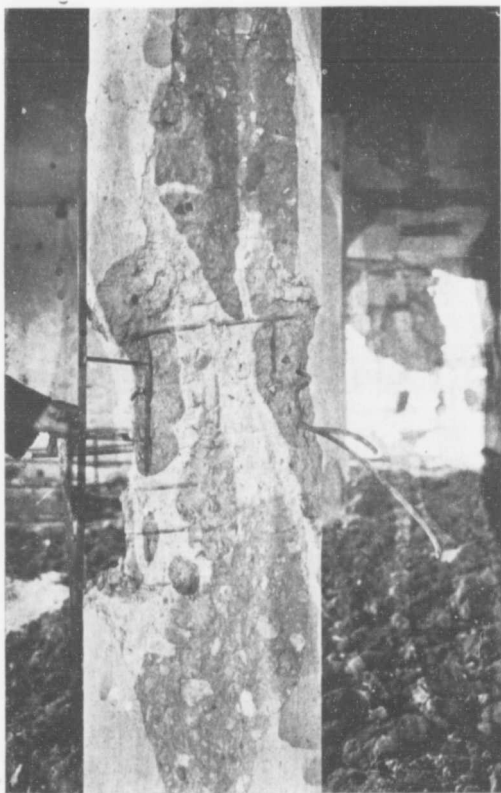
Fig. 10. Column examined to ascertain depth of dehydration. (See page 32)

the elevator. In the remaining standing portions destruction is practically complete and if not razed before long these portions will collapse of themselves; progressive disintegration is rapidly going on. In these standing portions lessons of great value as to the fire-resisting qualities of different materials and appliances may be learned. From their appearance in the photographs, the columns do not seem to have sustained much damage, but upon examination it was found that the surface of the concrete had been calcined to a depth of from half an inch to an inch and beyond this, dehydration of the cement extended inward to an undetermined distance. In an endeavor to ascertain the exact depth of this dehydration, the concrete on one column was removed until the reinforcement was reached when two of the spiral bands were cut. Upon proceeding to cut one of the longitudinal rods with a hack saw, it suddenly pulled apart when the saw had cut only about two-thirds the way through, indicating that stresses of unknown magnitude existed. Although a depth of 5 inches from the surface had been reached and sound concrete not yet discovered, it was considered advisable to abandon any further effort. This column is shown in Figure 10 where a pencil may be seen in the saw cut mentioned.

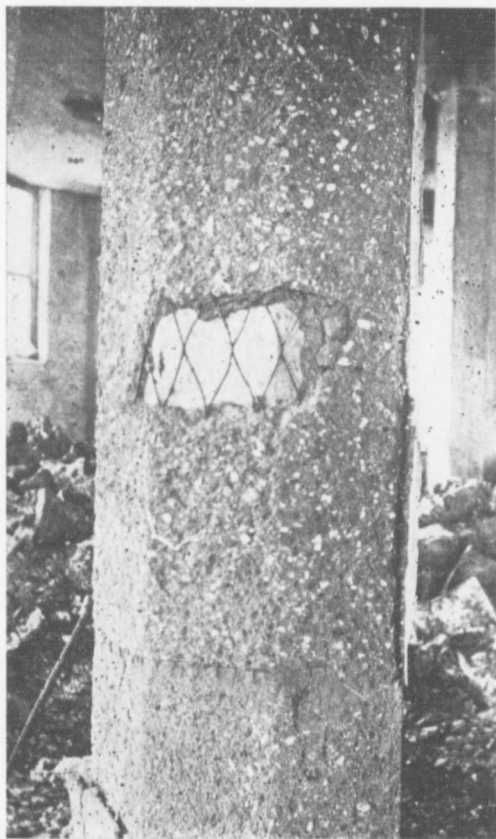
Fig. 11. Column which had been thickened by pouring of additional concrete. (See page 32)

In the third and fourth stories, where the original columns had been thickened by pouring an additional 2 inches of concrete around them, the difference in damage is quite marked. Beneath this 2-inch coat the concrete of the original column appeared to be in a better condition than in those columns that were entirely exposed to the fire. One of these is shown in Figure 11. On account of the condition of the building it was unsafe to ascertain the exact condition of these columns.

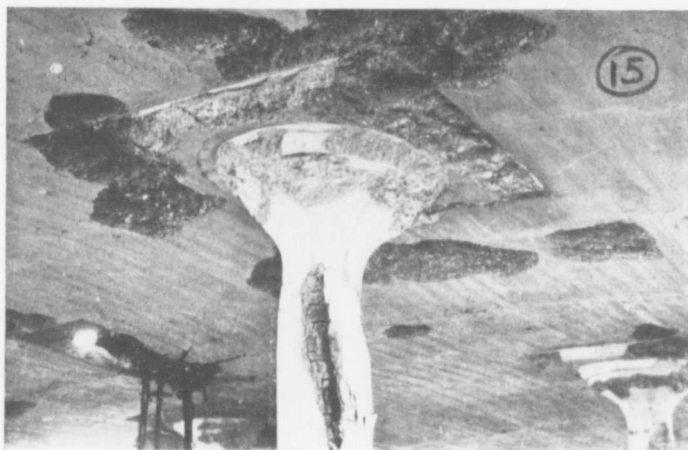
Fig. 12. A column failure.

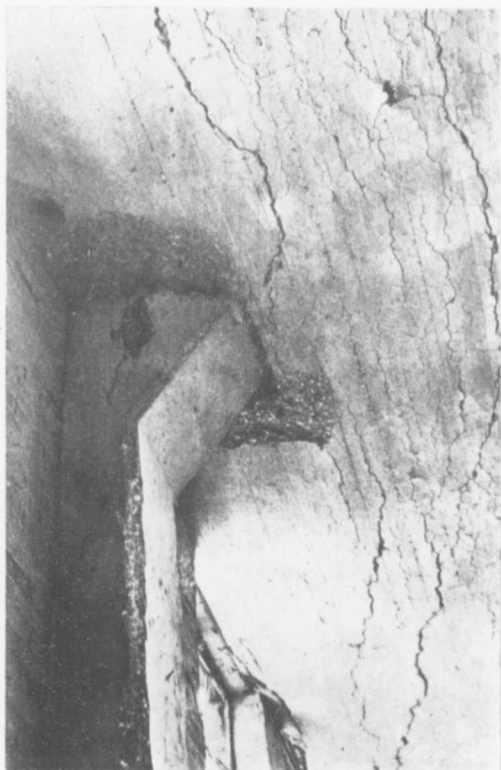
Fig. 13. A column which forced its way through ceiling.

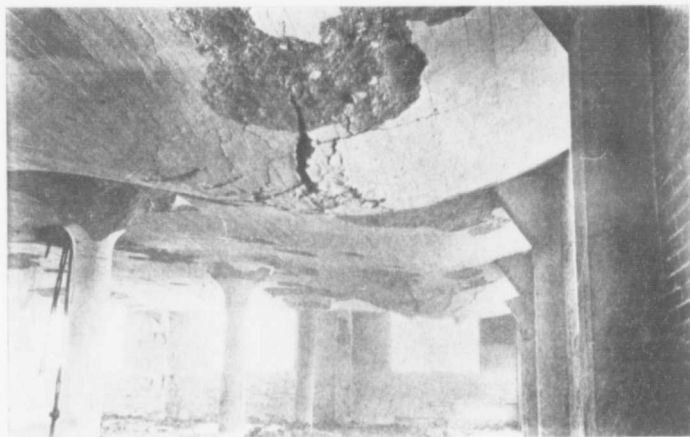
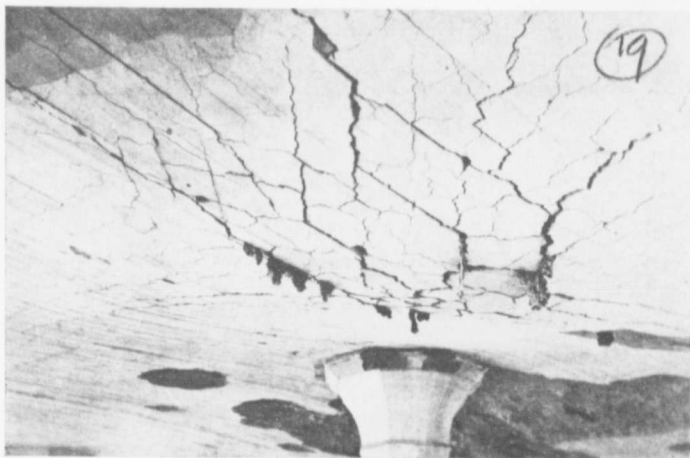
There is no doubt, however, as to the condition of the floors for they sagged in practically every panel as may be seen in Figures 14 and 15. Here, as in the columns, all surfaces have been calcined and large patches of the ceiling surface have fallen to the floor and crumbled into heaps of air-slacked lime. Upon examination of the concrete in numerous places on all stories, the floors were found to have been dehydrated completely through. This is entirely at variance with the experiences of the "Edison Fire" where it was found that the concrete was seldom injured more than an inch and a half to two inches in depth except at the corners where it was first thrown off by expansion of the concrete and later by the reinforcing bars. It is also at variance with the experience at the "Far Rock-away Fire" where a quartz aggregate caused serious disintegration of the concrete.

Figs. 14 and 15. Sagging of floors.

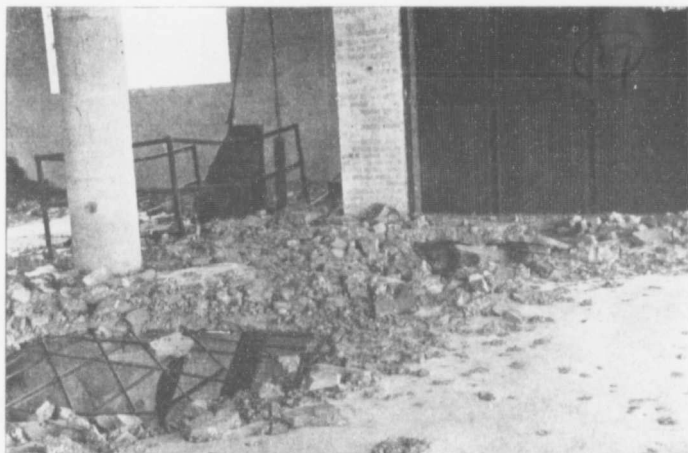
Fig. 16. Corrugated steel doors in elevator shaft. Note also condition of wood tin-clad trap at stair opening on left,

places damaged the weakened floors. Evidence of one such explosion is shown in Figure 16, where the broken concrete may be seen around the opening instead of having dropped to the floor below.

It is interesting to compare the condition of the wood tin-clad fire doors in Figure 17 with the corrugated steel doors in Figure 16 which were on different floors in the same shaft and probably had to withstand about the same temperature. The remains of a wood tin-clad trap door can be seen near the centre of Figure 16. On all other floors these traps were in the same or even worse condition.

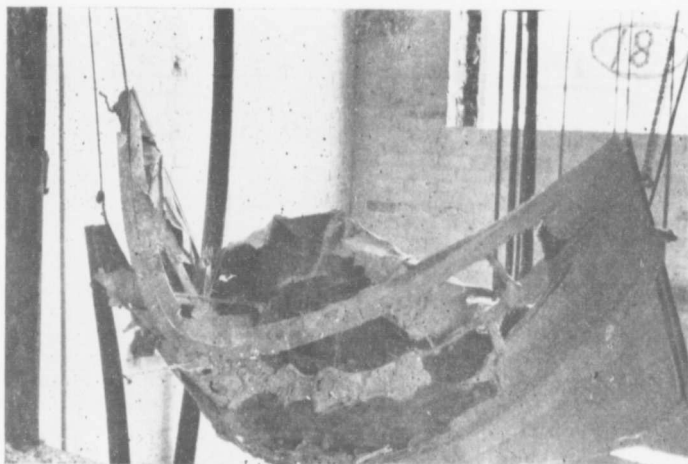
Fig. 17. Wood tin-clad fire door in elevator shaft.

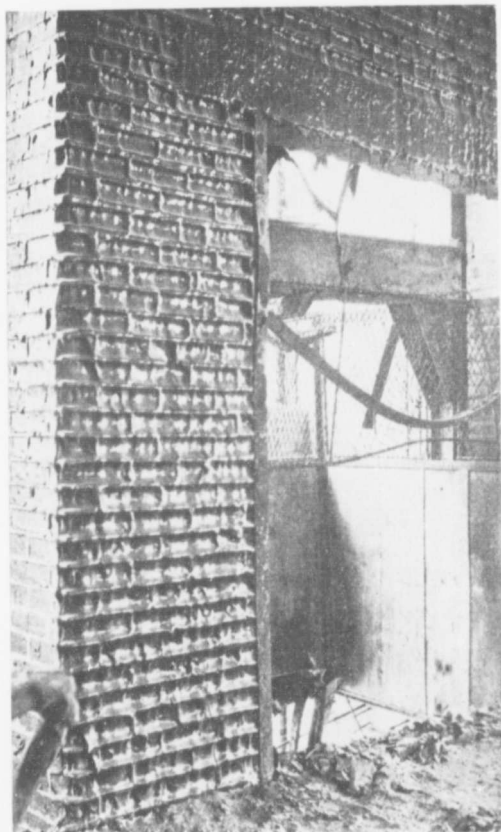
Fig. 18. Melted brickwork at an elevator shaft.

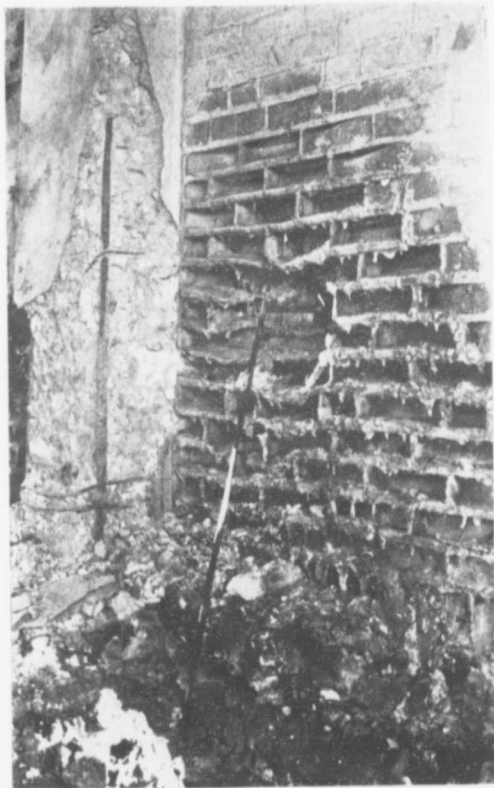
Fig. 19. Melted brickwork in concrete warehouse.
