FORT WILLIAM WATER SUPPLY.

By H. SYDNEY HANCOCK, JR., A. M. Can. Soc. C. E.

CITY OF FORT WILLIAM
 LOCH LOMOND WATER SUPPLY
 General Details of Scheme.

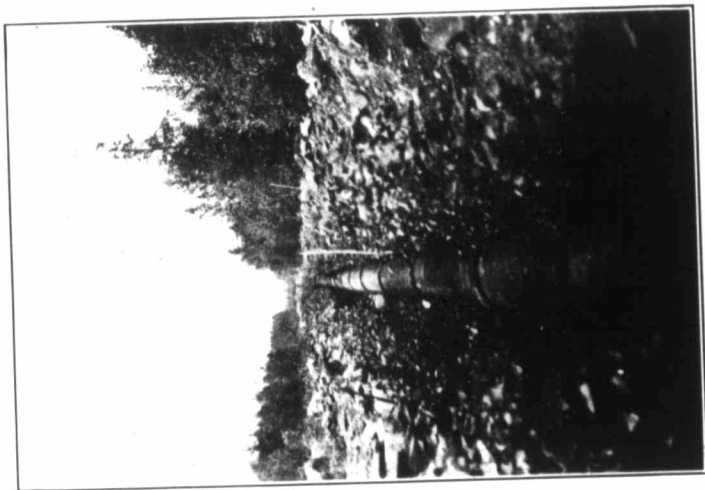
Wood Pipe in Trench. Northwest from Station 195.

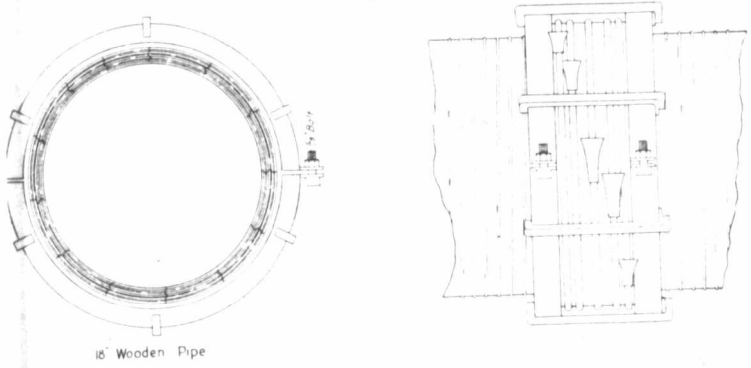
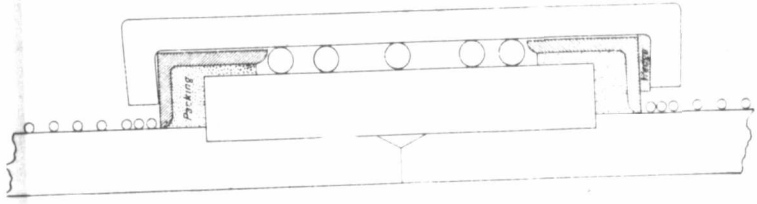
SUGGESTED METHOD OF REPAIRING DEFECTIVE JOINTS
Keating & Brethaupt
Civil Engineers Toronto

After describing the pipe and its location, Mr. Keating stated that, "Practically the whole of the trouble in connection with this pipe line has occurred at the joints. The leakage in nearly every case was brought to my attention being at or near the shoulder, where the water spurts out through defects which exist at this point, or in that vicinity. In some cases, a number of such defects exist in a single joint, while in others the leakage is small and the water spurts out in a small jet. These small leaks, however, unless stopped soon after they start, cut into the wood and increase in volume rapidly. Several cases were noted where these jets had not only cut into the wooden staves to a considerable extent, but had also cut completely through and severed the banding wires at the pipe joints."

"The method hitherto adopted for stopping these leaks has been to drive wooden wedges into the ends of the collars, which has so far proved to be only a temporary remedy."

Mr. Keating also stated that this method of repair could never be satisfactory or permanent, and, if persisted in, could only have the effect of splitting off the upper portions of the collar staves and irretrievably ruining the collar.

Shortly after inspecting the pipe line, Mr. Keating, in a letter to the writer, and one to the Pacific Coast Pipe Company, suggested the following method of repair, intimating that it seemed to him evident that the method hitherto followed of driving wooden wedges in the end of the sleeves was not a satisfactory remedy.

The drawing shows clearly the proposed method of repair, and Mr. Keating suggested that a trial be made on eight or ten of the worst joints.
