Electrolysis
in the
City of Winnipeg

BY
L. A. HERDT, E.E., Ma.E.
Consulting Electrical Engineer

In January, 1909, the writer was instructed by the Council of the City of Winnipeg to report upon the danger to the watermains and telephone cable system that might exist in the city, due to the return currents of the Winnipeg Street Railway Co., and to submit recommendations dealing with improvements of the present street railway system, so that electrolysis, if it existed, would be eliminated. A report was made following the above instructions, and was published in the *Canadian Engineer*, August 20th, 1909, *Canadian Electrical News*, September, 1909, and in other technical periodicals.

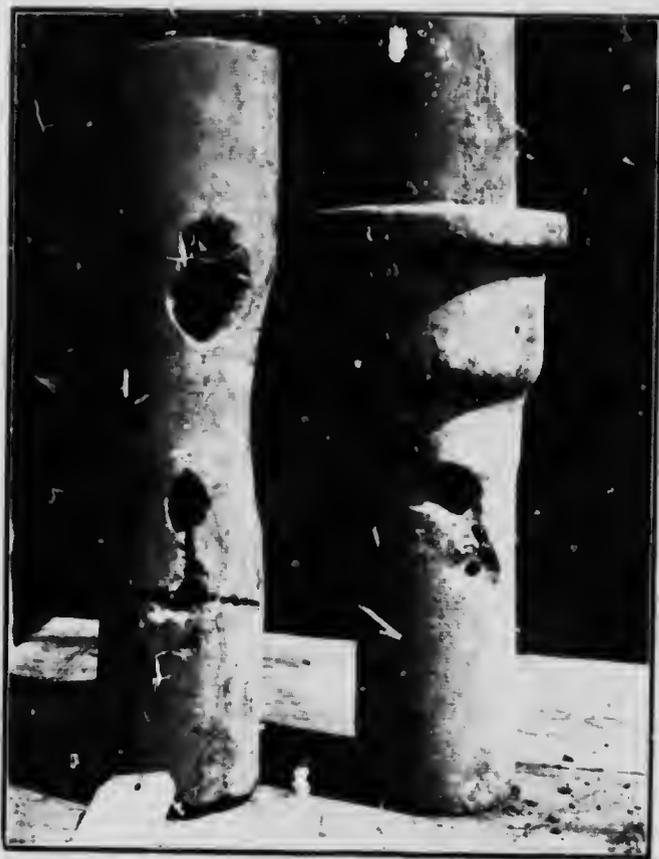
Fig. 1.
Electrolytic Action on Water Mains.

Pieces of water pipe and lead covered cables taken from these districts by Mr. Cambridge were examined, and showed without doubt that holes and breaks in them had been caused by electrolytic action.

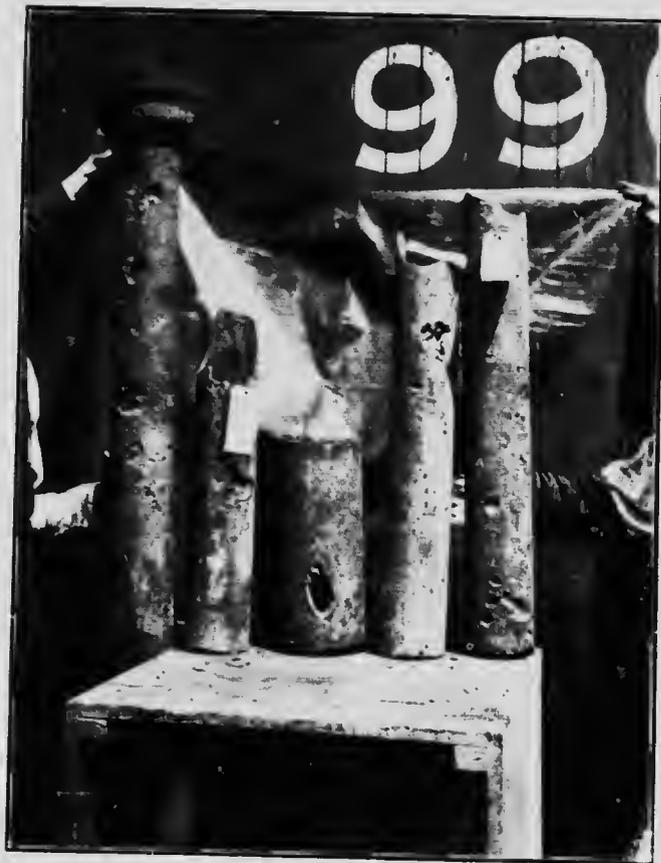
Fig 2

Waterpipes Pitted and Burst on Account of Electrolysis.

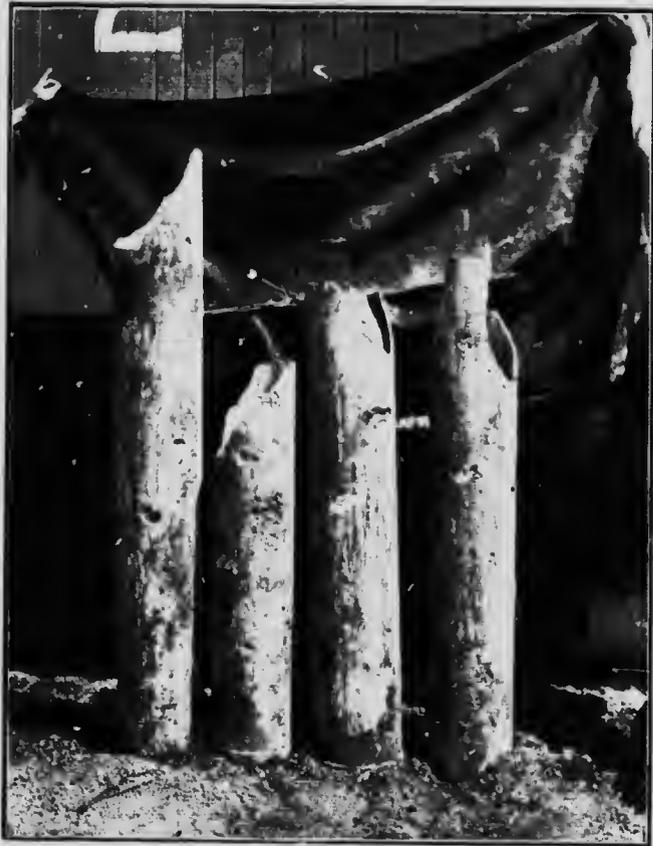
Fig. 3.

Destruction of Waterpipes by Electrolytic Action.

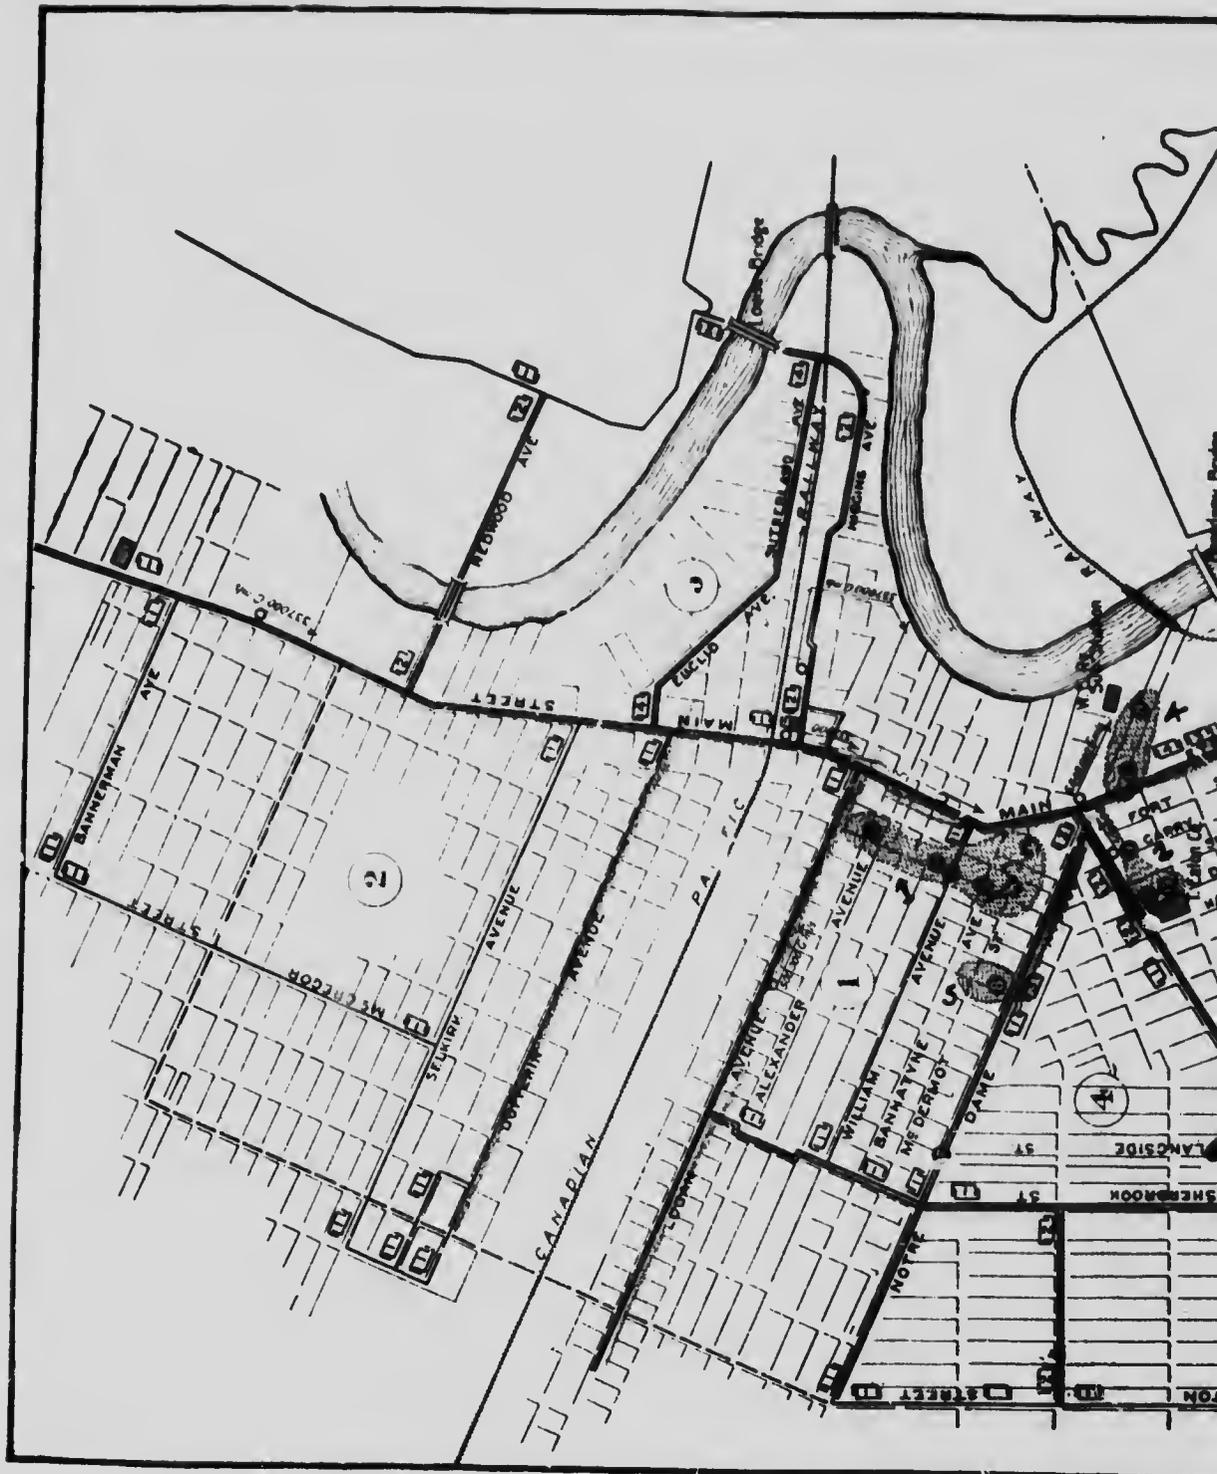
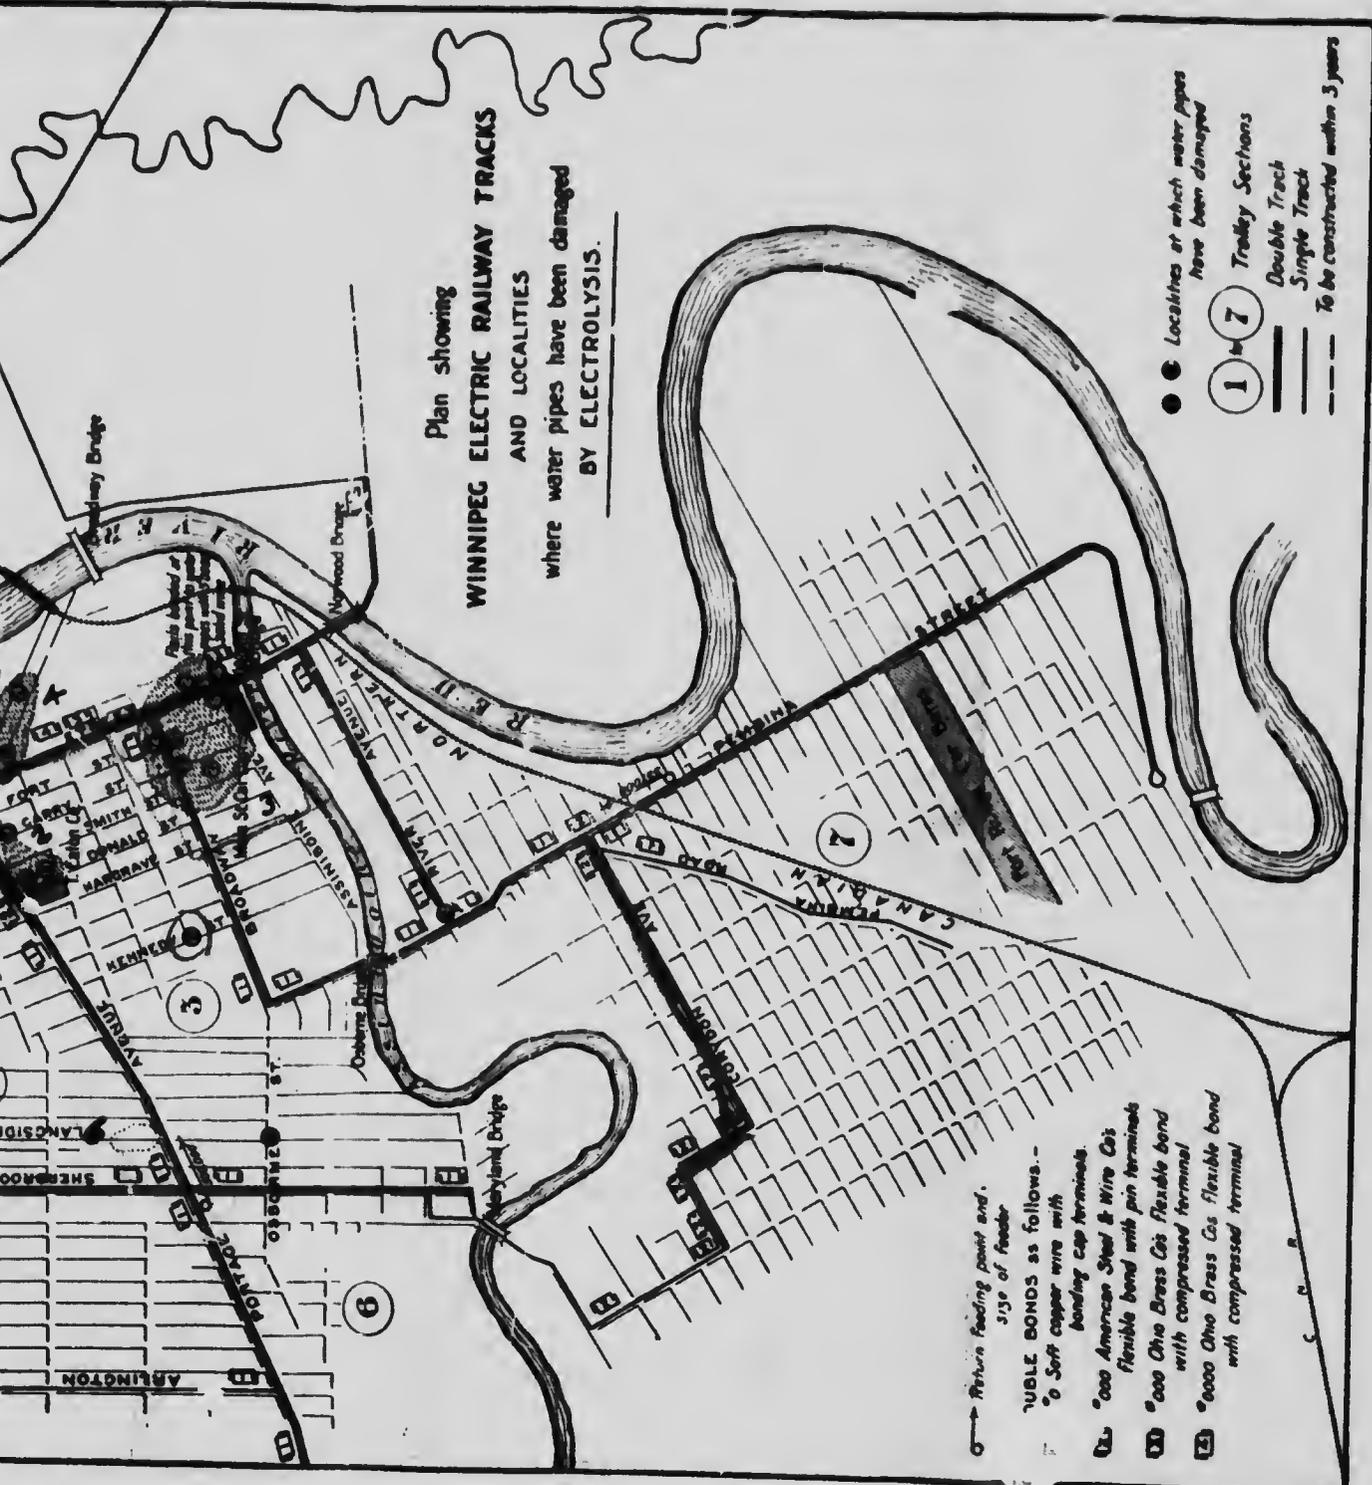
Plan showing
WINNIPEG ELECTRIC RAILWAY TRACKS
AND LOCALITIES

Plan No. 1 shows localities in the city of Winnipeg where damage to water pipes has taken place. This plan also gives the location of the terminal station feeding the whole railway system, the type of bonds used, and return feeders used.

- 1st. Princess Street, from Logan Avenue to Notre Dame Avenue.
 - 2nd. Portage Avenue, from Hargrave Street to Fort Street.
 - 3rd. District enclosed by Main, Broadway, Hargrave and the river.
 - 4th.—Notre Dame Avenue, from Main Street to Winnipeg Electric Railway Company's substation.
 - 5th.—Ellen Street, from Notre Dame Avenue to McDermot Avenue.
 - 6th.—Langside Street, from Portage Avenue to Ellice Avenue.
- (These districts are shown shaded in Plan No. 1.)

The damage reported in districts Nos. 1, 2, 5 and 6 is caused by the very bad condition of the bonding on Portage, Notre Dame, and William Avenue, and Sherbrooke Street tracks. On Portage Avenue, from Hargrave Street towards Sherbrooke, where the roadbed is unpaved, the bond wires, which are Nos. O, B, and S, soft copper wire with bonding cap terminal, give readings in equivalent feet of rail of 20 to 60 feet—this shows very bad condition of bonding.

where water pipes have been damaged
BY ELECTROLYSIS.
