Canadian Society of Civil Engineers.

NOTES ON RETAINING WALLS IN MONTREAL.

By H. IRWIN, M.CAN.SOC. C.E.

(To be read Thursday, October 25th, 1894.)

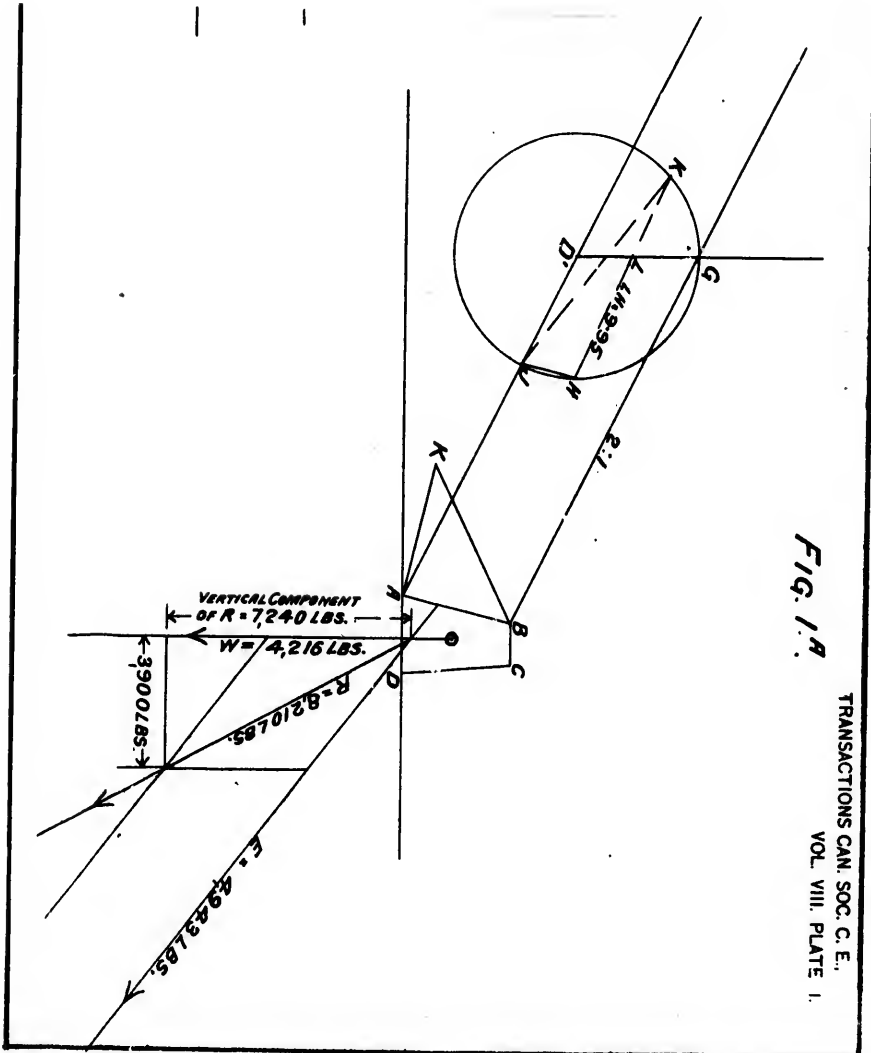
FIG. 1.

The wall shown in section by Fig. 1 is of dry masonry, built of stones from three feet to eight feet in length, by from ten inches to fourteen inches thick, the beds of the stones being fairly flat, but the back of the wall, in some places, seems to be rather poor, the stones being too small; the top front course was built with large, flat stones from five feet to eight feet six inches in length, but the writer has not been able to find out what proportion of through stones were used. The filling behind the wall is principally clay, a small proportion being earth and sandy clay, and was dumped from cars running on a temporary trestle.

The bank on which the filling rests has an average slope of about $2\frac{1}{2}$ to 1, and was not benched before the filling was begun; at the temporary trestle must have largely helped to keep the embankment from sliding, as it was built for a double track and was well braced longitudinally.

The wall at the foot of the slope was built with a face batter of 1 in 12, the batter of the back being 1 in 4; and shortly after the filling was finished it pushed the wall gradually forward till the top overlung the base by about 1 in 12, the embankment rising behind the wall.

wall should have been strong enough to resist overturning, but that, at the ground level, the horizontal component of the thrust would be 4,500 lbs., per foot run, while the vertical component of the resultant pressure, divided by 2 to give the frictional resistance to sliding, was 4,790 lbs., without taking the vibration caused by trains into account. Had the wall been built of the dimensions given above as derived from "Trautwine," it would have appeared to be quite strong enough, according to Weyrauch's theory, to resist the extra thrust from vibrations.
