Canadian Society of Civil Engineers.

TRANSACTIONS.

THE CORNWALL CANAL.

By S. KEEFER, M. CAN. SOC. C. E.

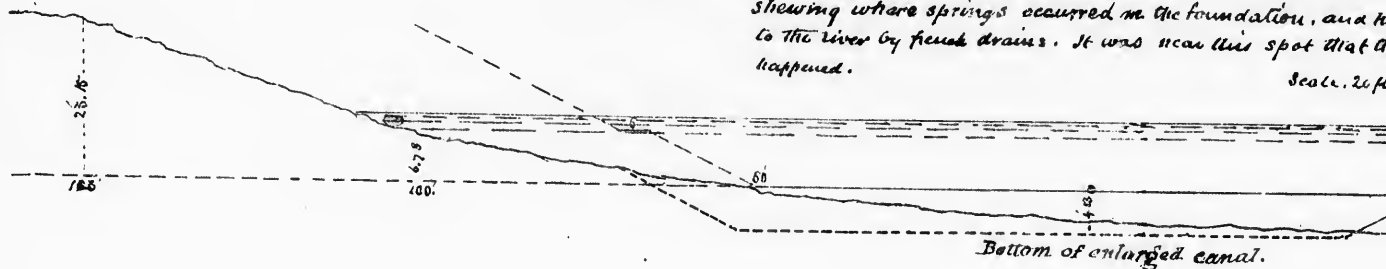
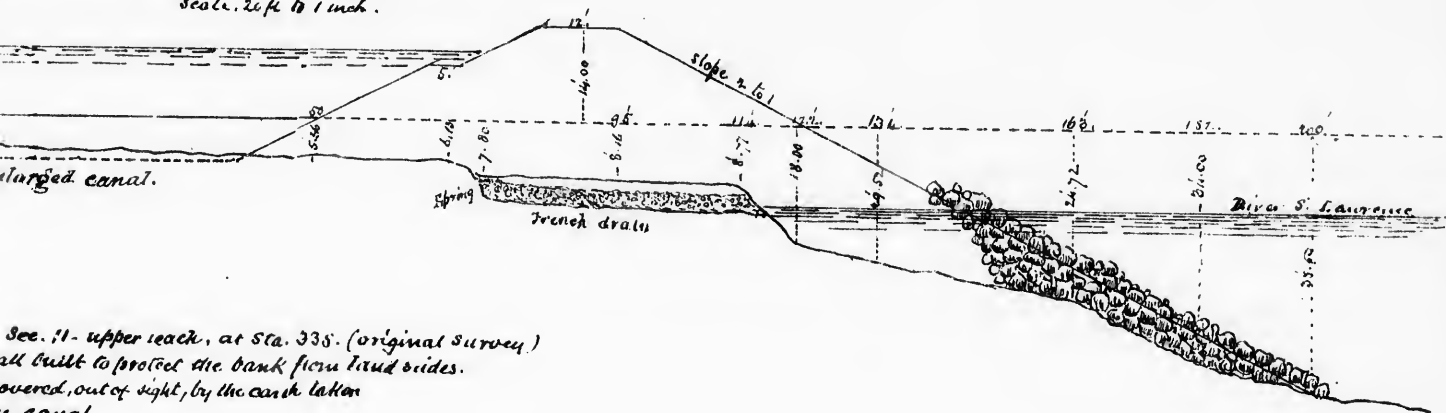
N^o 3. Cross-Section of the embankment on Sec. 6. at Sta. showing where springs occurred in the foundation, and how to the river by French drains. It was near this spot that the happened.

Cross-section No. 3.—This section is taken 1400 feet east of No. 2, near the place where the *third* breach, the most serious of all, occurred on the 11th Oct., 1888. It will be observed that there is no excavation here. The work is altogether in embankment—an embankment that rests half on the land and half in the bed of the river, which at the end of the slope is 38½ feet below the bottom of the canal. The river bank is 8 feet below canal bottom. The soil is clay out of which arise natural springs, which during construction were led out to the river by longitudinal and transverse French drains under the seat of the embankment. This expedient was by no means effectual, for when the bank had been raised nearly to its full height, even before the water was let into the canal, the outer slope began to slide off towards the river. The springs received into the drains rose up in the outer slope and softened the bank, and of course it must yield to the superincumbent weight of the more solid material resting against it. To remedy this evil a series of cross diagonal drains was sunk in the outer slope to carry off the leakage. A good deal of this kind of protection had to be resorted to during the progress of the work; but when all was done and the outer slope protected by rip-rap, it is evident, from the facts stated, that there could be no assurance that the bank would be permanent. A clay soil infested with natural springs, whose source is unknown, is submitted to a pressure of 22 to 24 feet head of water—the difference between the water in the canal and the water in the river. The quantity of water that leaks out through the bank may be trifling at first, but the power exerted by it for mischief is not measured by the actual volume of water that leaks through (as is well understood by what is known as the "*hydrostatic paradox*"), but is in direct proportion to the sum of the vacant spaces within the bank or area on which the pressure is applied. This power, constantly acting on the clay soil forming the outer slope of the bank, first softens it, and then it gives way to the pressure from above, causing slides.

The breach which occurred in this vicinity in October last, no doubt exemplified the hydrostatic law before referred to, for after it was nearly closed another slide took place and materially retarded its completion. This, with the almost incessant rains, delayed the navigation 32 days, and raised the cost of repairs to nearly \$50,000.

It must be admitted that the foundation of the embankment here is by no means reliable, nor is it likely that it can be made so at any reasonable cost. Certainly it is not a foundation such as an engineer would select for the base of a dam, for while the bank of the canal must maintain the water in it from 16 to 24 feet above the river, it is in reality a dam in every part of it throughout its three miles of length.

Work done on Sec. 6. at Sta. 240 (original survey) was done on the foundation, and now they were lean out was near this spot that the breach of Oct 1838

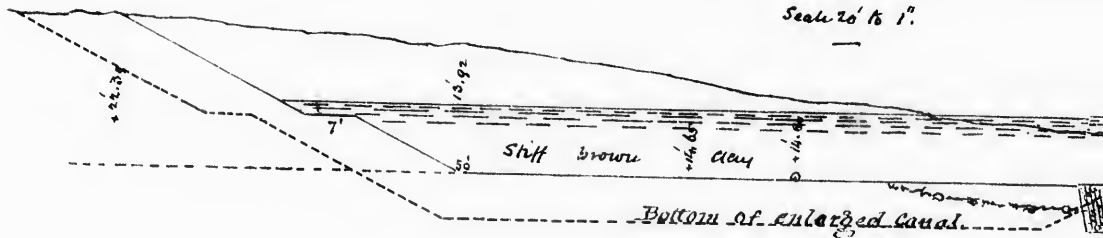
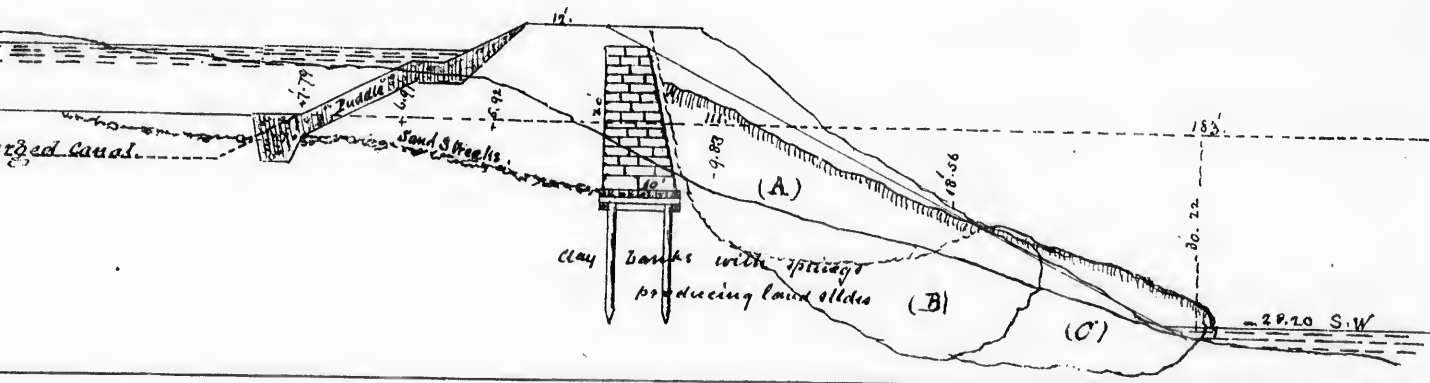
N^o 4. Cross-Section of the canal on Sec. 11. upper reach, at Sta. showing section of the retaining wall built to protect the bank. This wall was entirely covered, out of sight, by the canal from the canal.

Cross-section No. 4. This section is taken about a quarter of a mile above the first lift lock, and represents the retaining wall built in the bank by Mr. Mills. Before the canal was begun, land slides were observed in the high bank along the river, which at this place is forty feet below the surface of the canal. They were caused by springs in the natural bank. As a matter of protection to the canal, a wall, as shown, was built for a quarter of a mile in length along the line of the outer edge of the towing path, founded on a solid timber platform, supported on piles. The wall is built of heavy ashlar masonry, laid dry, so as to allow the spring water to pass anywhere freely through it. The clay excavated from the prism of the canal was thrown in spoil bank in rear of this wall, and as the top of it was 3 feet under top bank it is now entirely covered in and hidden from view. It extends from sta. 335.50 to sta. 349.60 of the original survey, and contains 9,037 cubic yards of masonry.

In constructing the canal, sand streaks running through the clay were discovered in the bottom, by which the water found a passage to the revetment wall and through it to the spoil bank outside. In August, 1836, a slide took place here, which carried away part of the original bank within five feet of the foundation of the wall, and exposed 6 to 8 feet of the natural bank below it. From a note made at the time, it was thought that the part (A) sunk down to the place (B) and pushed out (C) before it—(B) and (C) having first been softened and prepared to slide by the water leaking through the wall. To stop the leaks a puddle trench 8 to 10 feet deep and 4 feet broad at bottom was placed along the foot of the slope, and joined to an apron of puddle three feet in thickness, protecting the bank to its top. This method of protection was entirely successful, and there have been no further slides, nor any failure of the wall up to this time.

It is perhaps necessary here to state that the *cross-section No. 4* reveals a condition of things apparently unknown to the chief engineer, since his specification for Sec. 5 makes no reference to the retaining wall, and the puddle trench and apron in front of it. Special means will have to be adopted in order to protect the canal from leakage along the front of this wall, and thereby prevent land slides.

Sec. 11 - upper reach, at Sta. 338. (original survey) all built to protect the bank from land slides. covered, out of sight, by the earth taken from the canal.

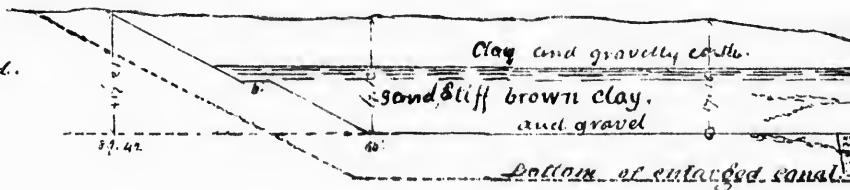
Cross-Section. *N^o 2.*
 taken below Moulinette on Section *N^o 6*
 at Sta. 22.6 (original Barrey)

Cross-section No. 2.—This section is taken a short distance below Moulinette, and is a fair sample of the doubtful character of the soil on which the integrity of the navigation depends. It was near this that the first breach occurred in December, 1843, shortly after the canal was first opened. Small streaks of sand were found in excavating the canal, which made their way in some unknown manner through the natural "drift" on which the embankment rests. These were discovered were cut off by a puddle trench, six to eight feet deep, another bank and canal bottom protected by an apron of puddle three feet in thickness. The second breach took place on the 30th October, 1850, just above the road culvert at Moulinette, after the canal has been seven years in use. The cause of the breach in this instance was attributed to a small rivulet that crossed the canal nearly at right angles, some fifteen feet below the bottom of the canal. It was a sort of blind water-course that had not been thoroughly cleared of the sand and vegetable deposits before the bank was built across it. Through this, without any previous warning, the canal water found a passage, and in a very short time, a gap 280 feet long and 26 feet deep was made, emptying the canal, and carrying away some 1500 cubic yards of the bank. The gap took the following shape. Fig. 1.

It was here the first breach occurred.
