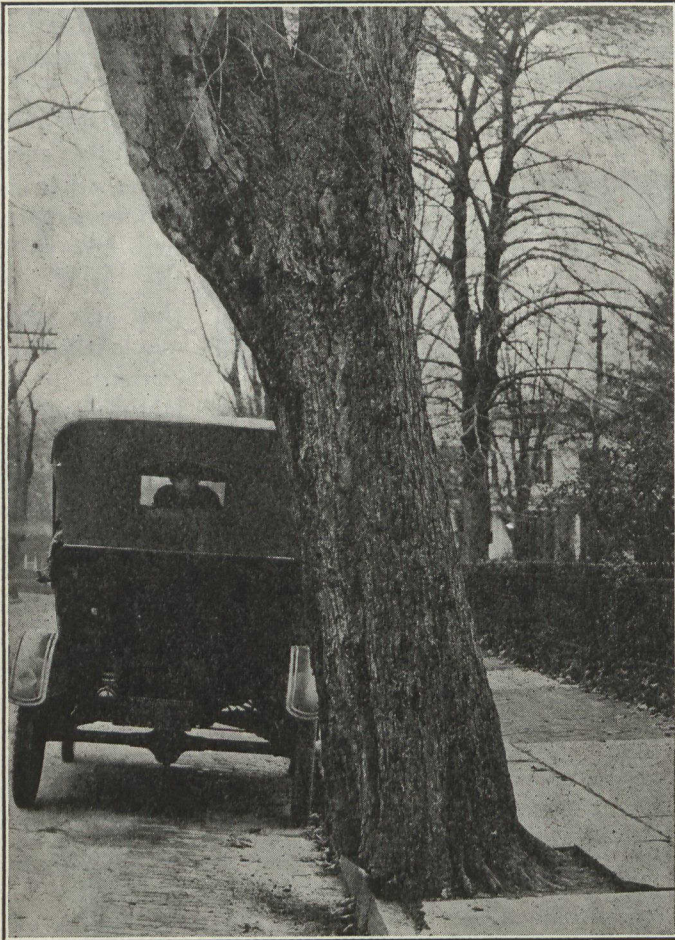
#### PRACTICALLY RUINED BY CURB SETTING

The curbsetter insisted on plying his art and rather than omit the curb where the tree projected a few inches, off came a sliver from the base of the tree! True, he did make a neat, clean cut and even painted it, but longitudinal cuts of this sort do not heal over like those made crosswise, and so this monarch of an erstwhile forest must pass the rest of its days with its "heel" chopped off and give thanks from its leafy branches which tower high above the house top that man spared it.

This beautiful Silver Maple was ruthlessly cut at the base by the curbsetter, who "had no idea that it would hurt the tree."

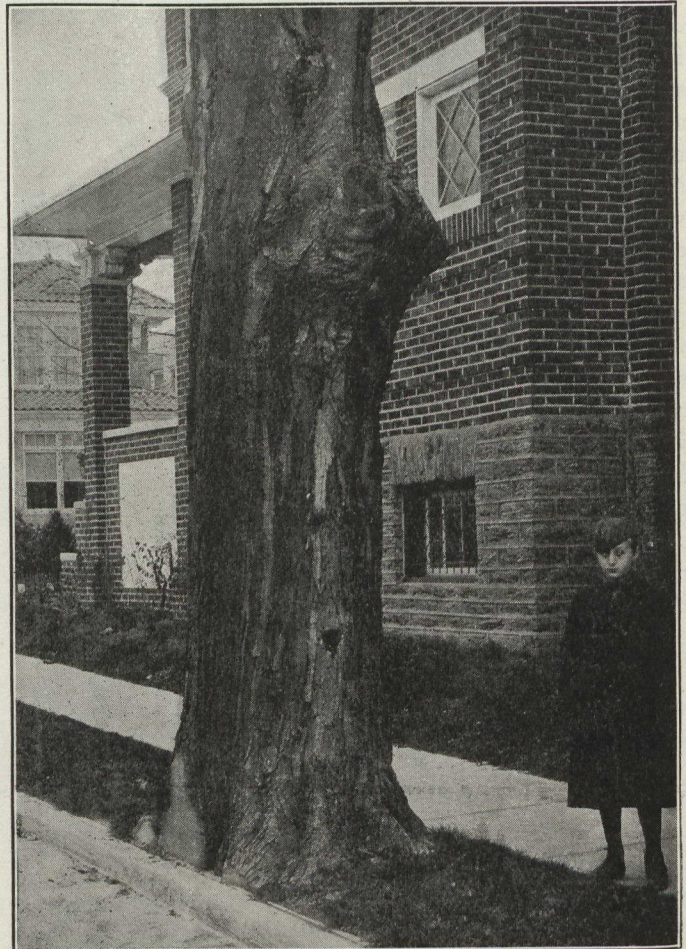
#### HERE, AGAIN, THE TREE WAS CUT AT THE BASE

To maintain the straight line of the curb, quite a cut was made on this old Sugar Maple, a species peculiarly sensitive to injury.
