FAILURE OF THE BOUZEY DAM.

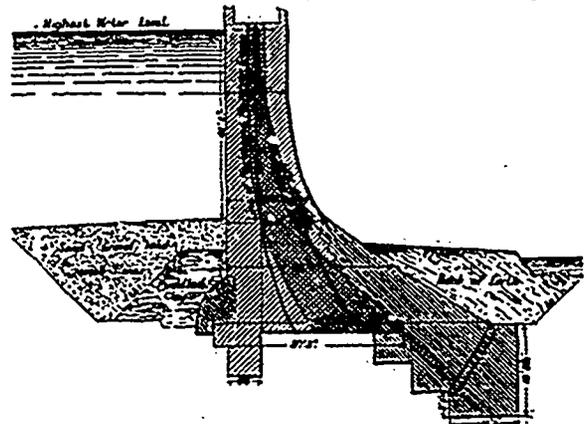
The news that on the 27th April a masonry dam of recent design had given way with disastrous results on the headworks of the Eastern Canal of France, was received with something like consternation by hydraulic engineers, particularly as the reputation of the profession in France for works of this class stands at a high level. The failure of an earthen embankment is always intelligible, and most of the old dams in India have been swept away one after the other, owing to bye-washes insufficiently large to pass exceptional floods. A full investigation into the circumstances of the Bouzey disaster, however, tends to allay the first feelings of alarm, as the structure in question is one for which English engineers would hardly care to be responsible. The dam was intended for supplying water to the summit level of the Eastern Canal, and was situated near Epinal, in the valley of the Avrière. When it gave way the impounded water, amounting to 7,100,000 tons, rushed down the valley, destroying everything on its path as far as Chatel, some ten miles to the north. From the contours, it would seem that the Avrière valley is very narrow, though at intervals it widens out somewhat, closing in again later on. The fall in the ten miles between the bottom of the reservoir and the River Moselle at Chatel is about 430 feet. Hence there was a fall of over 40 feet per mile, which is, of course, excessive for such a body of water as that set free by the failure of the dam. This latter was built of dressed stone laid in lime mortar, the material being a sandstone conglomerate having a crushing strength of from 295 to 550 tons per square foot in different specimens. The tensile strength was, however, comparatively low, amounting to only eleven tons per square foot. The specific gravity of the materials used is stated to be about 2.0. The profile of the structure, as originally built, is shown by the dotted line outline in cut. In plan the structure

is quite straight, and is 1,705 feet long. It was founded on the same conglomerate rock as that used for building it. The upper layers of this rock were, however, greatly fissured, and to save expense it was determined not to carry the foundation down to impermeable material, but instead of this a "guard wall" was sunk below the dam, as shown in the figure, the bottom of this wall being 3 feet below the top of the sound rock. On attempting to fill the dam, however, serious disturbances took place, the structure bending horizontally for a length of 440 feet, the deflection at the centre being 1'22 feet, and the dam also sheared off from the guard wall; in short, it slid down the valley several inches. It was thereupon determined to empty the reservoir and strengthen the structure. The alterations made are well shown in the figure. The lower portion of the dam was increased in width from 37.5 ft. to 57.3 ft., and abutted on a heavy bressummer sunk down to solid rock. The thickening, however, was not carried up to sufficient height to avoid the objectionable tension on the up-stream face. As the figure shows, the line of resistance lies considerably outside the middle third of the section. There would thus be a tension on the up-stream face tending to open the joints there, and to admit water to the middle of the masonry. The mortar used was apparently not very hydraulic, as to make the dam water-tight the whole of its up-stream face had been rendered with a layer of Portland cement 1 3/8 in. thick. This rendering must have been considerably cracked during the shifting of the dam; but apart from this, the tension already referred to would also tend to crack it. In all probability, therefore, the structure was water-logged, and during the very severe frost of the past winter, this water, in freezing, would tend to disintegrate the

structure, rendering it liable to fail on the first opportunity. An examination of the débris would show whether this view of the matter is well based.
