# Failure of 'hotbox' caused train derailment

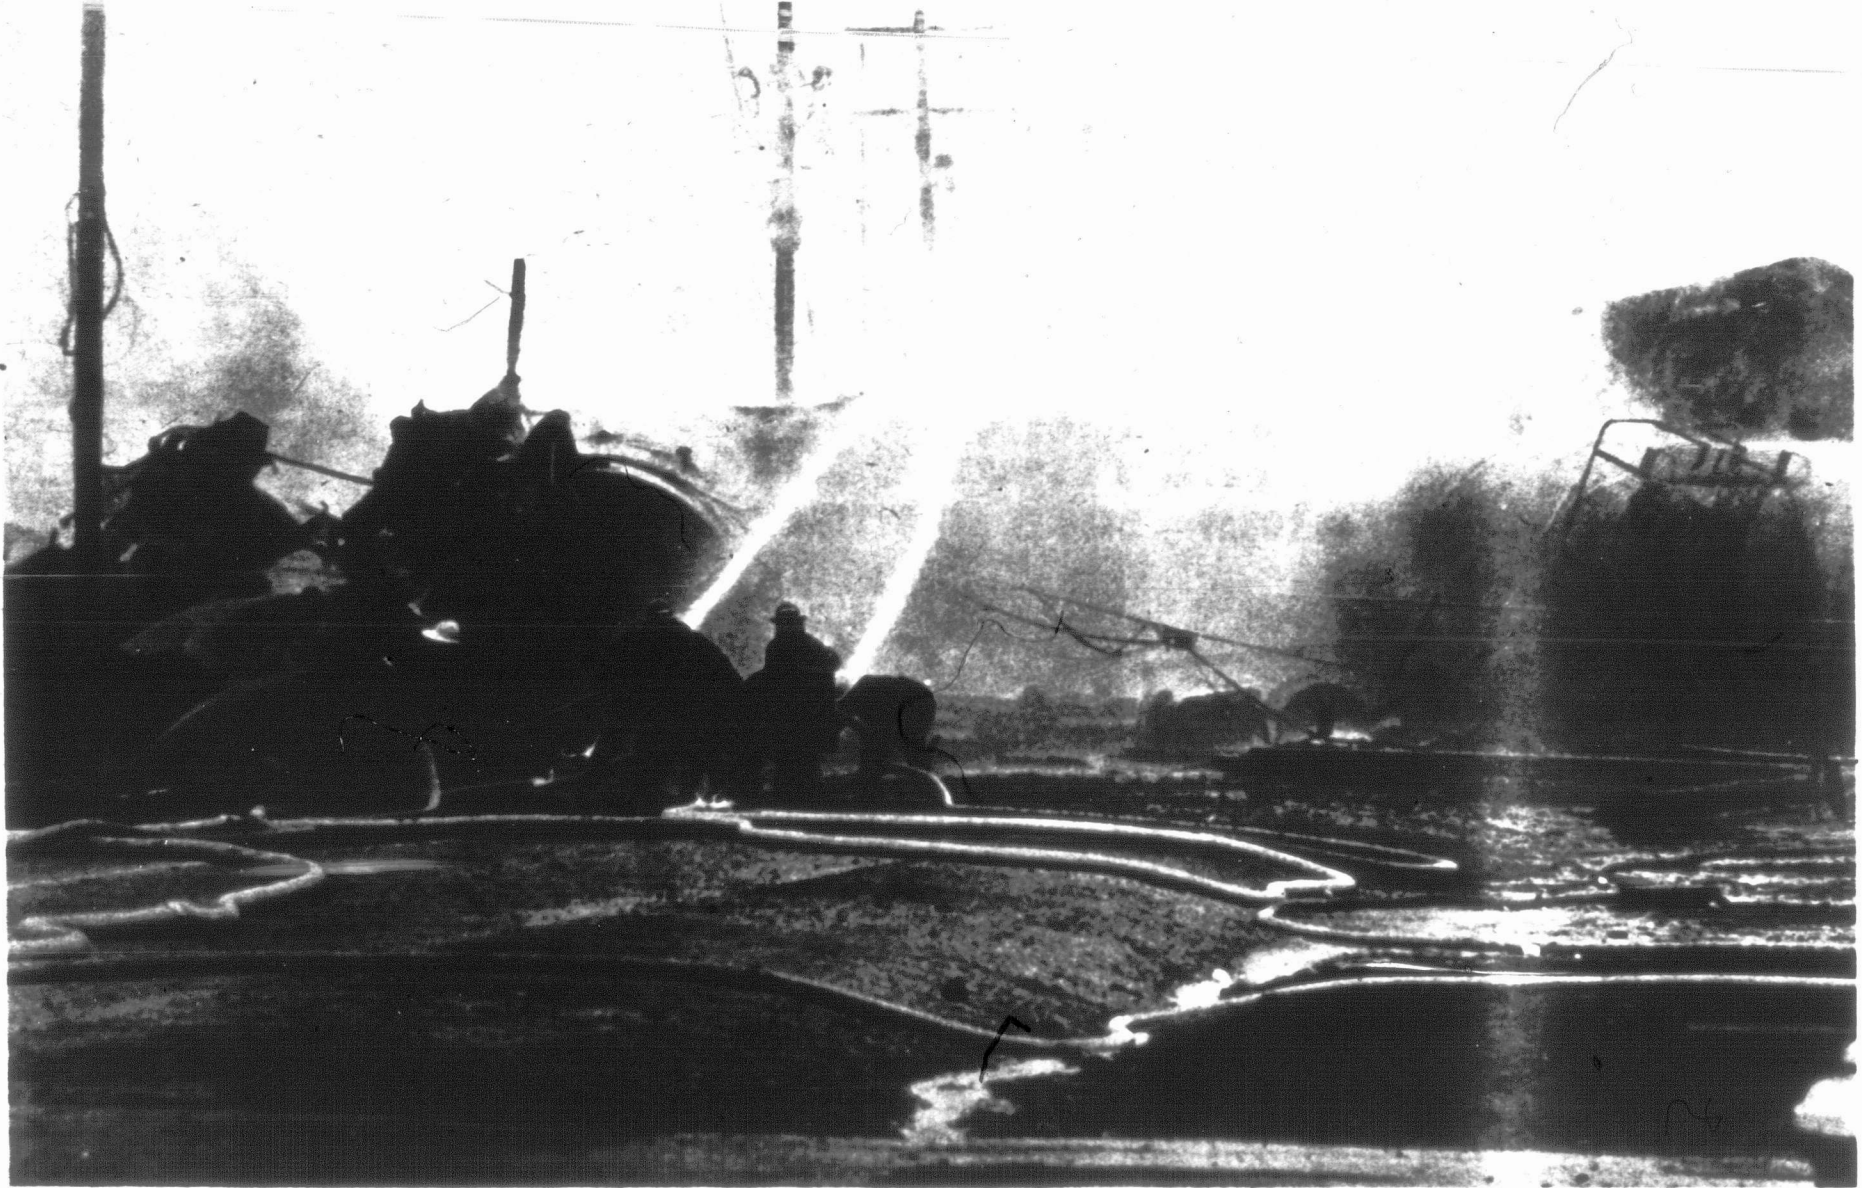
## the wreck

Canadian Pacific Railways is blaming the derailment of railroad cars which resulted in the explosion on Mavis Road on the failure of what is termed a "hotbox."

The technical reason given by CPR for the problem was an "overheated journal bearing," known informally as a hotbox, which resulted in the end of an axle breaking off and leading to derailment.

Ken Smith of CP says the company can say what caused the accident because it has examined pieces of the wheel assembly found near the scene. The "hotbox" which encountered the problem was of the conventional type. It was not the "roller bearing", in which oil is used to reduce friction. That type used on new cars.
