BOILER EXPLOSIONS FROM FAULTY CONSTRUCTION.

The particular boiler whose history is about to be narrated, exploded at Holyoke, Mass., November 11, 1879. Its dimen-sions were as follows : Shell, 6 feet long; upper part, 22 inches diameter; lower part, 30 inches. In this there were 38 tubes, 6 feet long by 3 inches diameter; shell plates, 4 inch thick, tubes, 5-16 inch thick. The four braces—the ends of which are visible at A A. Fig. 1-were 9 inches wide and of 5-16ths iron. The mode of fastening these braces is seen in Fig. 2, where they are shown attached below the small reverse curve of the waist, by means of four of the seam rivets, to each side of the boiler. The back tube plate was stiffened by short bars of angle iron, riveted on transversely above the tubes. The shell, as will be seen by consulting Fig. 3, was composed of three plates, two of which formed the cover of the upper part, and the third that of the lower part, a continuous seam on each side joining the upper plates to the lower one.

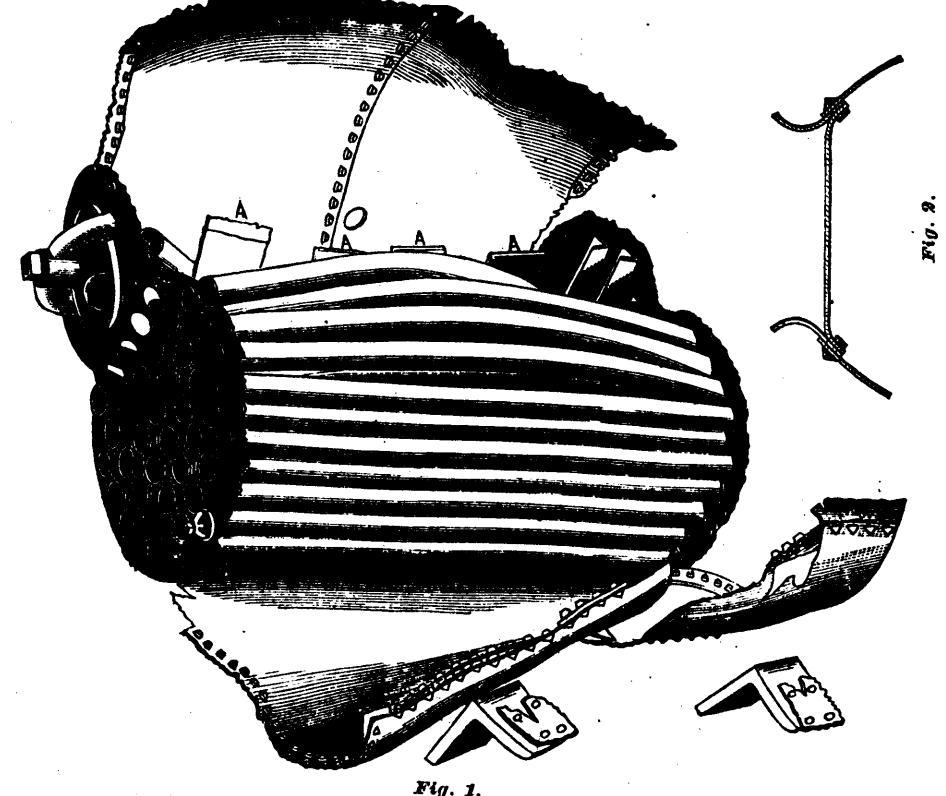
The plan of construction, therefore, shows a departure from the rules hitherto made use of, the idea of the inventor being apparently to construct a boiler similar to the Union boiler, with a continuous connection or leg. The execution of this idea, however, involves a fatal weakness of construction, which will shortly appear, and which the event has shown, justifies the Hartford company in their refusal to insure them. By reference to Fig. 1, it will be seen that the outline of the end plates, which gives general outline of the boiler shell, is that of two parallel, incomplete and intersecting cylinders. The tendancy

of an internal pressure upon such a form as this must manifestly be to distend this compound form into that of a simple cylinder and this must necessarily bring a powerful strain upon the angles of the braces (Fig. 2), tending to straighten them out. The of the braces (Fig. 2), tending to straighten them out. effect of this strain upon the rivets fastening the braces to the seam, will be to pry them downward as the angle of the brace yields to the straightening effect of the strain-something like the effect of a "claw bar" on a spike in drawing it from the fastenings. The correctness of this criticism will be obvious to any mechanical mind that studies the engravings, and furthe details of the settling of the boiler and its fittings are superflous The boiler was considered safe at 75 pounds working pressure but at the time of the explosion the pressure was supposed to be from 40 to 50 pounds.

The theory of this explosion advanced by the Hartford company, seems to be so perfectly justified by the acts, that we entire ly coincide with it, and give it without further comment : of the middle braces, the second or third from the end. became so weakened by frequent motions, caused by the straightening tendency of the internal pressure, that it gave way at the angle (where it will be seen from the drawing, Fig. 1, and three di-them are broken off). The rest of them, a little less weakened, perhaps, by the same cause, gave way in turn immediately, have ing received a sudden succession to their load, and the shell yielded and broke at the middle of the long seam, which may also have been weakened along the margin of the inner lap, as indicated by the leak on the left side. The shell being now fairly open, the steam and water rushed towards the place of least resistance, which was outward and upward, carrying the shell plates before them and tearing them from the end plates. The bending of the upper tubes indicates the direction which the water about them took in escaping, as does also the tearing out of the entire upper row of tubes which, it will be seen from the one in sight on top of the cluster, were so much bent as to draw them from their setting in the tube plate. The four brackets which supported the boiler being below the opening, constituted the over-balancing resistance in the downward direction. Had the brackets been above the opening, the boiler would doubtles have gone high in the air, instead of tumbling over and over to the left, as observed by the attendant, who caught sight of it just before the whole scene was enveloped in steam and dust. The hypothesis seems to be so well supported by the facts that the word is almost a misnomer.
