LINING AN IRRIGATION CANAL WITH GUNITE

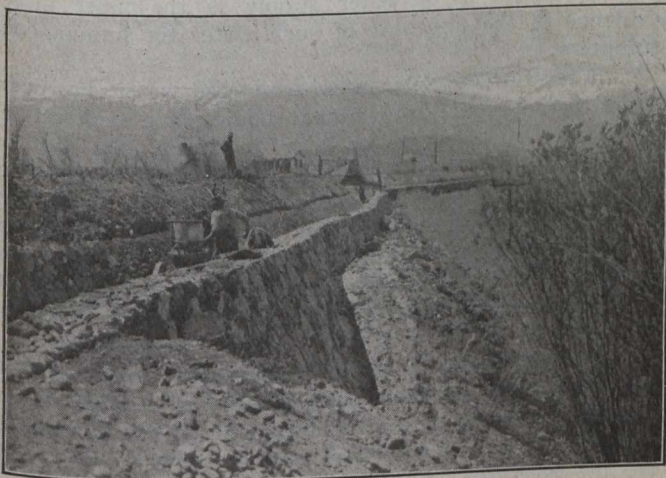
Fig. 1.—Showing Retaining Wall on Downhill Side of Canal

The ditch, it will be seen, runs along the side of a hill. The wall on the lower side was built of boulders and rock taken from the side of the hill, laid up dry in most of the length, mortar only being used in a few places where the

wall is quite high and thick enough to form a gravity section retaining wall, as shown in Fig. 1.

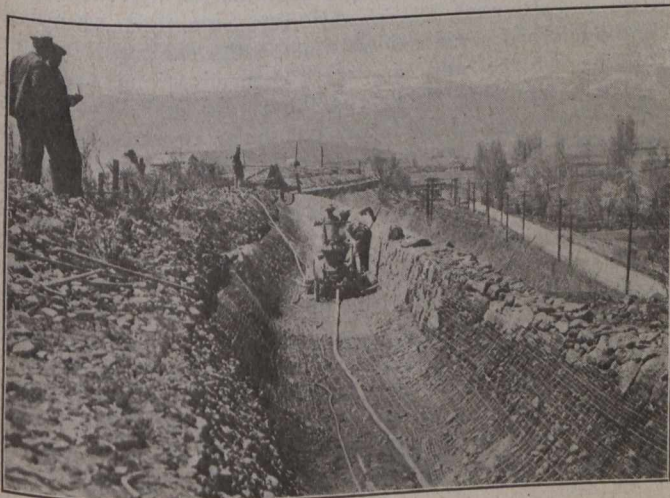
Fig. 2.—Reinforcing in Place Ready for Gunite

For reinforcing fencing No. 11 wire was used throughout. This was placed on the bottom and sides with end and side joints thoroughly lapped and wired. (See Fig. 2.) After the reinforcing was placed the gunite was shot to a thickness of two inches on the bottom and uphill side of the ditch, while on the wall the open joints were shot full inside and out and to a thickness of about half an inch over the reinforcing. (See Fig. 3.) No reinforcing was used on the outside of the wall.

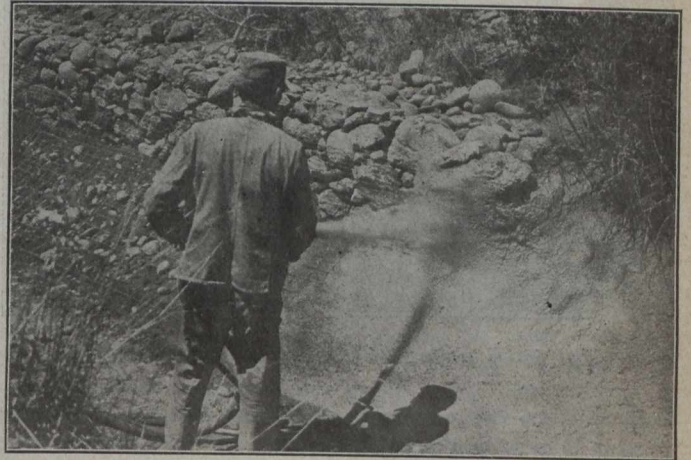
Fig. 3.—Shooting Gunite

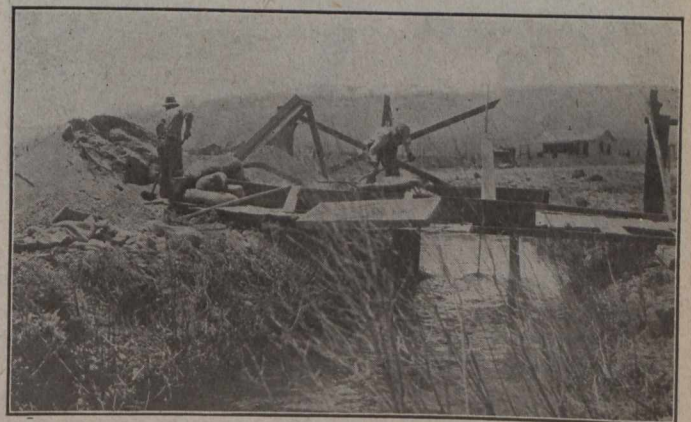
Fig. 4.—Mixing Plant

Sand had to be hauled a considerable distance and was delivered on the hill above the ditch. Another canal parallels the south side canal a short distance above it and about the crest of the hill. This made it necessary to mix the material above the upper canal and chute it across to a hopper located over the canal which was being lined and from where it was brought to the gun in wheel-
