NOTES ON THE CONDITION OF SOME UNDER-GROUND CONCRETE WORK IN WINNIPEG*

By Bertram Stuart McKenzie, B.A., B.Sc. Consulting Engineer, Winnipeg, Man.

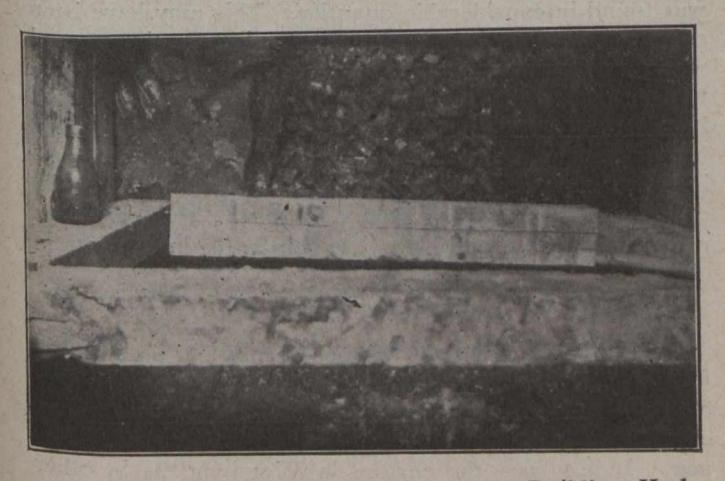
Fig. No. 1—Caisson Under Ten-story Building Had Appearance of Pile of Broken Stone

(2) The second example was discovered when exposing the surface of caissons which had been lying in the clay for over 14 years. These were under one of the 10story office buildings in Winnipeg. It was found necessary, on account of settlement in the building, to excavate under these old caissons and continue same to rock. They were generally lying at a depth of about 35 ft. below ground level, and in practically every case (21 in number) water in considerable volume was found lying around the caisson and concentrated at the bottom. This water had come from under the basement floor and seeped down along the surface of the caisson. The first caisson exposed had an unusually rough surface, having the appearance of a pile of broken stone. (See Fig. No. 1.) There was a certain bond between the stones but the concrete was full of large voids.

If any mortar had ever existed in these spaces, it had entirely disappeared. It was noted that in the spaces mentioned above, a deposit of a brown jelly was often found. It was thought at first that this might be gelatinous silica, left as a residue from some chemical action, but this was not confirmed by analysis. Wherever this rough surface appeared there was discovered a curious sheath of hard clay about $1\frac{1}{2}$ ins. in thickness, which showed quite a marked cleavage from the mass of sur-

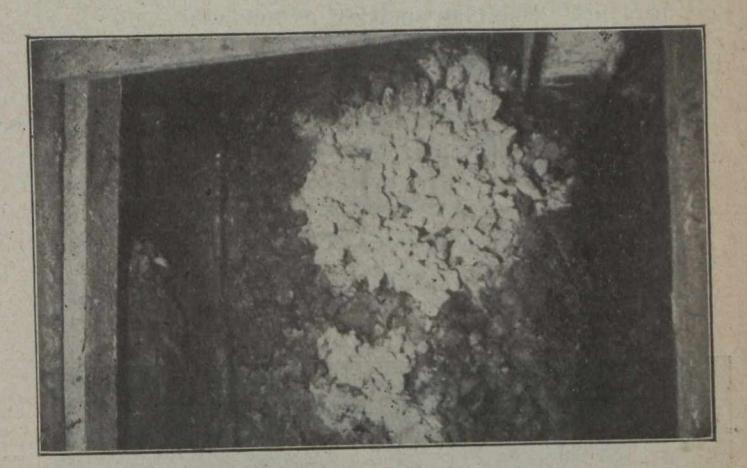
Fig. No. 2-A Sheath of Hard Clay Adhered to Rough Parts of Caisson
