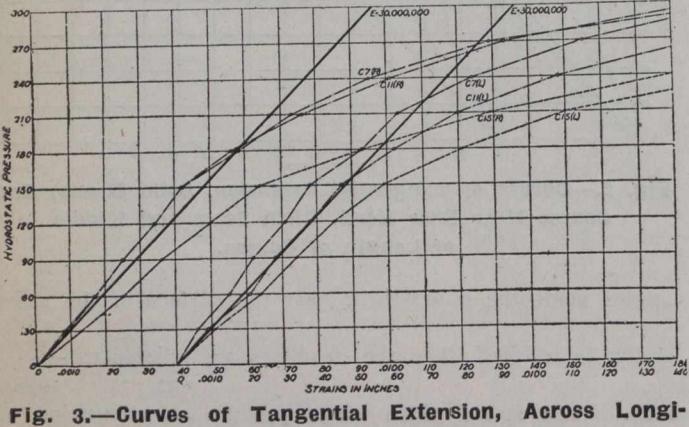
The strains produced at the various places measured are plotted in this way and the diagrams accompany the paper. E-8 was taken near the girth seam between this and the next sheet and E-16 in the centre of the rear sheet close to, but not spanning, the longitudinal joint. Diagrams of the boiler are given in the paper showing the location of each of the spans measured. Fig. 3 shows the extension across the longitudinal seam on the middle course, curve C-7 being taken at the front edge, C-11 at the rear edge and C-15 in the middle of the sheet. The author points out that in the case of a three-course boiler with one sheet to a course, as found in current construction, it would seem that a double riveted lap joint might occasion (by reason of the greater extension) an excessive stress in the solid sheet abreast the end of the seam, under certain pressures.

Fig. 3.—Curves of Tangential Extension, Across Longtudinal Seams, at Middle of Length of Course and at Edges.

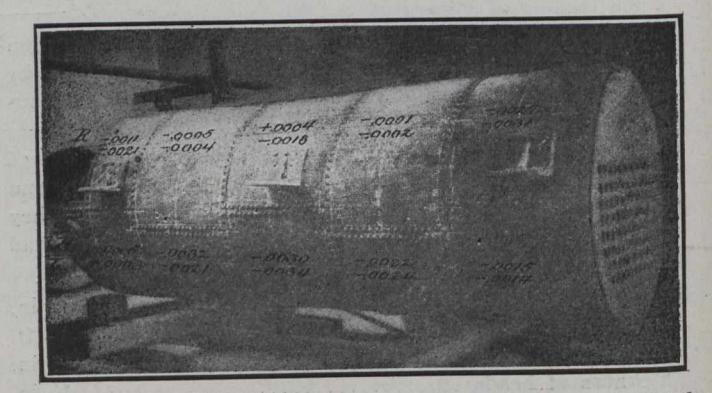
In a plain cylindrical shell, increase in diameter would necessarily be attended by a definite amount of endwise contraction, eliminating the effect of pressure on the heads. The tests showed that there were parts of the boiler which were nearly free from longitudinal strains, while there were other places in which the strains were reversed and longitudinal extension shown instead of contraction. Along the lower quarter of the boiler the longitudinal strains were contractions, while along the upper quarter they were in part contractions and in part extensions. Figs. 4 and 5 show the amount and character of these strains at 270 pounds in the middle of the sheets and across the girth seams respectively.

It will be noticed that the lower part of the shell contracted notwithstanding the fact that the tubes were extended by the exterior pressure to which they were subjected. This behavior calls for bending at the flanges of the heads to compensate for the difference of these movements. The six through braces would relieve the shell of a portion of the longitudinal tension coming from the heads in the upper half of the boiler. Longitudinal gauged lengths on the upper part of the shell showed diminished contractions over those observed on the lower portion or displayed strains of extension. On the very top of the boiler the strains were extensions of a pronounced order. The tests for which the figures and diagrams in the paper are given were made upon only one of the boilers. In the tests of the first boiler greater strains were displayed in the vicinity of the dome and the manhole frame than at other parts of the shell, which resulted in an early failure at these places. Actual rupture of the dome was not accomplished, but leakage along its single-riveted longitudinal seam became so great at 266 pounds that it was necessary to remove the dome and close the opening to it in the shell with a patch in order to reach higher pressures with the pump available.

Fig. 4.—Longitudinal Strains on Solid Sheets at Middle Length of Courses. Minus Signs Indicate Longitudinal Contraction; Plus Signs, Longitudinal Extension.

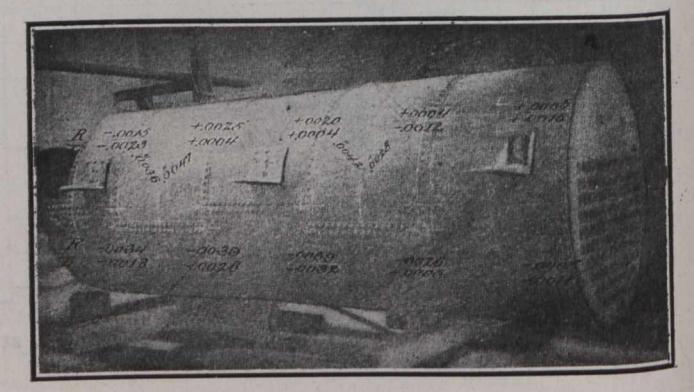
A feature, however, in the test of the first boiler was absent or obscure in that of the second. Measurements of strains across the longitudinal seams increased progressively in passing from the front to the rear end of the boiler. The author says: "While these seams were not directly exposed to the heated gases over the grates, nevertheless it seems probable that a wider range of thermal conditions prevailed

Fig. 5.—Longitudinal Strains Across Cirth Seams, Also Strains on Diagonal Cauged Lengths of Courses.

in the vicinity of seams at the front end over those at the rear end of the boiler. If such was the case it would aid in explaining the greater slip of the forward seams." Leakage at the longitudinal seams began at 120 pounds and became general at 180, but at this time the slip of the joints had become pronounced and necessarily disturbed the calking.
