Letter to the Editor

INCRUSTATION IN VANCOUVER SEWER PIPE

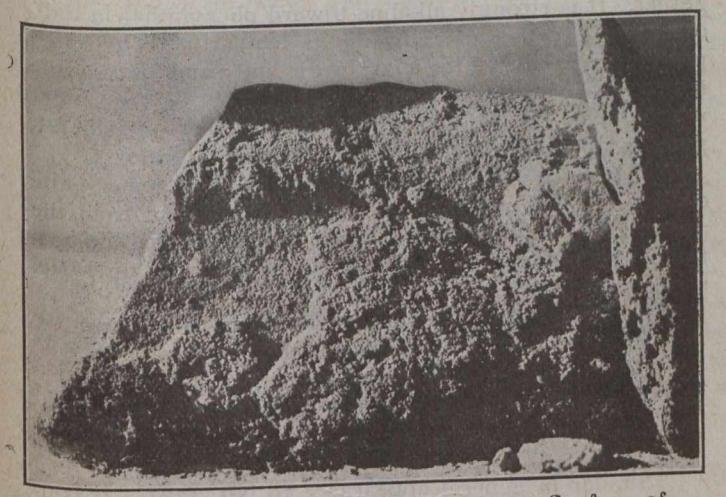
Fig. 1—Sample of Incrustation on Inner Surface of Vancouver Sewer Pipe—Natural Size

The sewer maintenance foreman then volunteered to go through the sewer without keeping the hose running, so as to locate and remove the obstruction. In the dry sewer it was seen that the obstruction was not caused by sand or road debris left in it, but that on each side of the sewer at the level of the ordinary dry flow, about four inches above the invert, there was a thick incrustation of material which looked very much like lime mortar, and that the wheels of the bogie broke this material and formed the obstruction. It was also found that in spite of the prolonged flushing in the endeavor to cleanse the sewer for examination, paper and sewage still adhered to the rough edges of this incrustation.

A 27-inch sewer carrying storm water only was then examined, and similar conditions found; so that it was evident that the incrustation was not caused by sewage. Many other sewers of the same class of pipe were examined, and it was found that the presence of this incrustation was most marked where the pressure of ground water was most evident. In one sewer where the pipes had been laid in tunnel and covered with coarse concrete, incrustation was only found at one or two joints; and in sewers built of concrete in situ, the same thing applied, the continuous scale on the water line of the sewer being peculiar to the machine-made pipe.

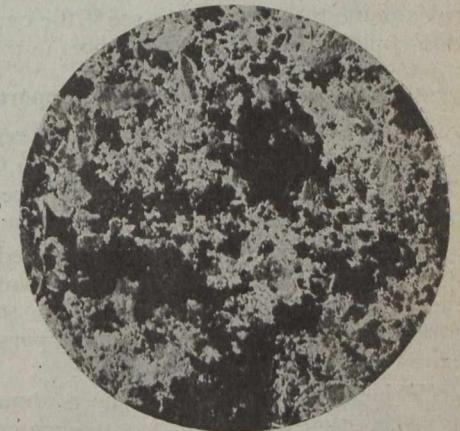
No stipulation was made as to the proportions of the materials entering into the construction of the pipe, as it was considered best that the manufacturers should be responsible for their product. It is however known that the proportion of cement in the pipes hereinafter described was not less than one of cement to three of aggregate, though the manufacturers afterwards made pipe which they claimed to be of superior quality, with the proportion of one of cement to five of aggregate.

Fig. 2—Sample of Concrete from Vancouver Sewer Pipe, Magnified Two Diameters—Black Areas Indicate Voids
