## The Oxy-Acetylene Process in the Railway Shop.

## By Frederick H. Moody, B. A. Sc.

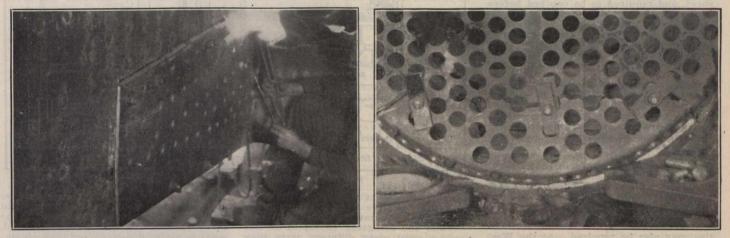
with the air piping. In these shops, a great variety of work is handled, though the principal work is that of patching up boilers, for which the oxy-acetylene process is peculiarly adapted. The accompanying il-lustrations show two instances where heavy repairs were made unnecessary. In fig. 1, the front end of the inside sheet at the bottom of the water leg near the mud ring had been so reduced in thickness, from the attacks of acid water accumulating in the interior at that point, that the plate was considered

Fig. 1—Patching the Inside Sheet of the Firebox by the Oxy-Acetylene Process.

Fig. 2-Repairing the Front Tube Sheet by the Oxy-Acetylene Process.

There are two classes of welds. The first, for very thin plate, requires the ad-The dition of no extra material at the weld, the edges being brought into intimate contact and fused'together. The second class, for heavier plates, requires that the contact edges be chamfered, and the dangerous. Under former conditions, this would have required a patch to cover this part of the firebox, a construc-tion that in itself is objectionable from the fact that it makes a double thickness wall through which the heat has more difficulty in penetrating, and, in conse-quence, that part of the inside sheet is particularly liable to further damage particularly liable to further damage from burning. The oxy-acetylene pro-cess solved the difficulty. The original piece that had been corroded was first of all cut out by the oxy-acetylene flame, removing the whole area that was affected. The oxy-acetylene flame in removing the injured piece cuts it out per-fectly clean, the flame penetrating a small incision made at one end, cutting along at a rapid rate with a narrow cut. The holding staybolts are drilled out and the damaged portion removed. Another plece of good plate is then cut to the shape of the removed portion, and the staybolt holes laid out and drilled or punched to make it in every way a coun-terpart of the removed piece. The jointerpart of the removed piece. The join-ing edge of this plate, as well as the good edge of the side sheet, are cham-fered, and the new piece bolted in place
