Canadian Society of Civil Engineers.

AN OLD REVETMENT WALL.

By W. J. SPROULE, Ma. E., M. Can. Soc. C.E.

To be read Thursday 28th January, 1892.

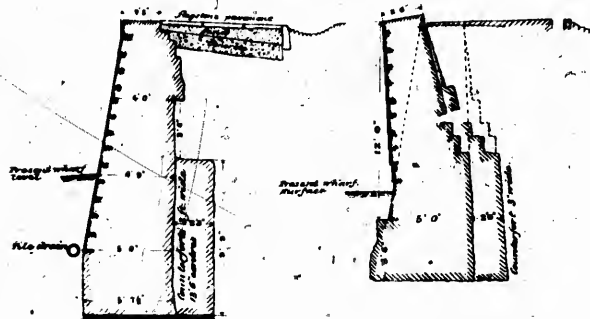
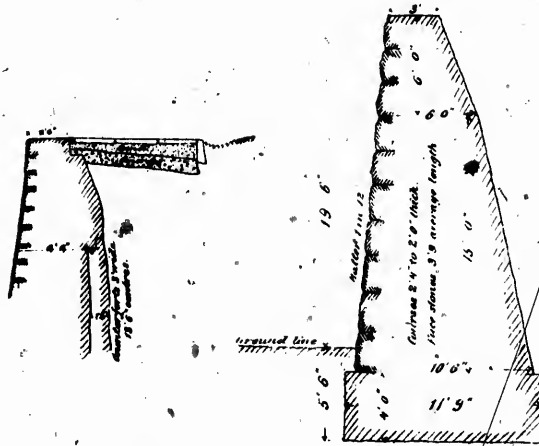
CAN. PAC. RY. REVELMENT WALL.
MONTREAL HARBOUR

for a long period in winter one to three feet up on the face of the wall, fluctuating one to two feet with variations in the temperature of the weather. Part of the wall in this way is often exposed to temperatures 15° to 20° below zero after being immersed in water for days or weeks. But this does not seem to be the determining cause of failure, for the best and worst parts of the wall have been equally exposed to these conditions. The masonry on the inclined surface of the ramps, however, at about one to three feet above wharf level is much displaced. The wall is built of limestone from quarries in the vicinity of Montreal. A few stones are cracked and somewhat weathered, but sufficient disintegration has not taken place in the stones
