VOL. VII—PART I.
(JAN. TO JUNE, 1893.)

THE QUEBEC LAND SLIDE OF SEPTEMBER 19, 1889.

By CHAS. BAILLAIRGÉ, M. Can. Soc. C. E.

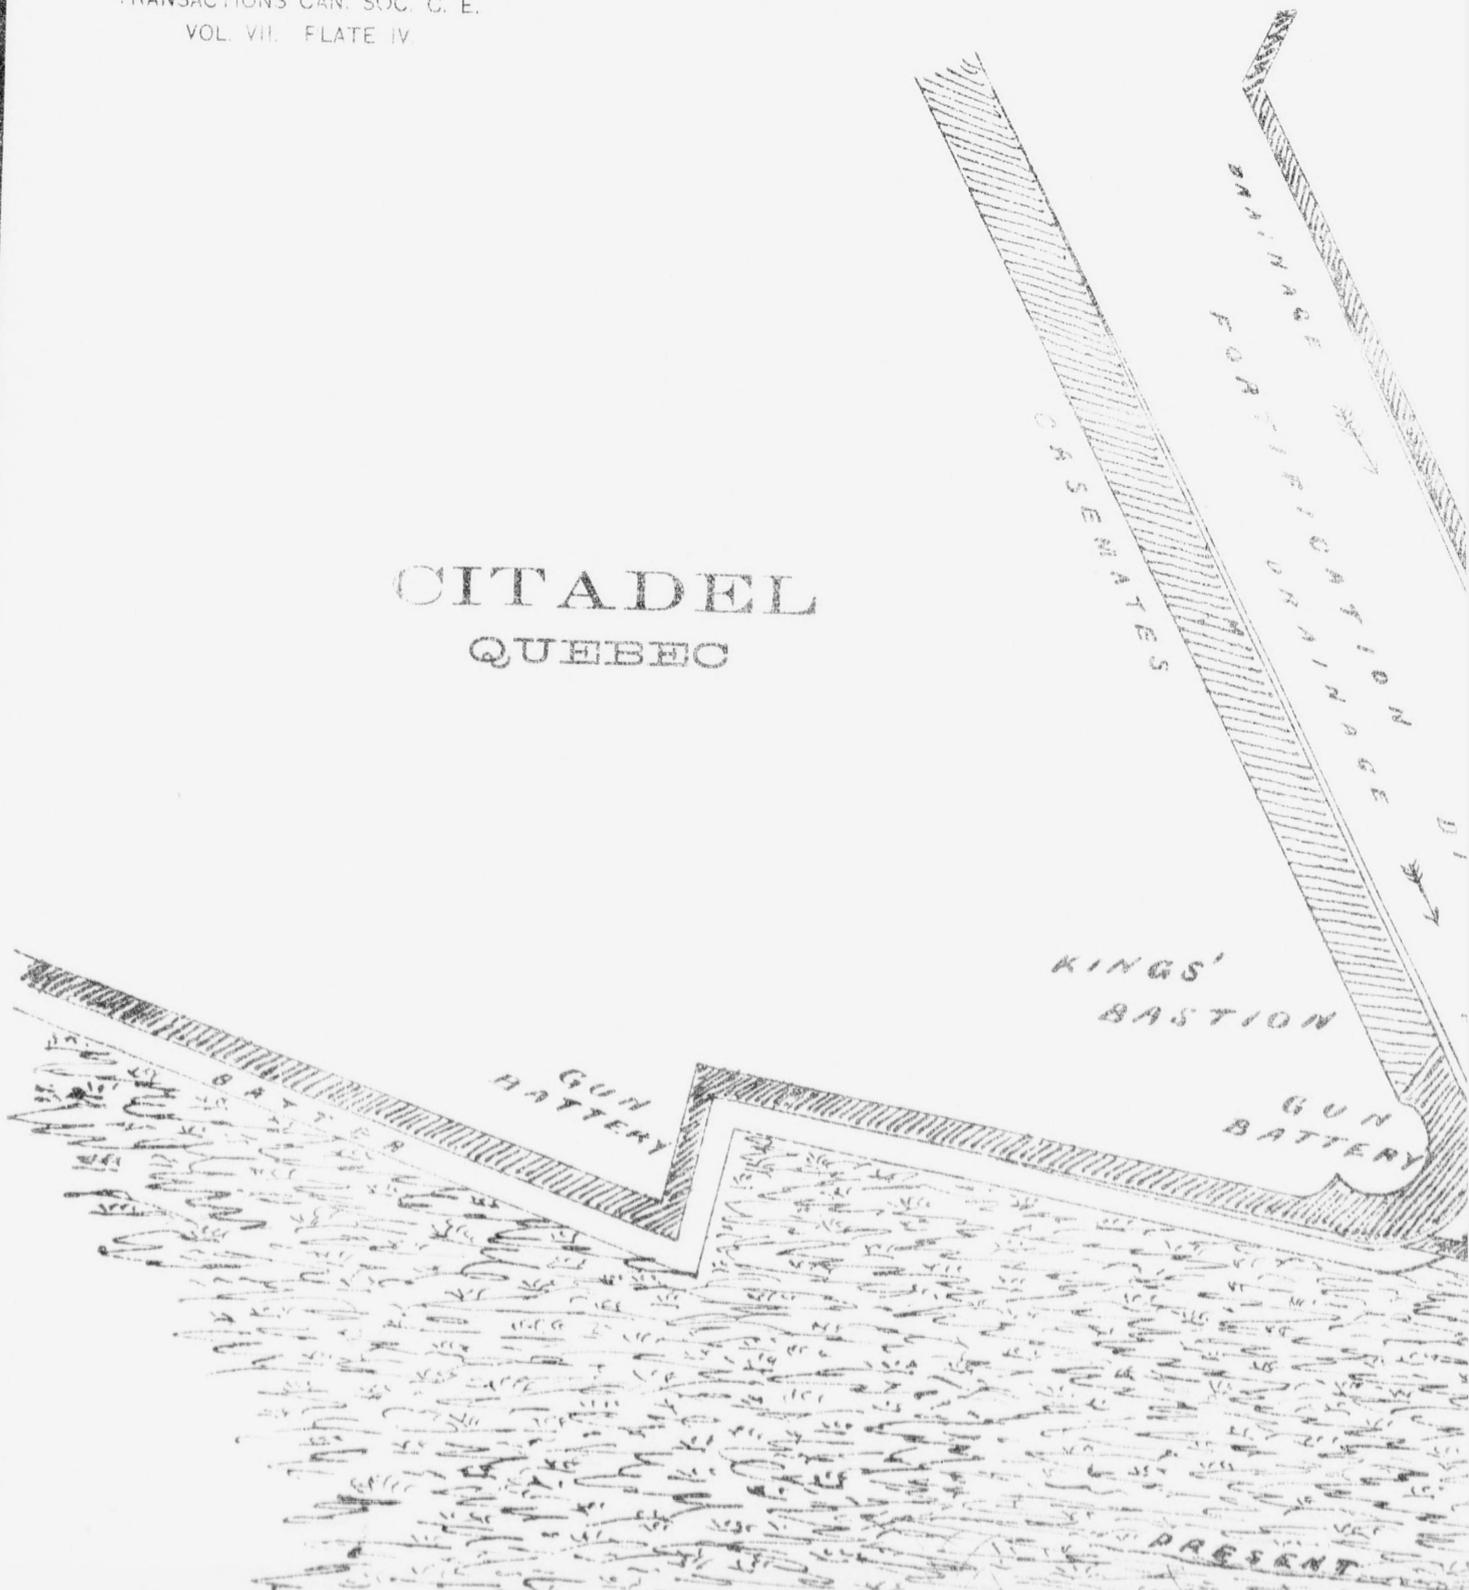
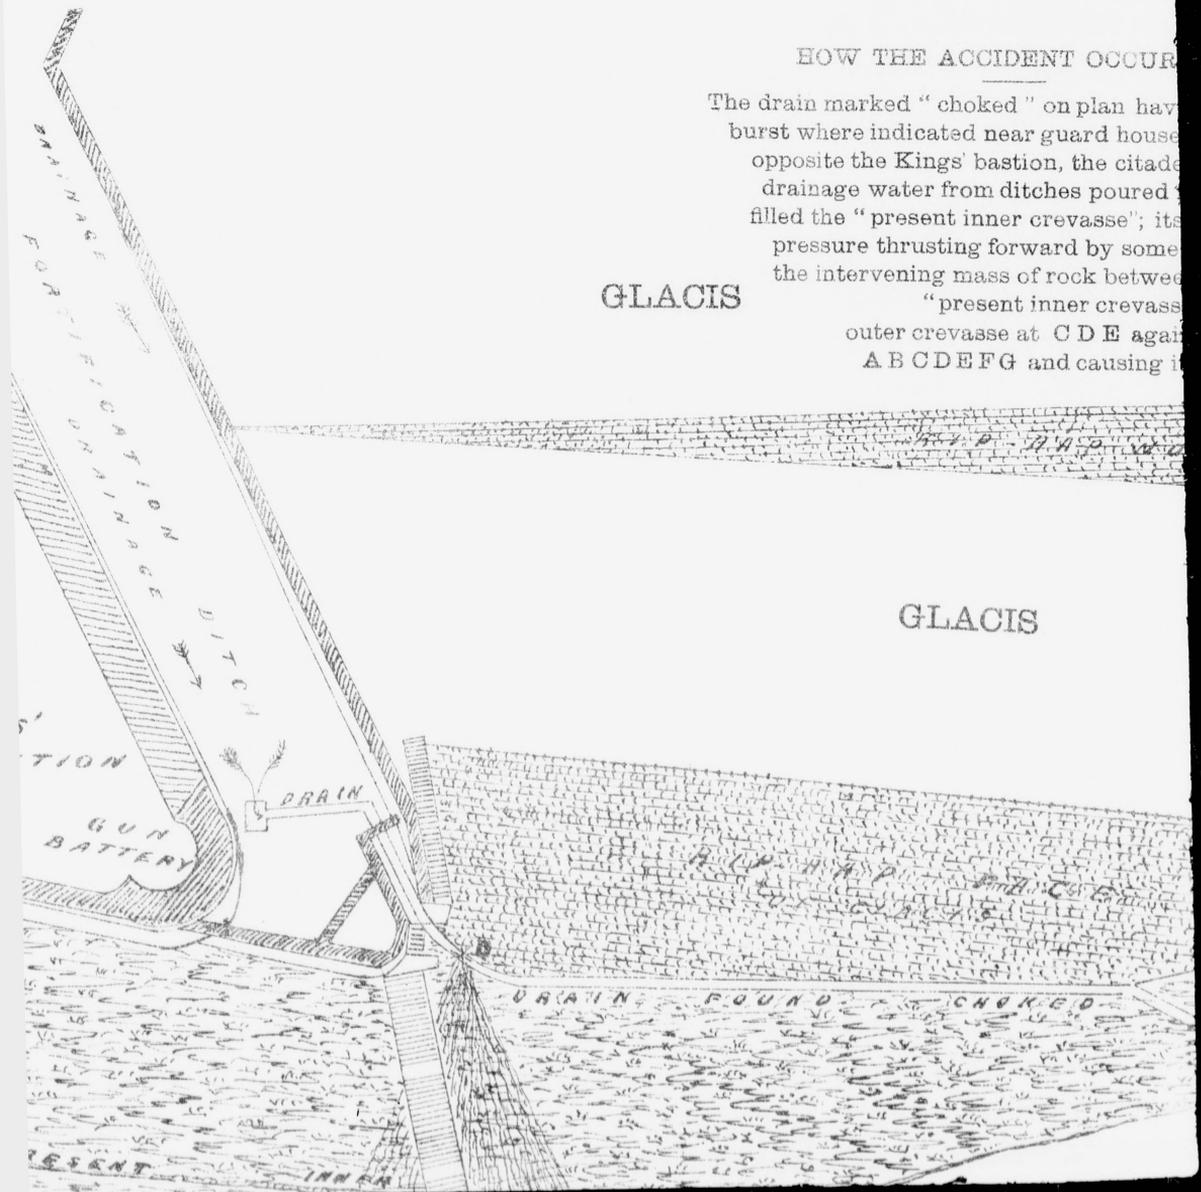
HOW THE ACCIDENT OCCURRED

The drain marked "choked" on plan having burst where indicated near guard house opposite the Kings' bastion, the citadel drainage water from ditches poured into the "present inner crevasse"; its pressure thrusting forward by some of the intervening mass of rock between the "present inner crevasse" and the outer crevasse at C D E again at A B C D E F G and causing it to burst.

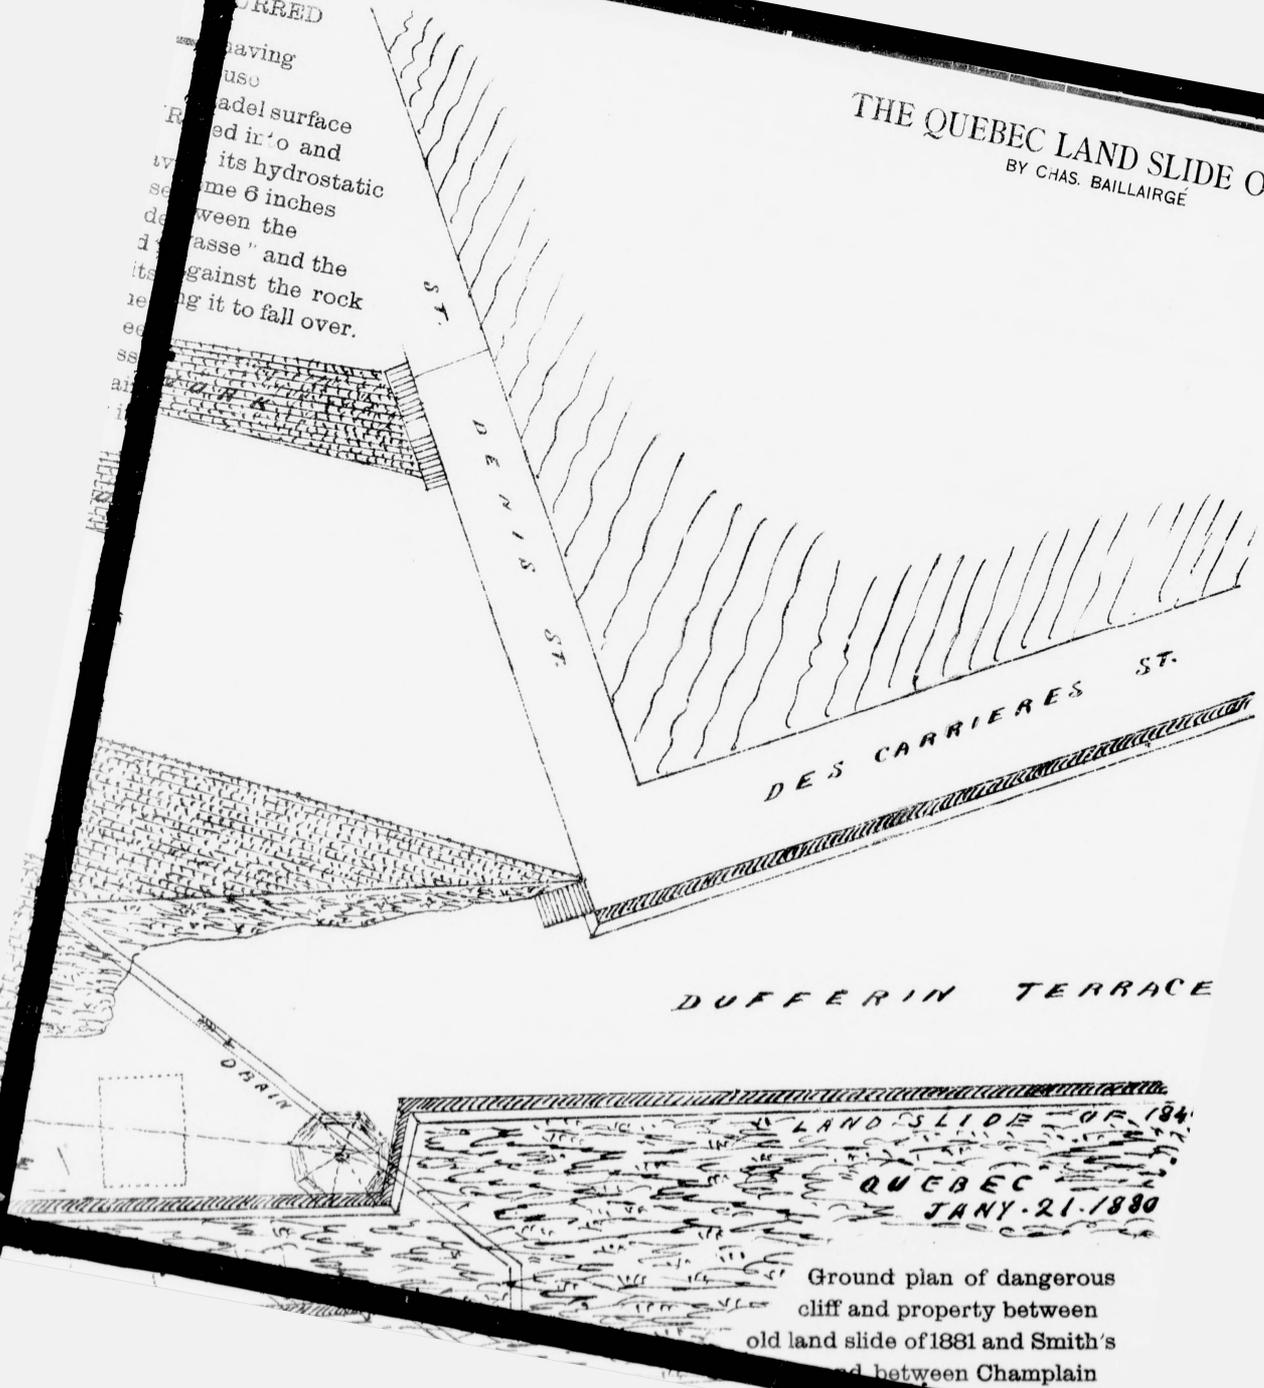
LAND SLIDE OF 1889
QUEBEC
JAN. 21. 1890

N. B. The "houses" so indicated along west side of Champlain St were after 1880 purchased by the Fed. Govt. demolished and a screen wall built along a b c d e to widen street and guard against stones from cliff rolling over roadway and thus causing accidents.

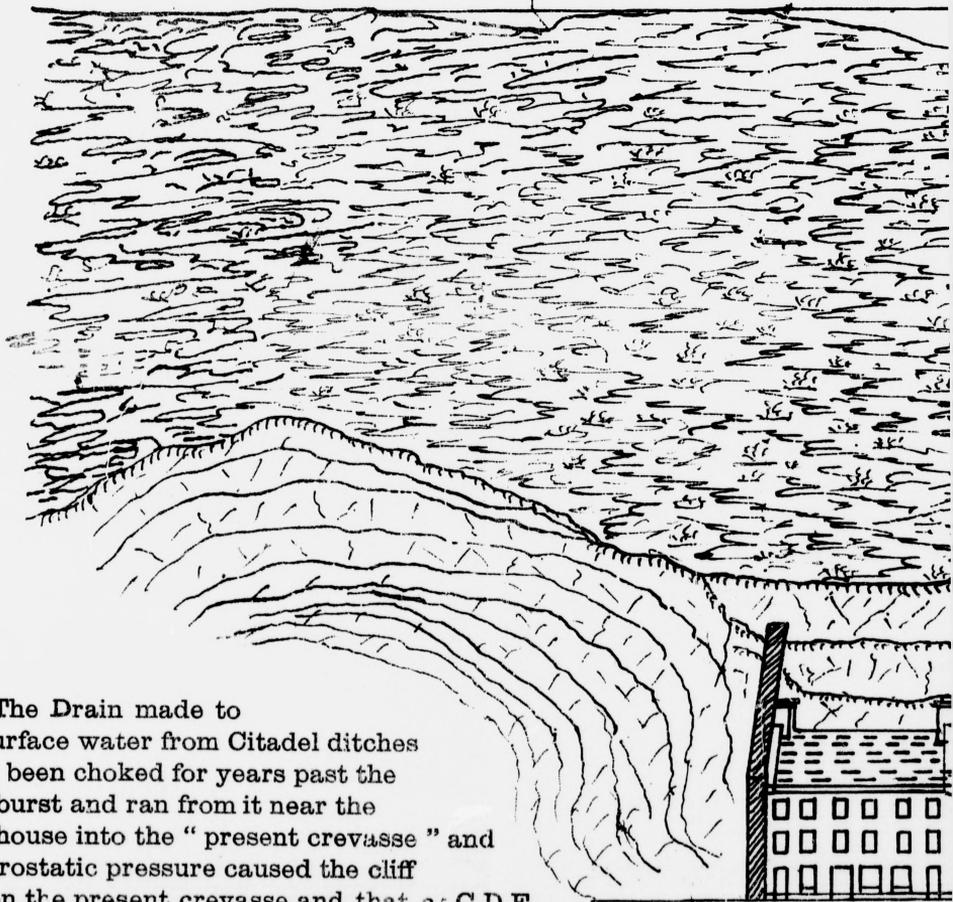
QUEBEC CITADEL

N. B. The Drain made to take surface water from Citadel ditches having been choked for years past the water burst and ran from it near the guard house into the "present crevasse" and by hydrostatic pressure caused the cliff between the present crevasse and that at C D E to move forward some 6 inches at D which pushed forward the rock beyond D and caused it to fall over.

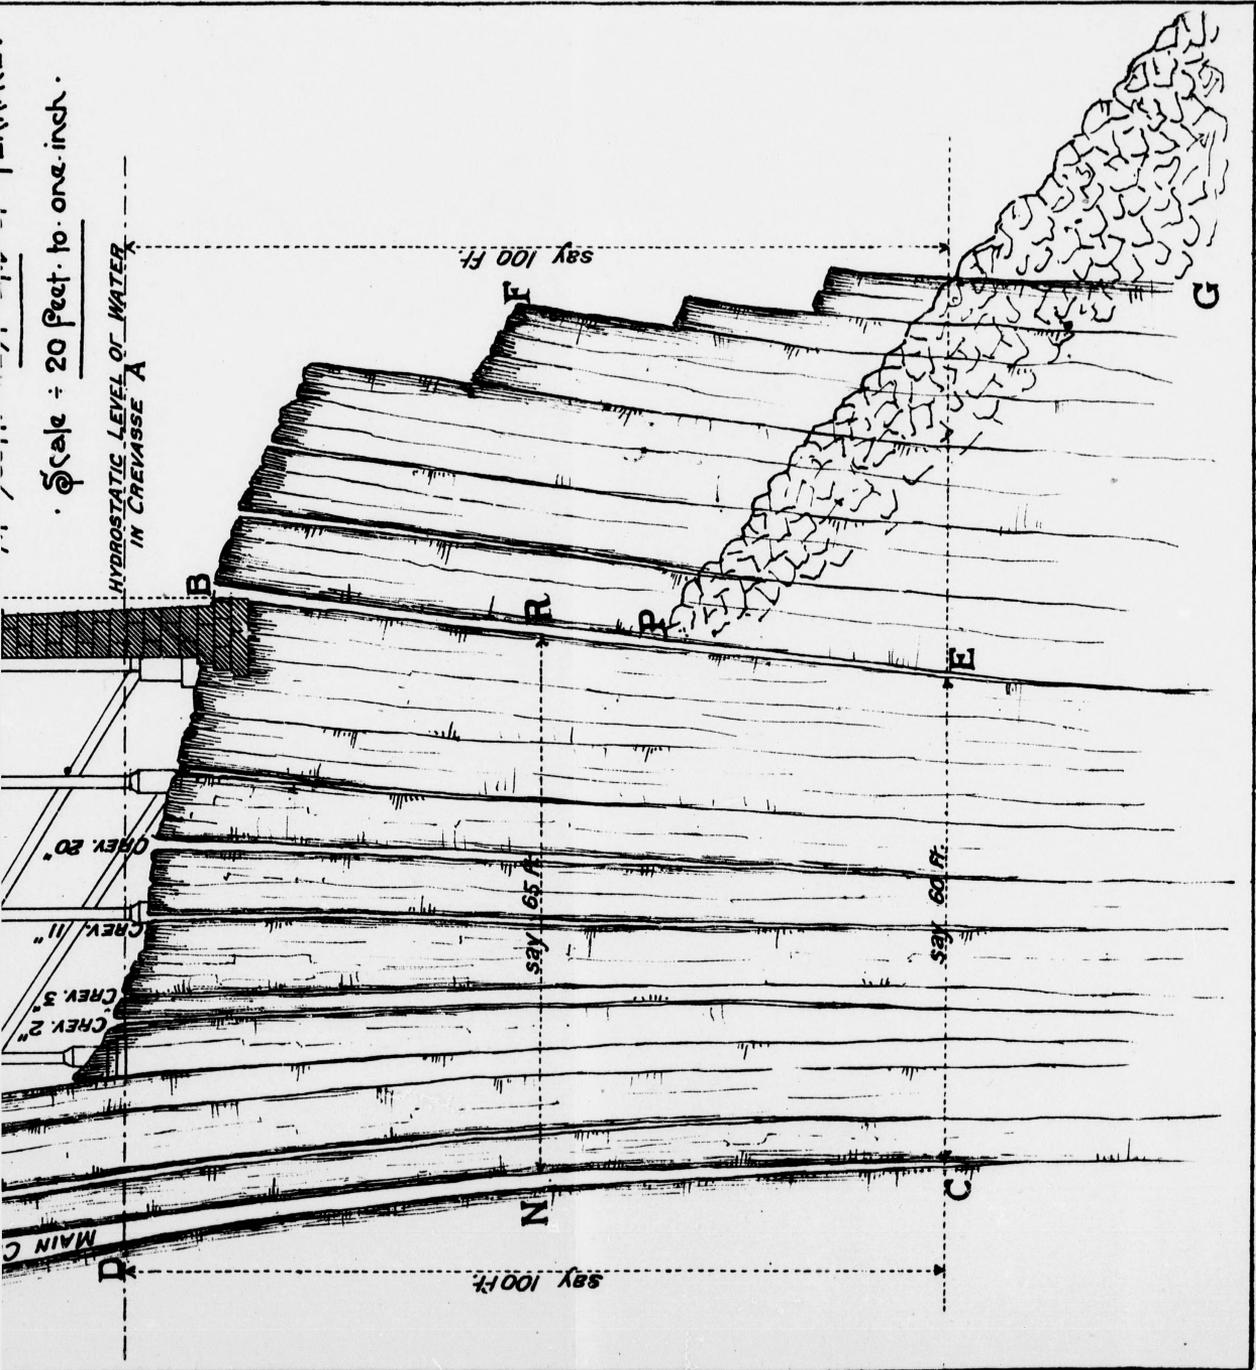
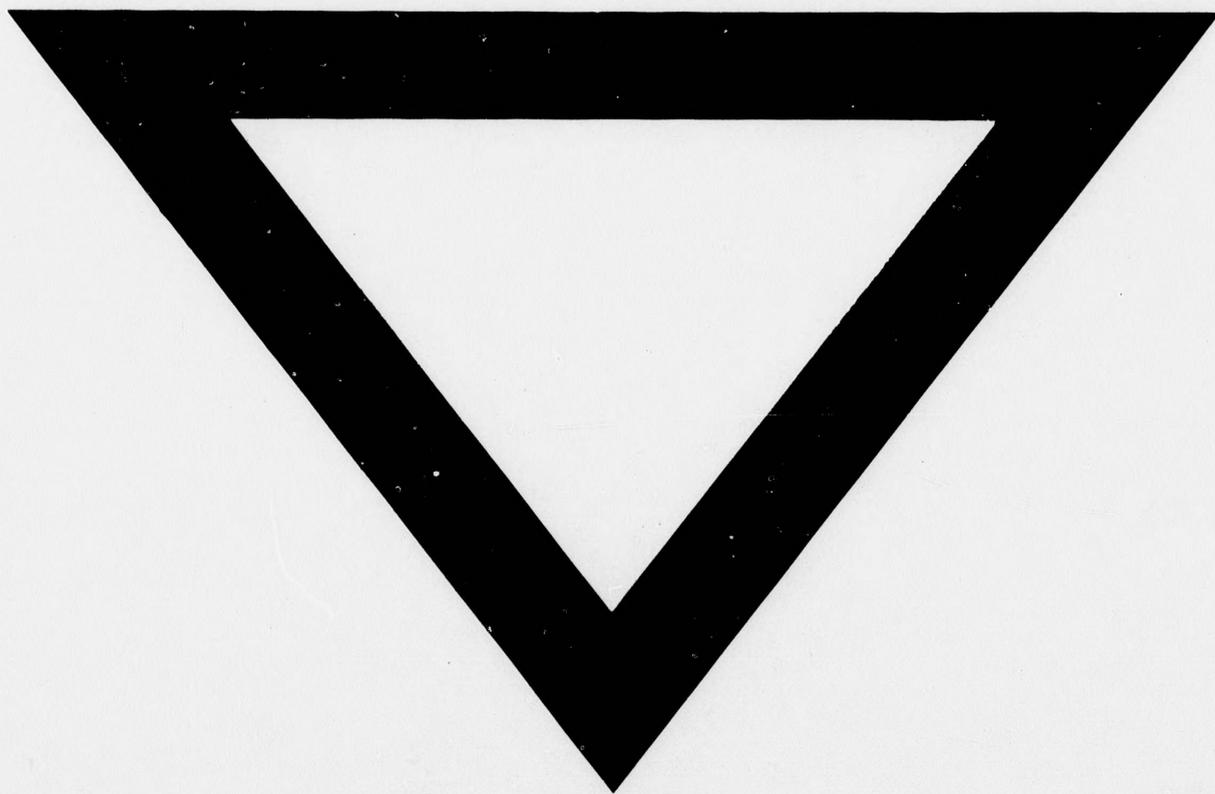
· VERTICAL · CROSS · SECTION · OF · CLIFF ·

· HYDROSTATIC LEVEL OF WATER
· IN CREVASSE A ·
