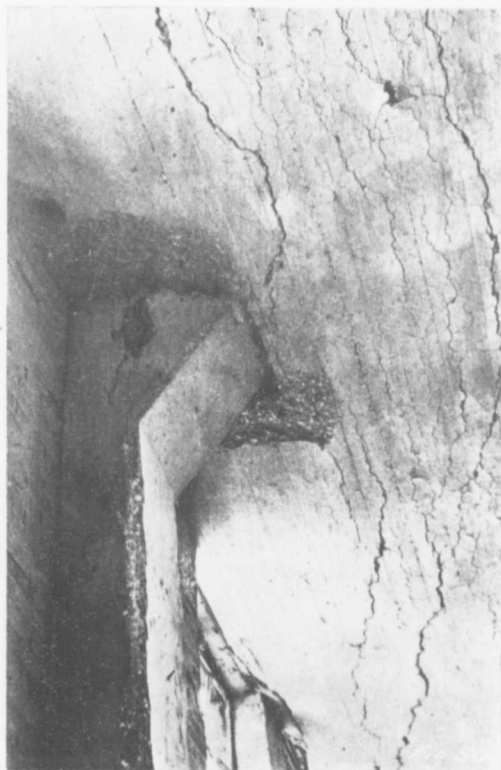
Fig. 13. A column which forced its way through ceiling.
