WASWANIPI HOUSE: 1 entry vestibule. 2 hallway. 3 closet. 4 toilet. 5 kitchen. 6 bedroom. 7 living/dining. 8 bathroom. 9 Band Manager's office. 10 Chief's office. 11 storage. 12 Clivus Multrum tank. 13 solar collector. 14 thermal storage.

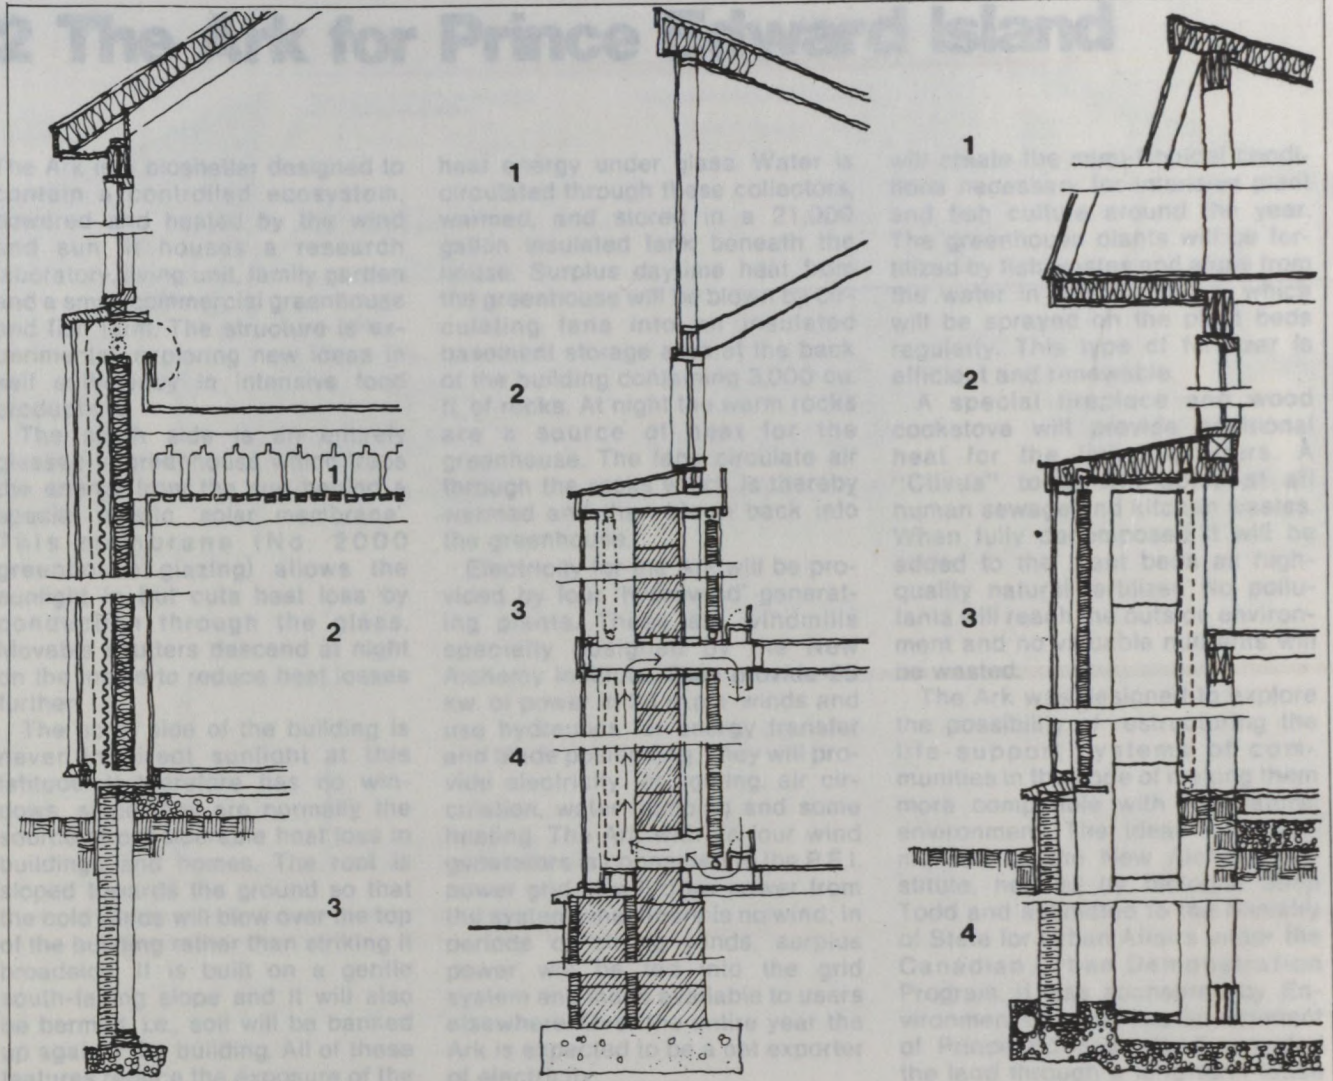
SECTION, SOUTH WALL OF WASWANIPI UNIT: 1 plastic bottles between two floors store heat. 2 absorber plate, wire mesh and transparent acrylic cover form heat collector. Corrugated insulation layer is between collector and house interior. 3 glass-reinforced plastic insulative drainage layer protects wood foundation.

SECTION, SOUTH WALL OF POINTE BLEU UNIT: 1 double transparent acrylic cover. 2 sliding double-glazed sealed windows. 3 glass-reinforced plastic insulating curtain for night use. 4 concrete block, painted black, absorbs daytime heat which can be circulated through house by opening vent at second floor.

SECTION, SOUTH WALL OF MISTASSINI UNIT: 1 acrylic transparent cover over greenhouse. 2 case-ment windows. 3 oil barrels filled with chemical solution are painted black on outside, white toward interior. Glass-reinforced plastic insulating curtain keeps heat in at night. Transparent acrylic admits sun to warm solution by day. 4 wood foundation has glass-reinforced plastic insulative drainage layer.

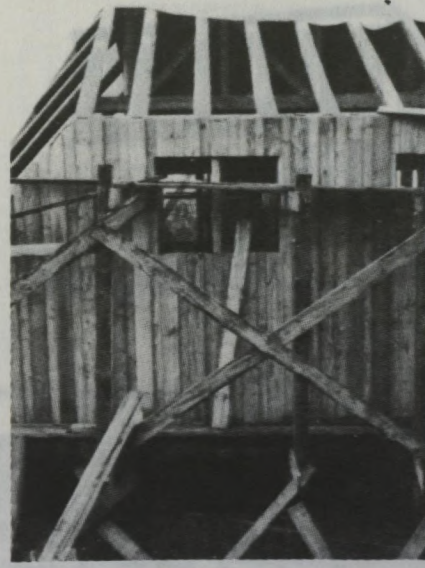
5 North wall bedroom window and roof framing, Waswanipi house.
