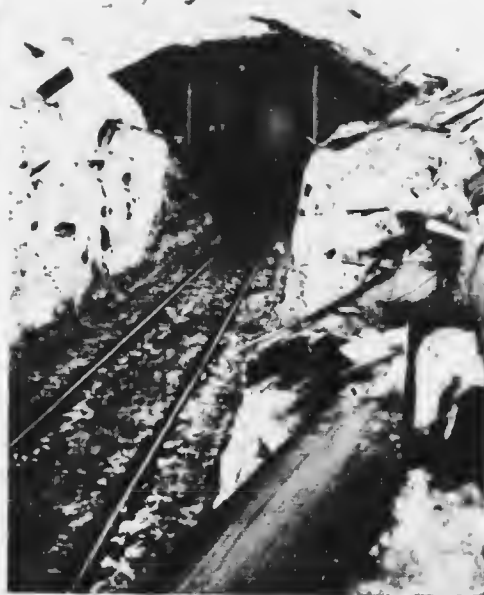
END OF SNOW-SHED AFTER SLIDE HAS BEEN  
CLEARED OUT.

Observe the baulks of timber brought down by the avalanche.
