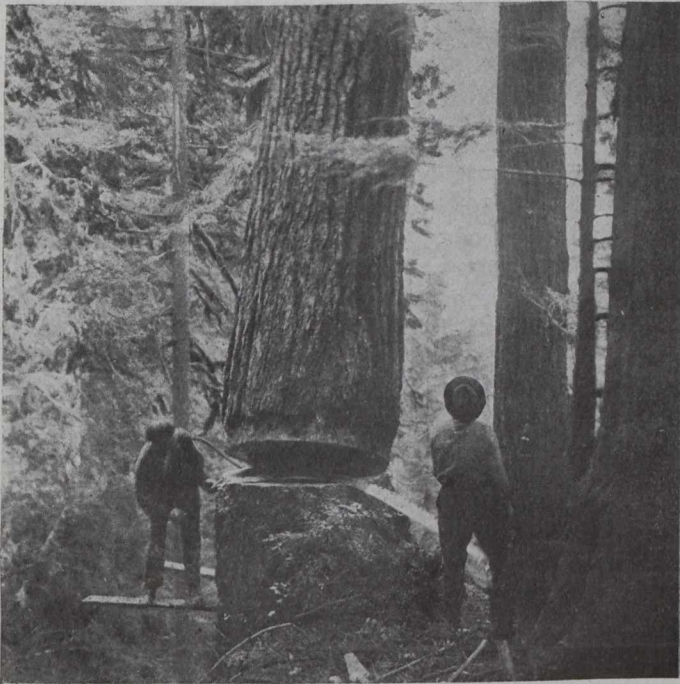
Fig. 4.—Falling Timber on the Banks of Coquitlam Lake. A Beautiful "Fall."

of all timber and underbrush, which was burned and disposed of. The swamp areas were surveyed by the writer and comprised some 255 acres; these areas were given special attention in clearing. The thoroughness with which this work was carried out is indicated by Fig. 4. The trees were eventually cut down level with the ground.

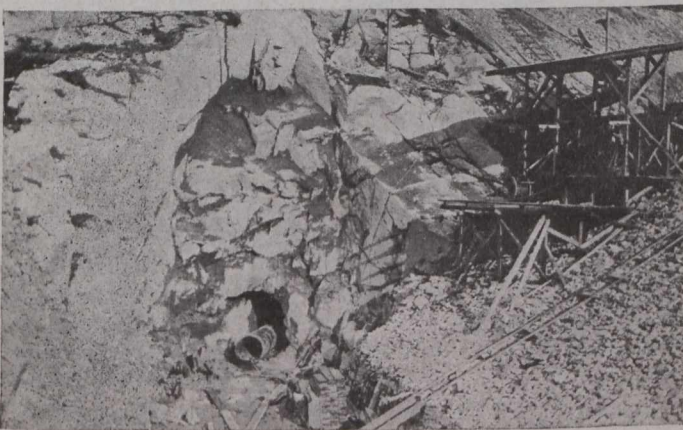
Fig. 5.—Foundation for Water Tower—4-ft. Pipe in Entrance of Tunnel. Note Solid Rock Foundation.

The Water Tower and Approach Tunnel.—This work was carried out entirely by the Vancouver Power Co. It will be seen from the photographs and the plans (see Figs. 5, 6, 7 and 8) that the design is of no mean architectural outline, and that it harmonizes with the surroundings. This is a case in which the engineer has appreciated the desirability of the beautifying of engineering structures and carried it out with great success. The tower is a heavy concrete structure built on bedrock on the east side of the lake, about 1,000 ft. north of the dam. The level of the floor of the tower is 428 ft.,

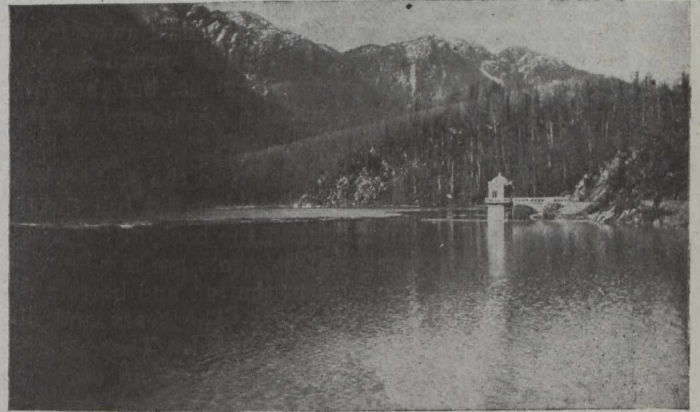
Fig. 6.—Water Tower with Lake Level Raised.

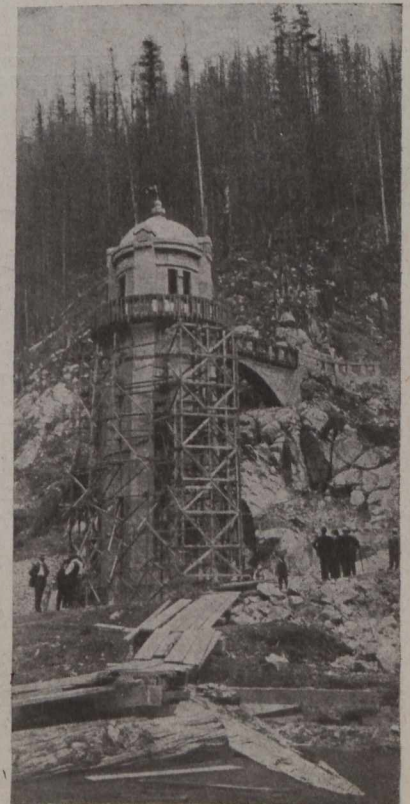
Fig. 7.—Water Tower, Front View.
